5-Year Condition Reassessment

Stepping Stones Lighthouse
Long Island Sound nr King's Point NY
Town of North Hempstead, Nassau County
WSA Ref No. 1701.02

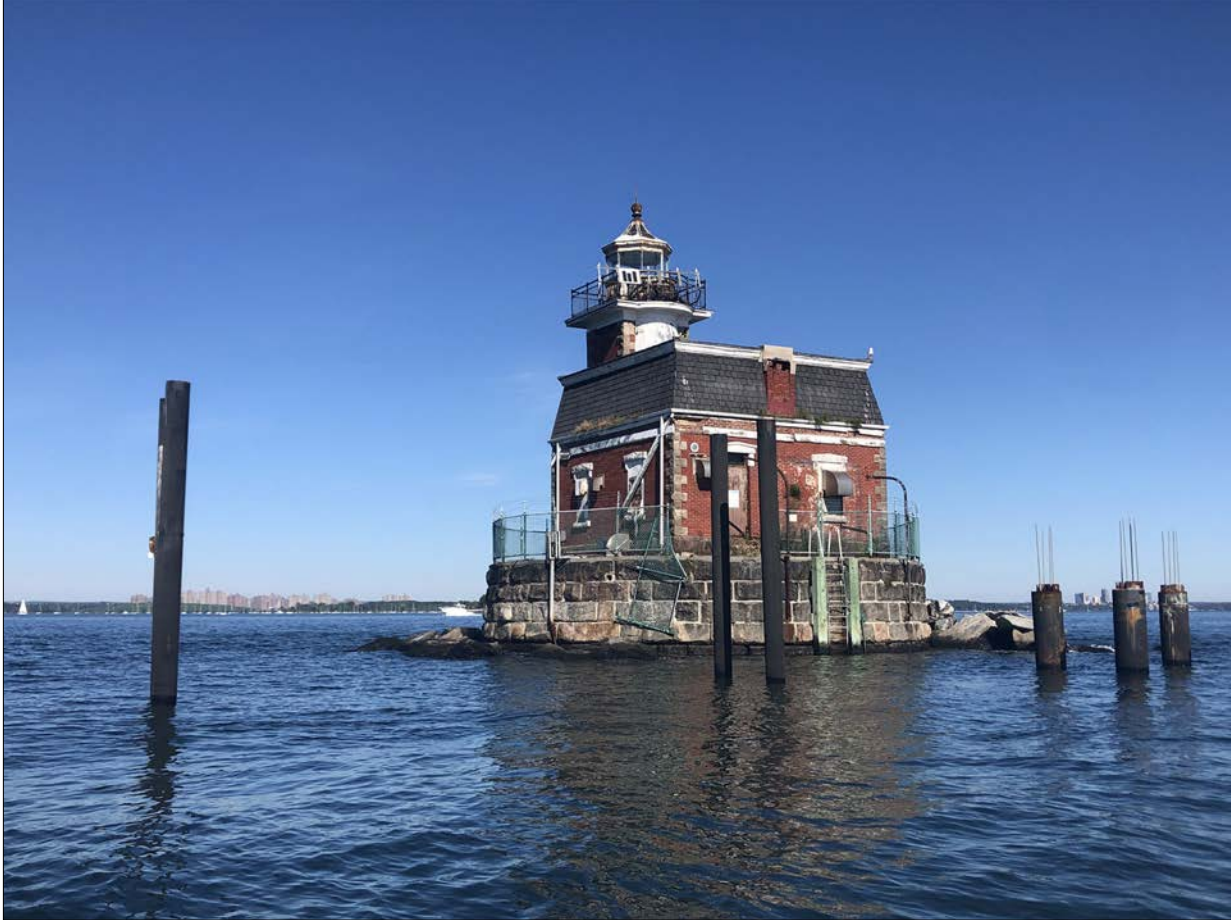
Photo 1. View of the approach to Stepping Stones Lighthouse, looking NE. Steel piles represent the initiation of a project to create a landing facility and gangway, which would simplify access for stabilization, restoration, ongoing operations & maintenance, as well as programmed visitation. Completion of the landing facility is an important and integral step in the ongoing stewardship of this historic Lighthouse.

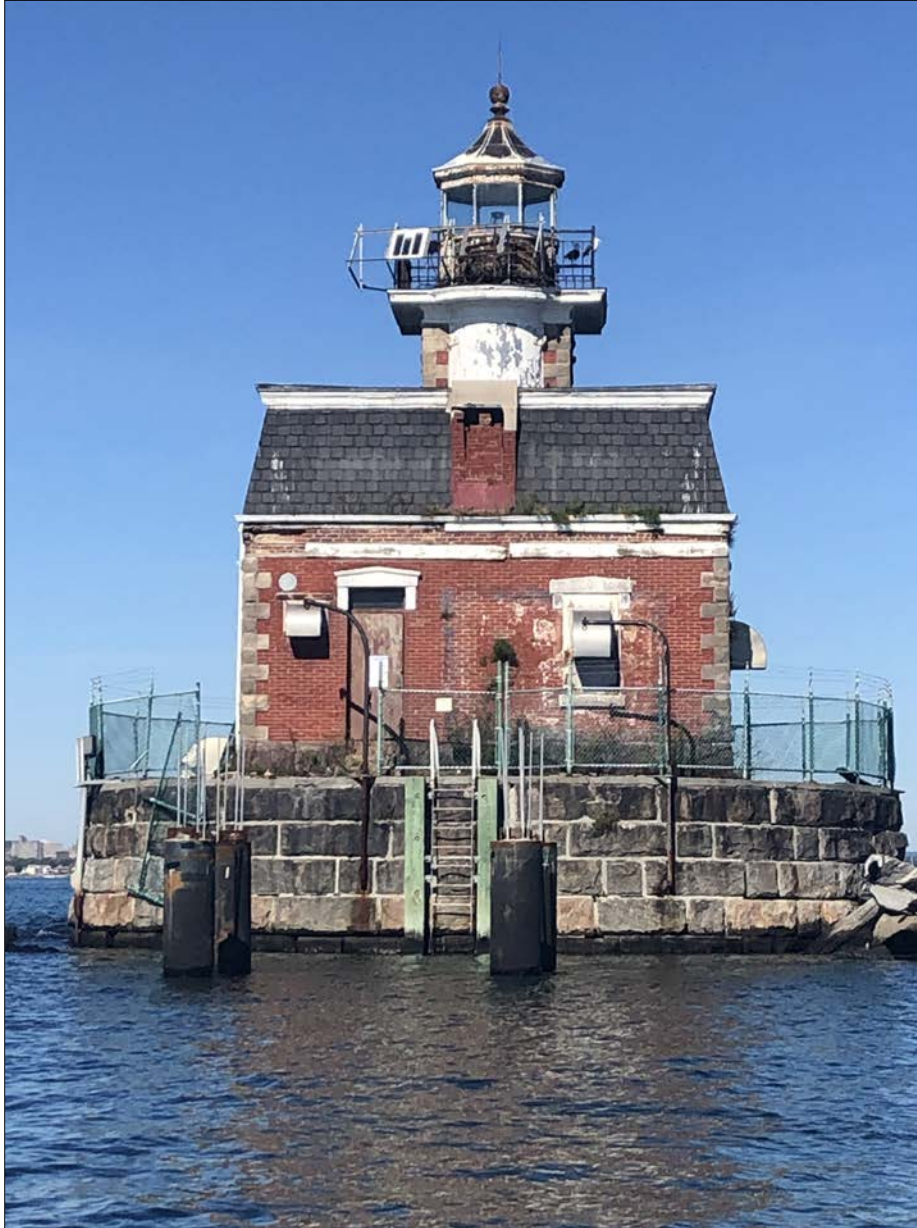
Photo 2. View of Stepping Stones Lighthouse, looking north. Surface conditions have worsened since WSA's 2017 report, but the underlying structure remains sound and imminently restorable. For now, stabilization of the site is paramount.

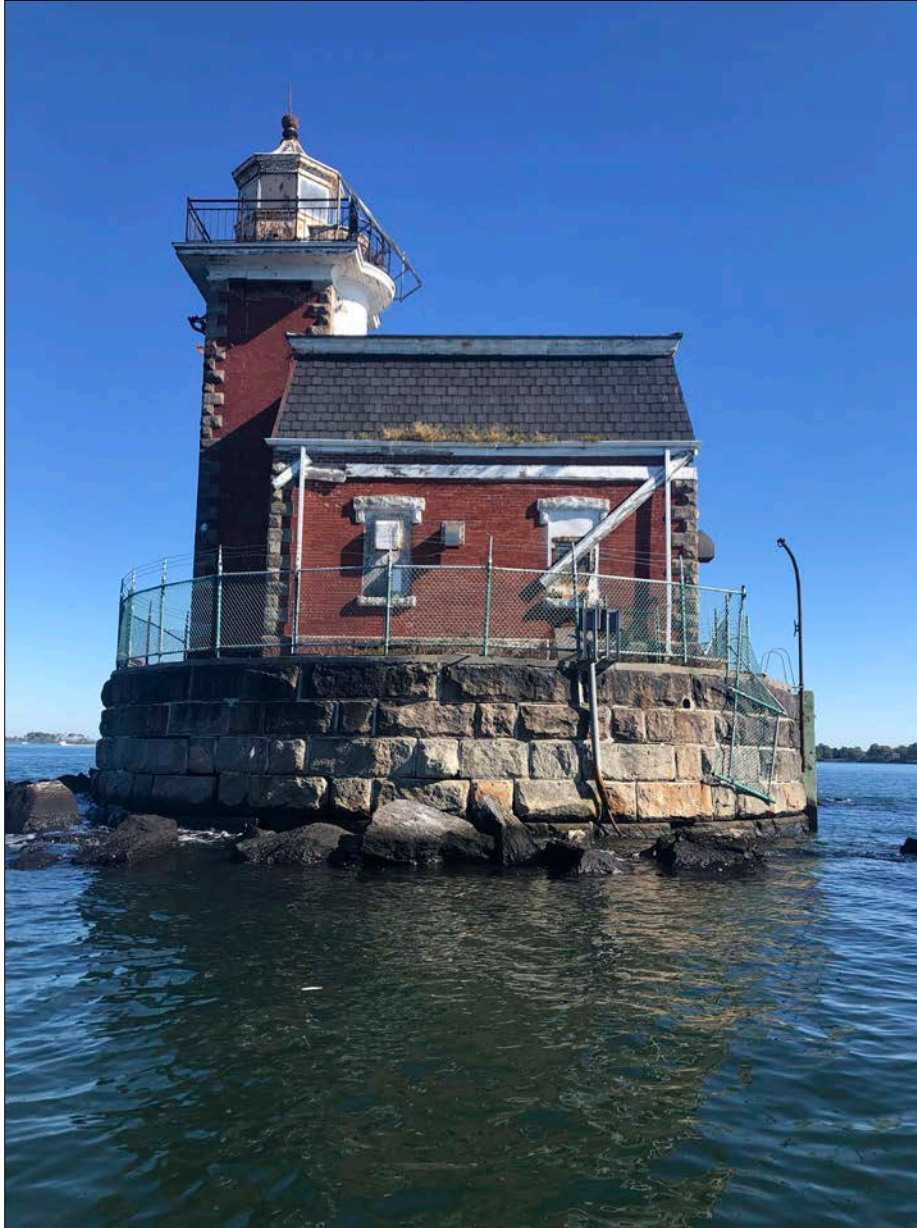
Photo 3. View of Stepping Stones Lighthouse, looking east. Surface conditions have worsened since WSA's 2017 report, but the underlying structure remains sound and imminently restorable. For now, stabilization of the site is paramount.

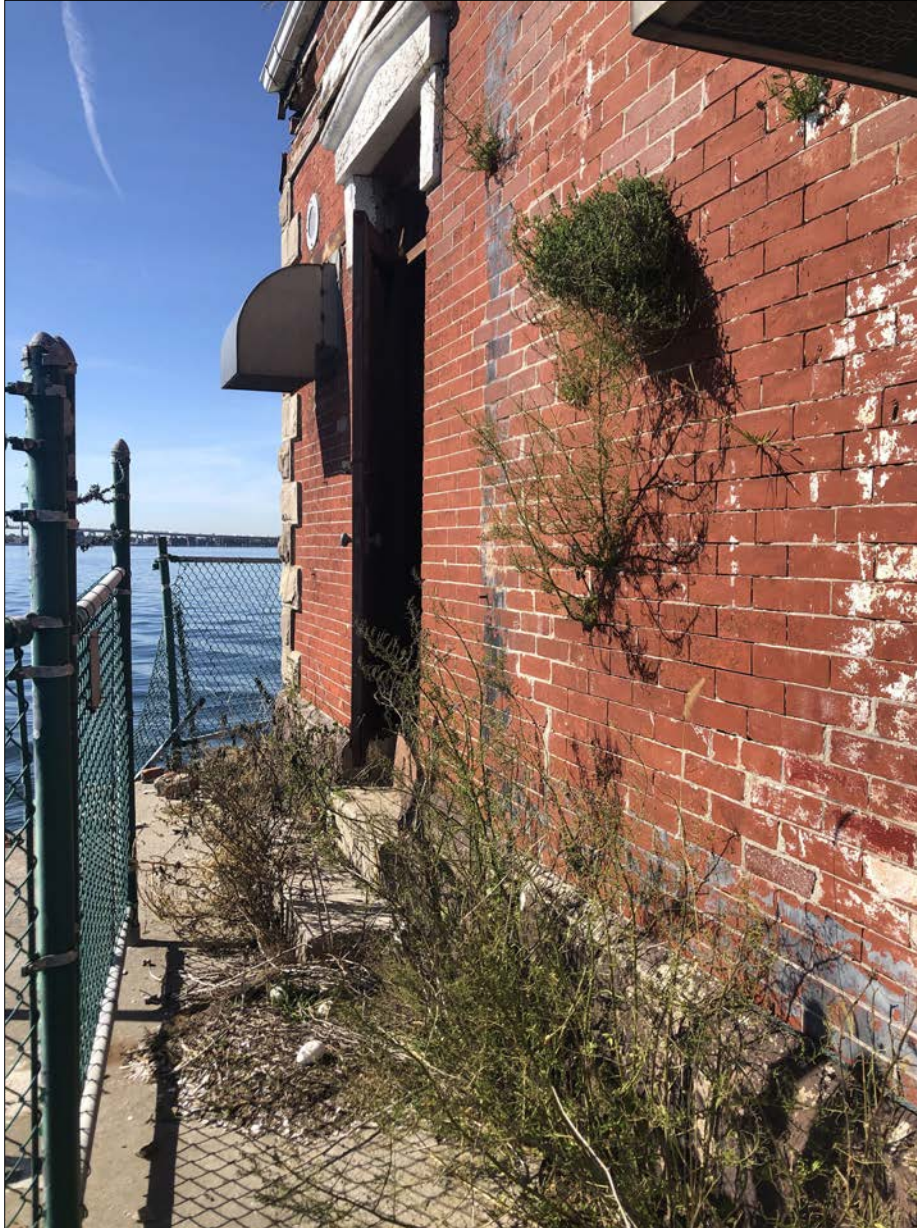
- The main (south) entrance to the Lighthouse is unsecured and difficult to properly close; there is evidence of unauthorized entry and vandalism within the Lantern.

Photo 4. View of south (landing) facade and unsecured entrance door, looking W. Nesting, vegetation and generally unkempt conditions send a signal that the site has been abandoned, which invites unauthorized access. Evidence of this already exists, and may affect the USCG's ability to properly maintain the light, which is an active aid to navigation.

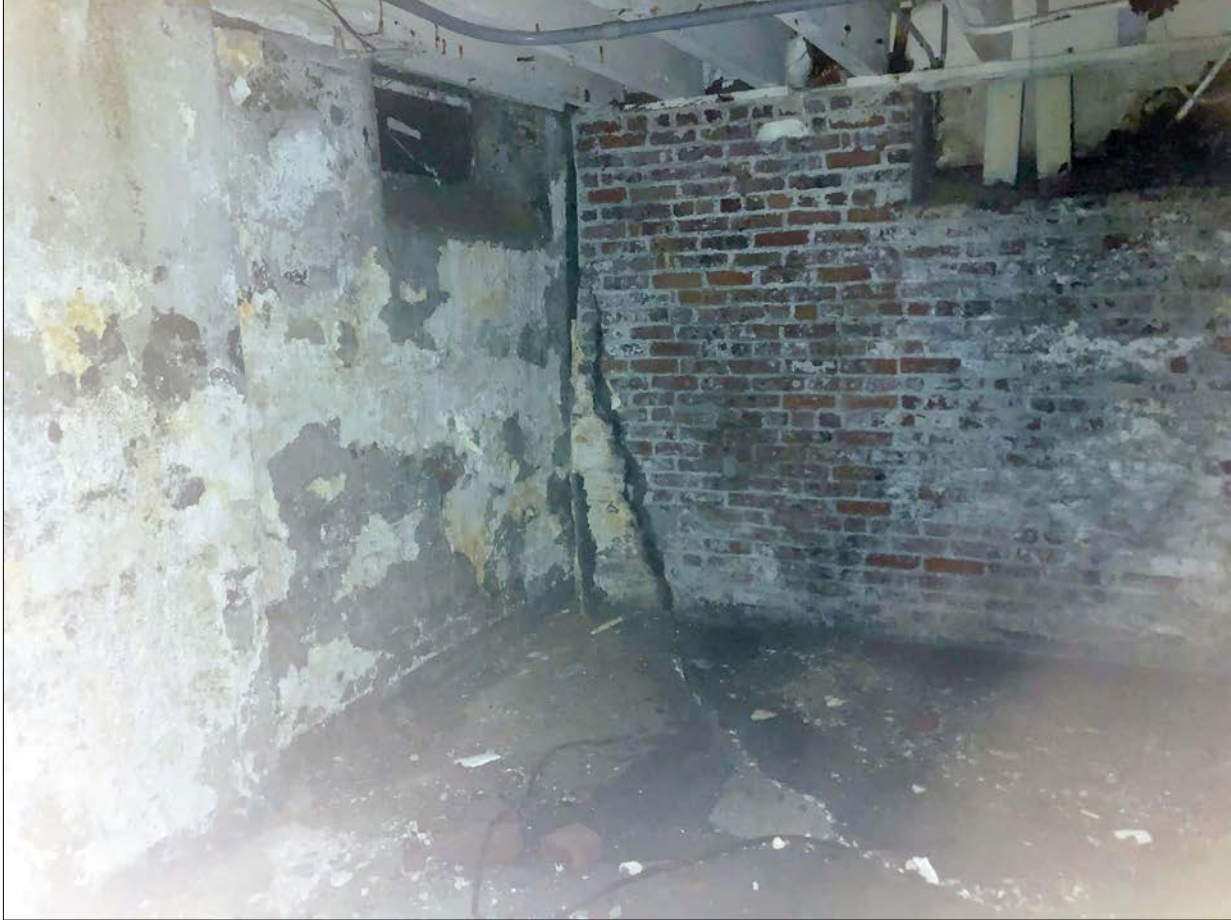
“Severe crack through foundation and concrete deck, oriented due north, permeating from beneath low tide water mark up through the north corner of the superstructure;

Present Condition & Priority Rating: This crack has continued to widen and propagate along its full length, reaching an open width of ± 1 ” in vulnerable locations. This is a significant pathway for water, ice, organic debris and microbiological growth. **HIGHEST PRIORITY**

Photo 5. Propagation of a crack through the concrete and masonry foundation was noted in WSA's 2017 condition survey. The crack continues to open because of the effects of ice forming, but it is not affecting adjacent elements significantly more than already noted in 2017.

1.201	Concrete: Stitch Open Crack Through Foundation Walls, Deck & Flooring	49,000
1.301	Stormwater: Refine Gutters, Leaders & Drainage Routing System	73,000

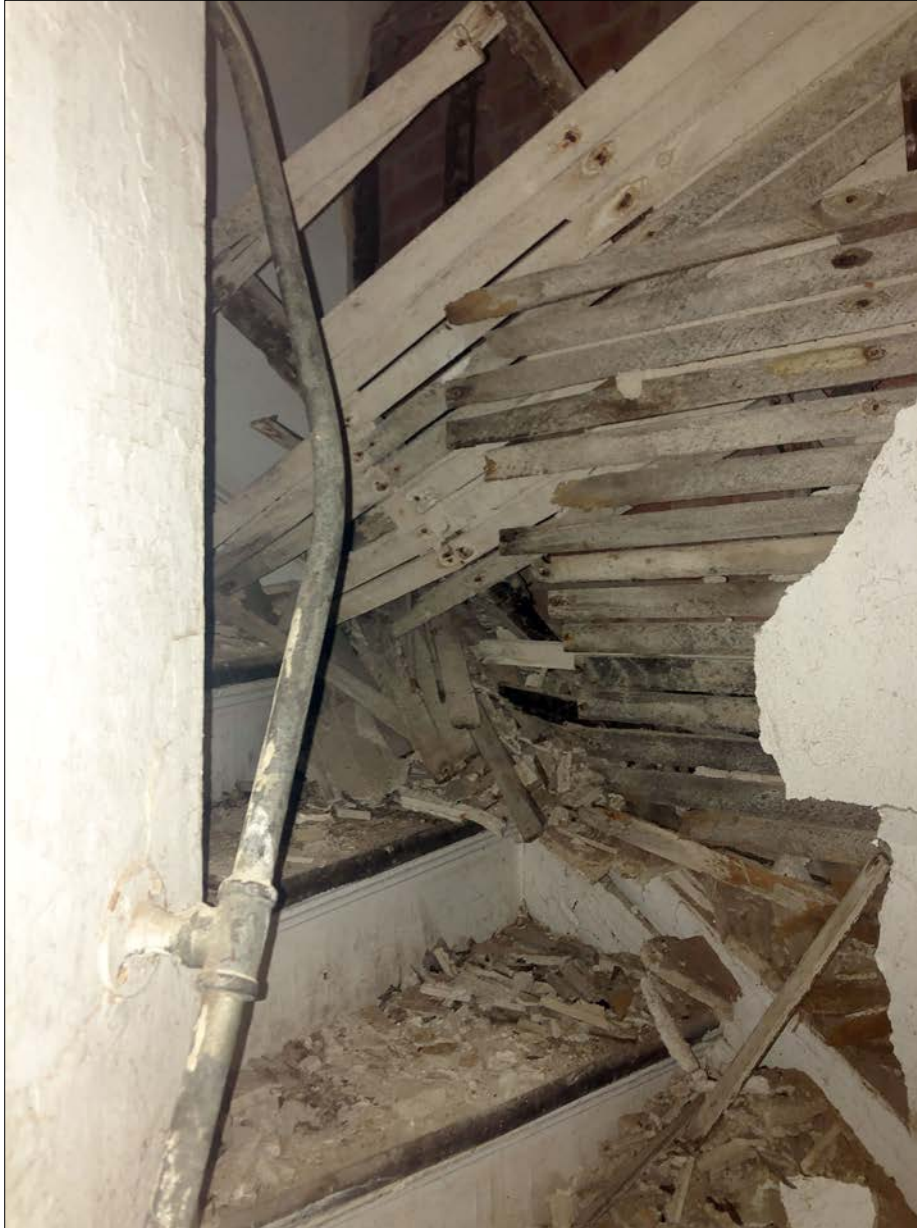
- Additional water migrating through dislodged brick & stone beneath the Lantern's west facade has caused nails securing plaster lath to rust; as a result, plaster has fallen within Tower stair.

Photo 6. Collapsed plaster & lath of the Tower stair, looking up. This is the direct result of water entering the structure and rusting the lath nails, and is a surface condition, not a structural failure. The Tower's dislodged masonry must be addressed (Photo 8) to stabilize this condition.

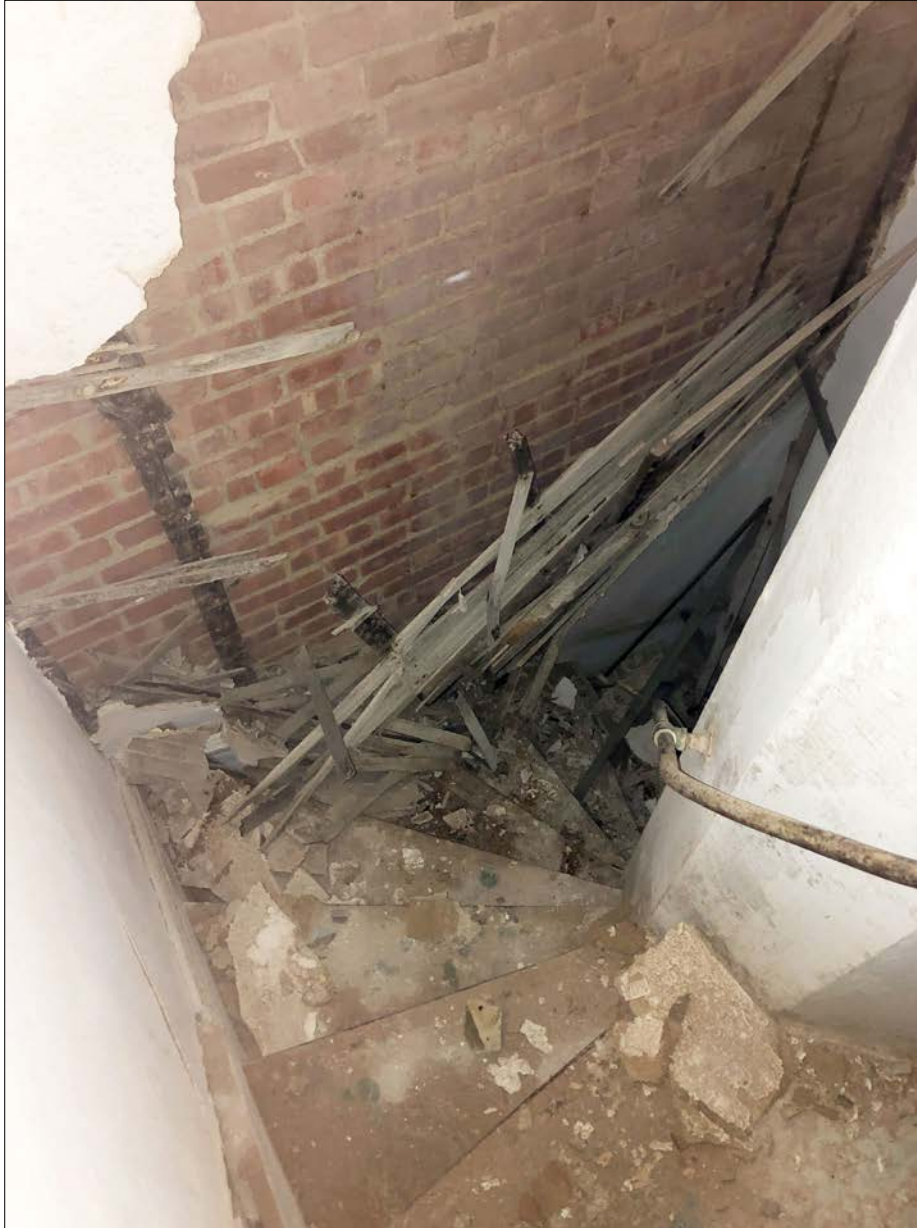
Photo 7. Collapsed plaster & lath of the Tower stair, looking down. This is the direct result of water entering the structure and rusting the lath nails, and is a surface condition, not a structural failure. The Tower's dislodged masonry must be addressed (Photo 8) to stabilize this condition.

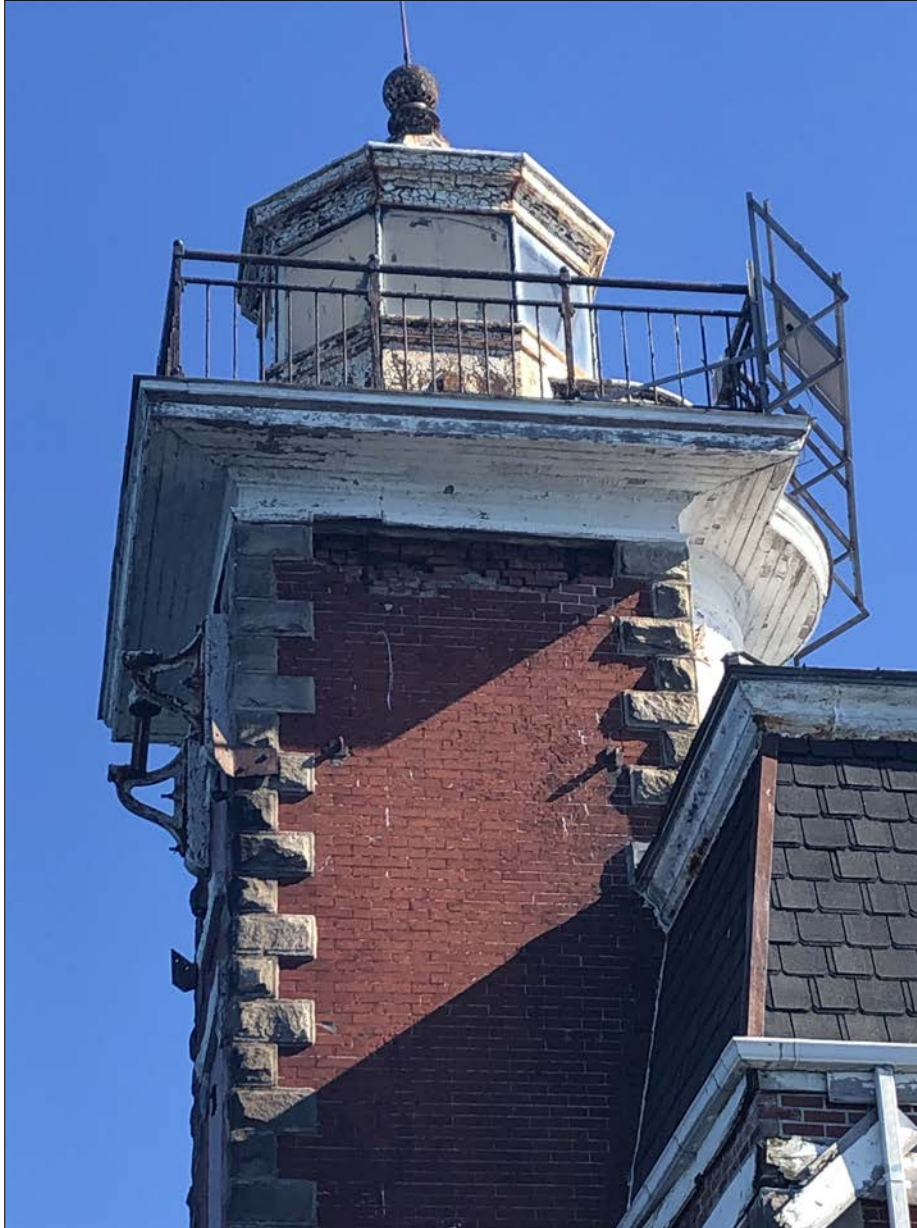
“Dislodged brick masonry directly beneath the lantern watch gallery on the northwest orientation of the tower (this condition is in possible danger of partially collapsing under the duress of a strong storm or wind event);

Present Condition & Priority Rating: This condition has worsened, now including the granite ashlar stones that were still in place in 2017; the entire band has fallen to the deck below. Resulting open backup masonry lacks the inherent structural capacity to indefinitely support the cast iron lantern above it, and it is allowing significant water to penetrate the Tower stair. **HIGHEST PRIORITY**

Photo 8. Dislodged brick at the upper reaches of the Tower's west facade was noted as a high priority concern in WSA's 2017 condition report, yet was never addressed. It has gotten worse, including fallen granite blocks in addition to the brick masonry. Resulting breach is unstable long-term, and allowing water to enter the Tower interior stairs, causing further damage. If attended to, this is a very straightforward masonry repair; if ignored, it's negative effects will accelerate.

1.101	Masonry: Replace Missing & Reset Dislodged/Rotated Foundation Stones	103,000
1.102	Masonry: Reconstruct Tower Cornice Band Brick & Stone	91,000
1.103	Masonry: Repoint & Stabilize All Exterior Brick & Stone Walls	79,000

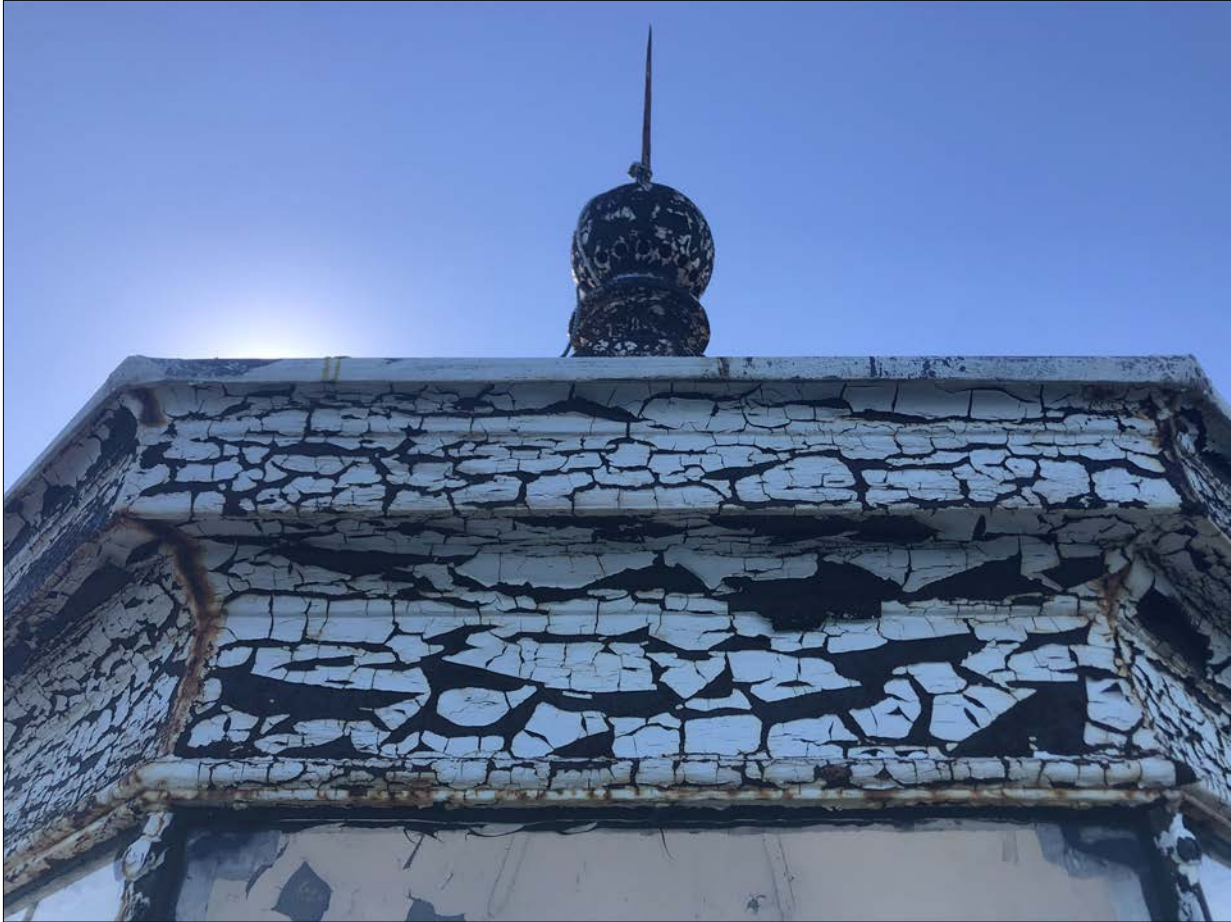
Photo 9. While degradation of the overpaint presents an image of vast deterioration, the underlying structure and surface conditions are sound. It looks far worse than it is. The ventilator ball and lightning protection system are intact and functioning; both are important contributors to the Lighthouse's well-being.

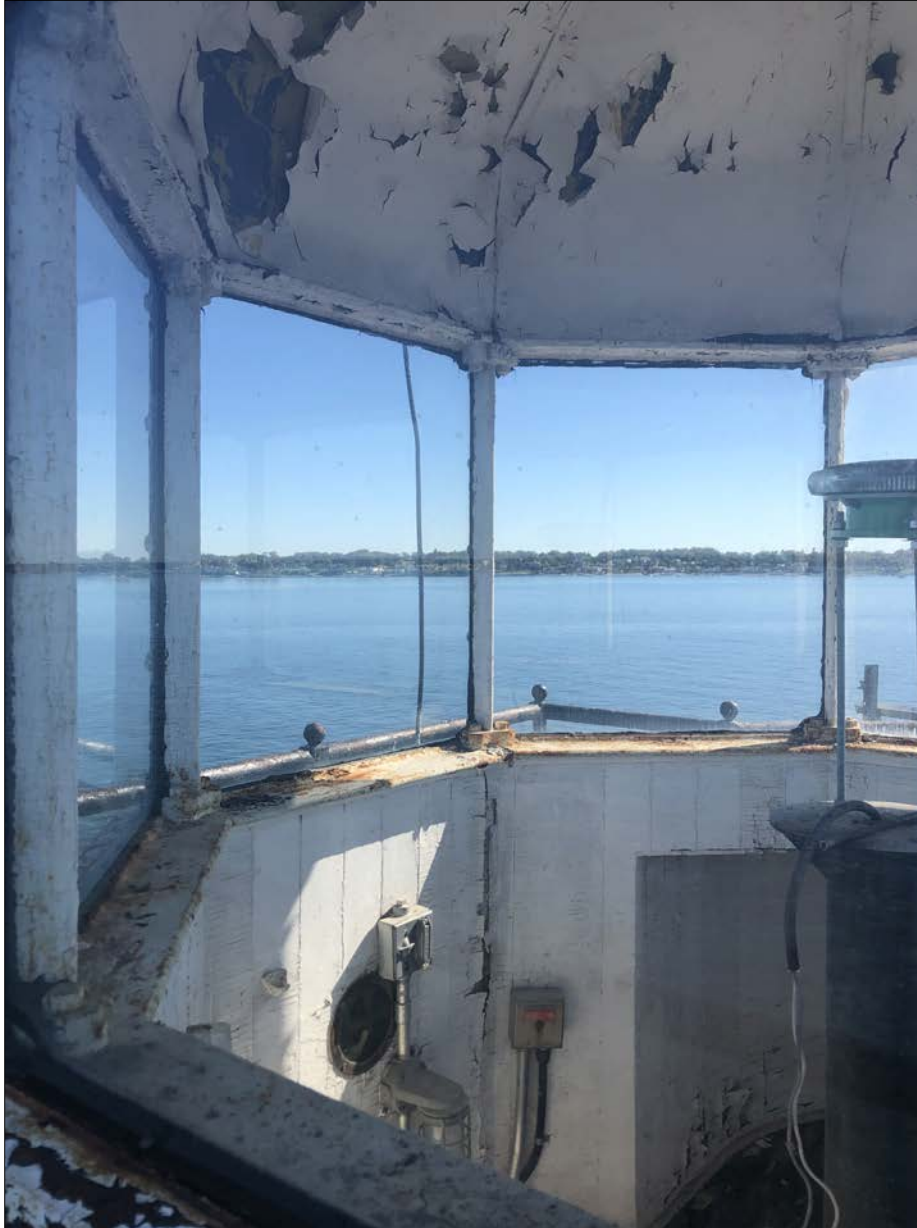
Photo 10. View of Lantern looking SE, toward King's Point. Generally, the space and its features are in relatively stable weathertight condition, with the exception of the dome liner, which shows damage likely related to unauthorized access via the unsecured south entrance door.

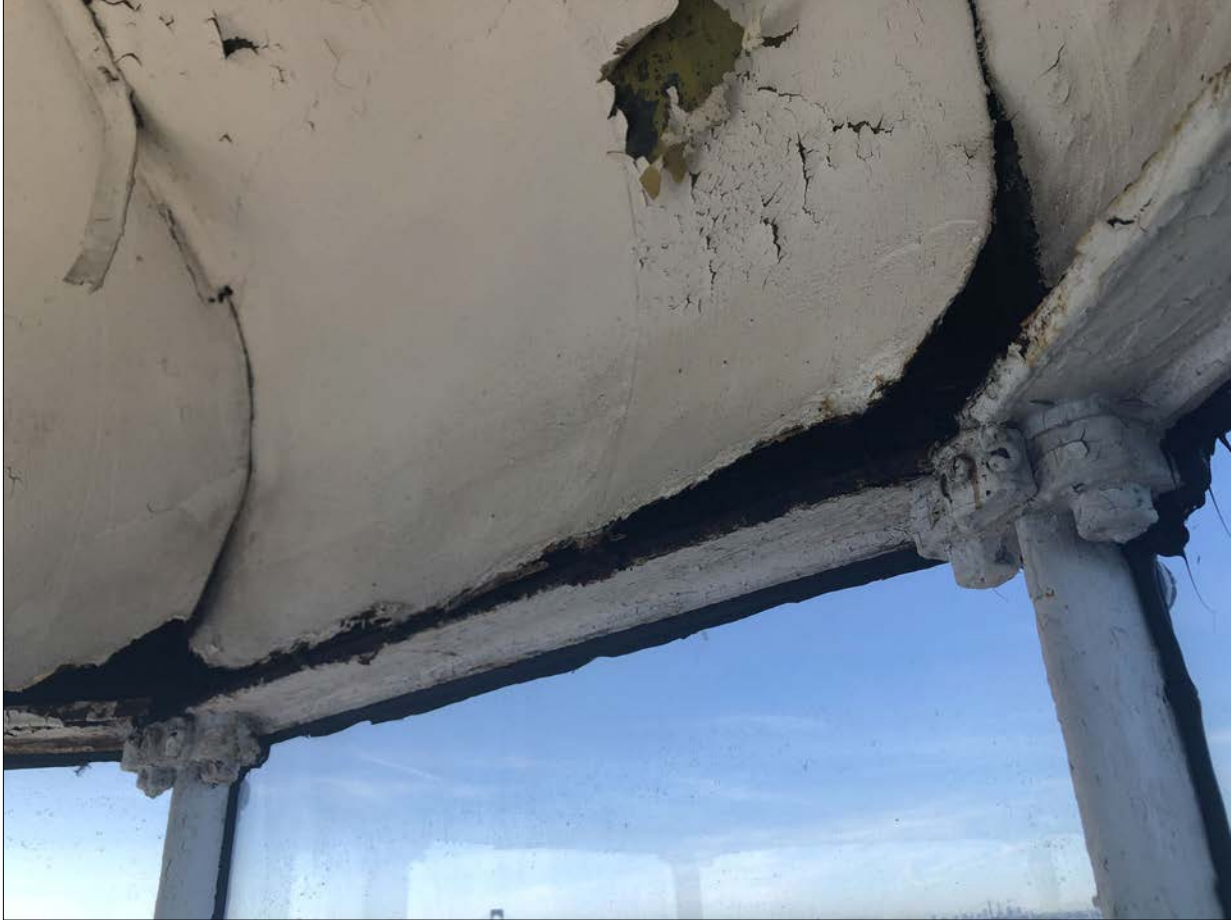
- The inner roof liner of the Lantern dome has been ripped away from its substrate along its base, rendering it deformed and allowing water to collect and drip onto the Tower stairs below.

Photo 11. Breaches in Lantern dome liner. The nature of the damage seems to indicate vandalism rather than the result of natural effects, such as rust jacking or ice forming behind the sheets. Inner surfaces are very wet.

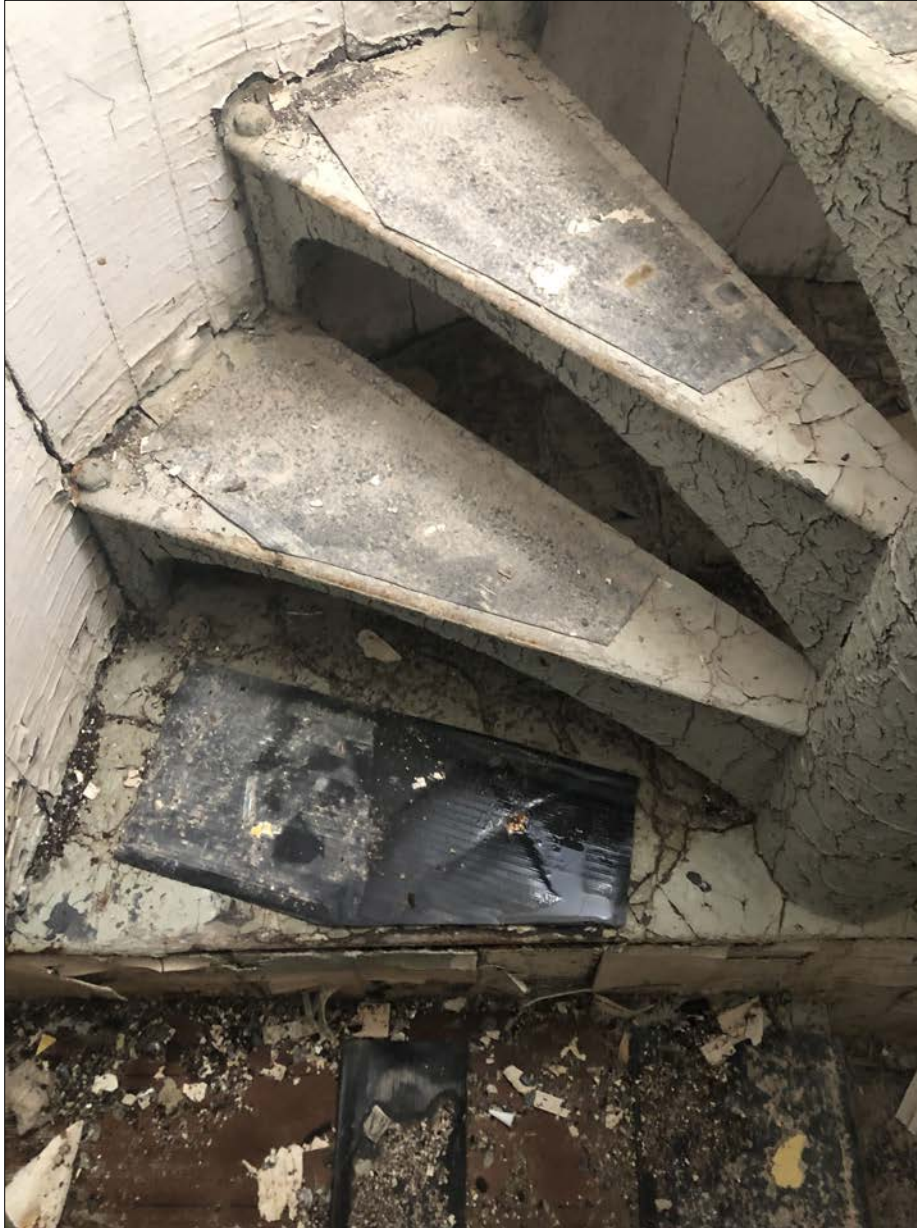
Photo 12. Accumulated water within Lantern dome liner is continuously dripping on Lantern stairs & flooring, affecting Service Level ceiling below.
