ST. JAMES FIREHOUSE CONDITIONS ASSESSMENT REPORT

533 NY-25A ST. JAMES, NY 11780

ISSUED: 08 September 2020

APS PROJECT NO: 20-018

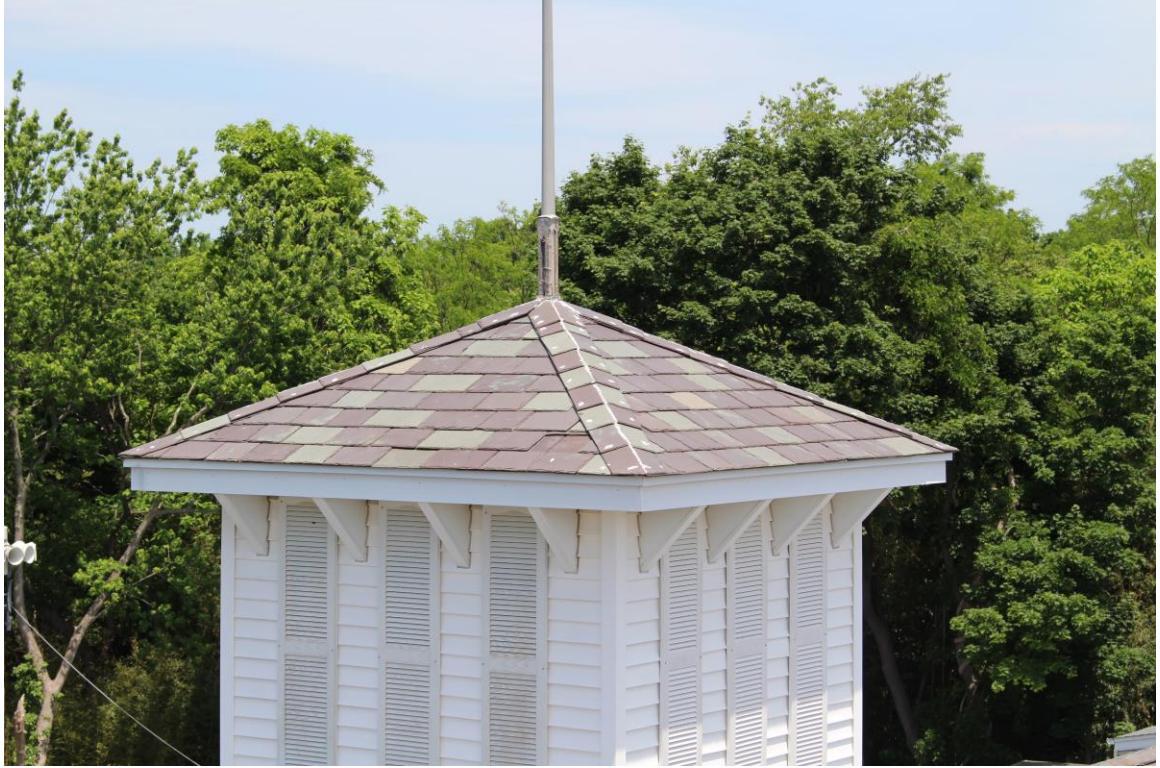
Figure 3-3 Slate roofing – Cupola. Deteriorated hip tiles, broken tiles.

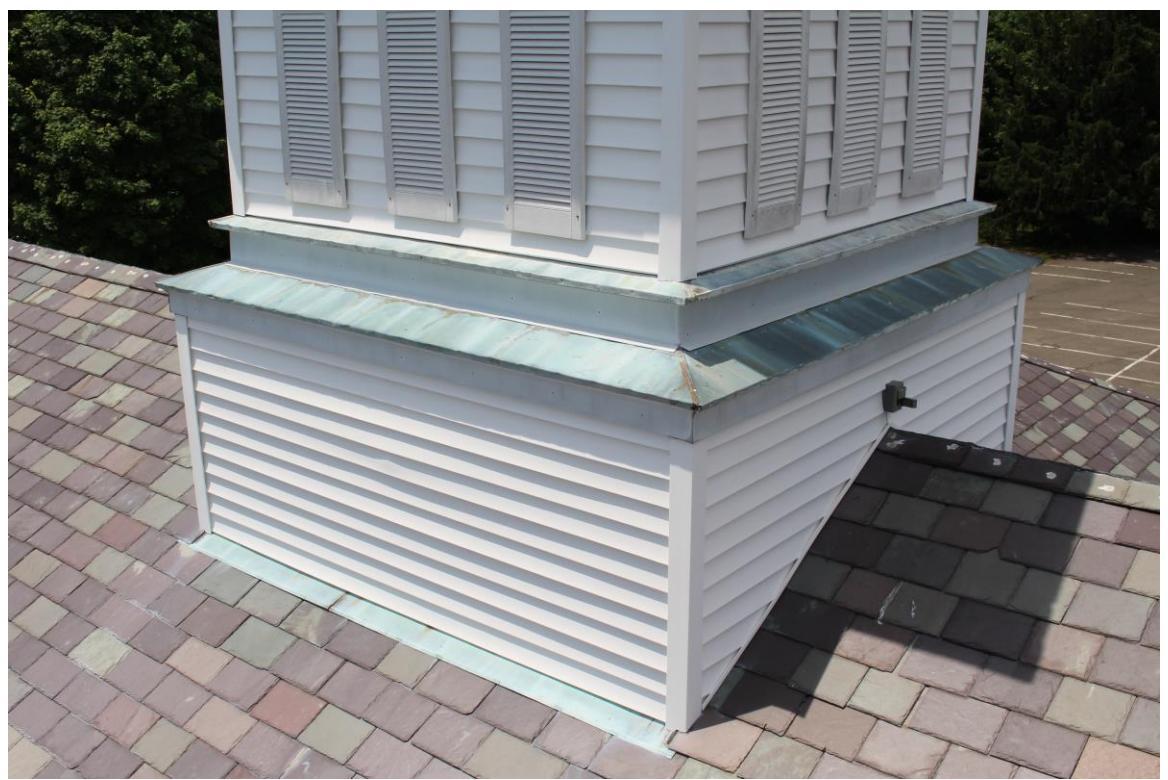
Figure 3-4 Slate roofing – Cupola. Deteriorated copper skirt and cap flashing, deteriorated ridge tiles.

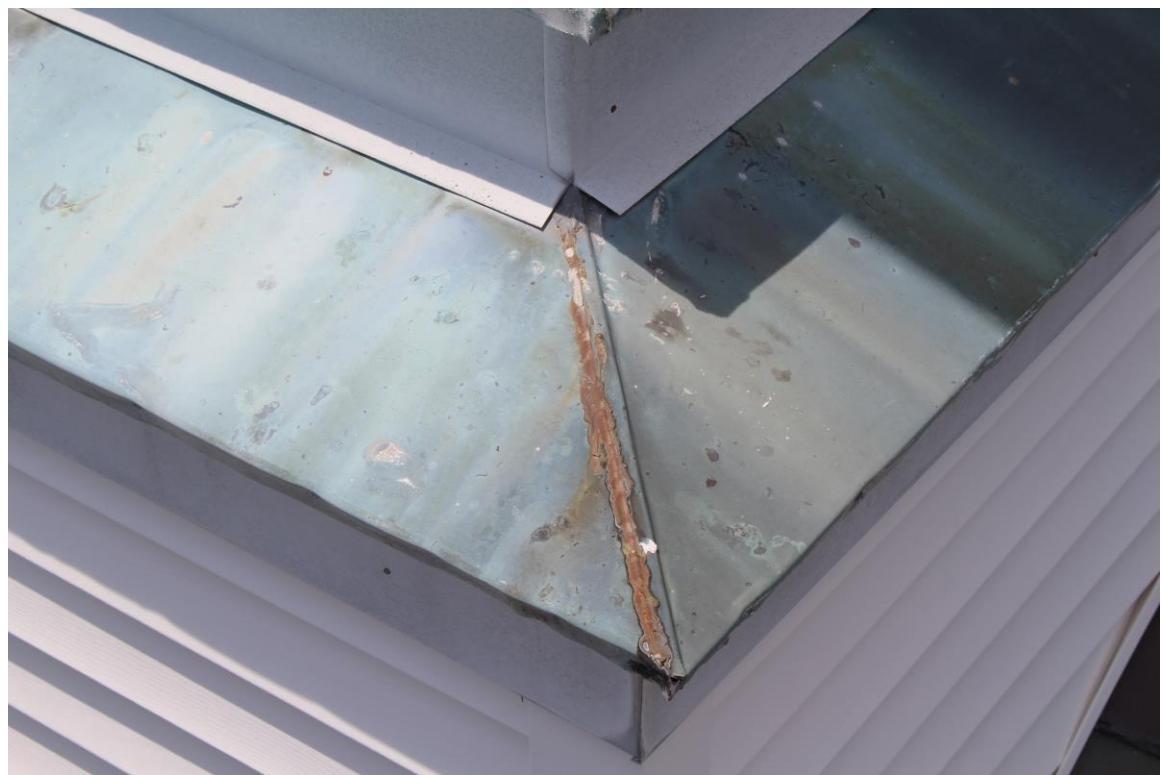
Figure 3-5 Slate roofing – Cupola. Deteriorated copper cap flashing.

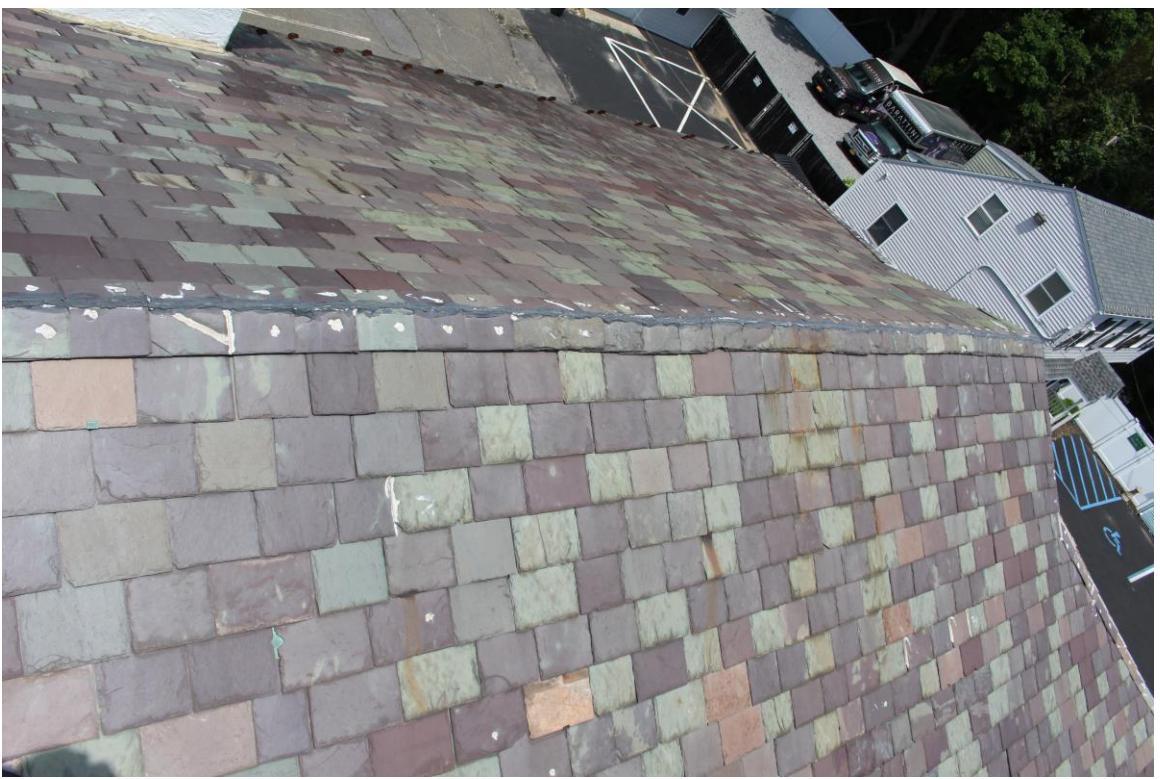
Figure 3-6 Slate roofing – South roof slope. Deteriorated ridge tiles.

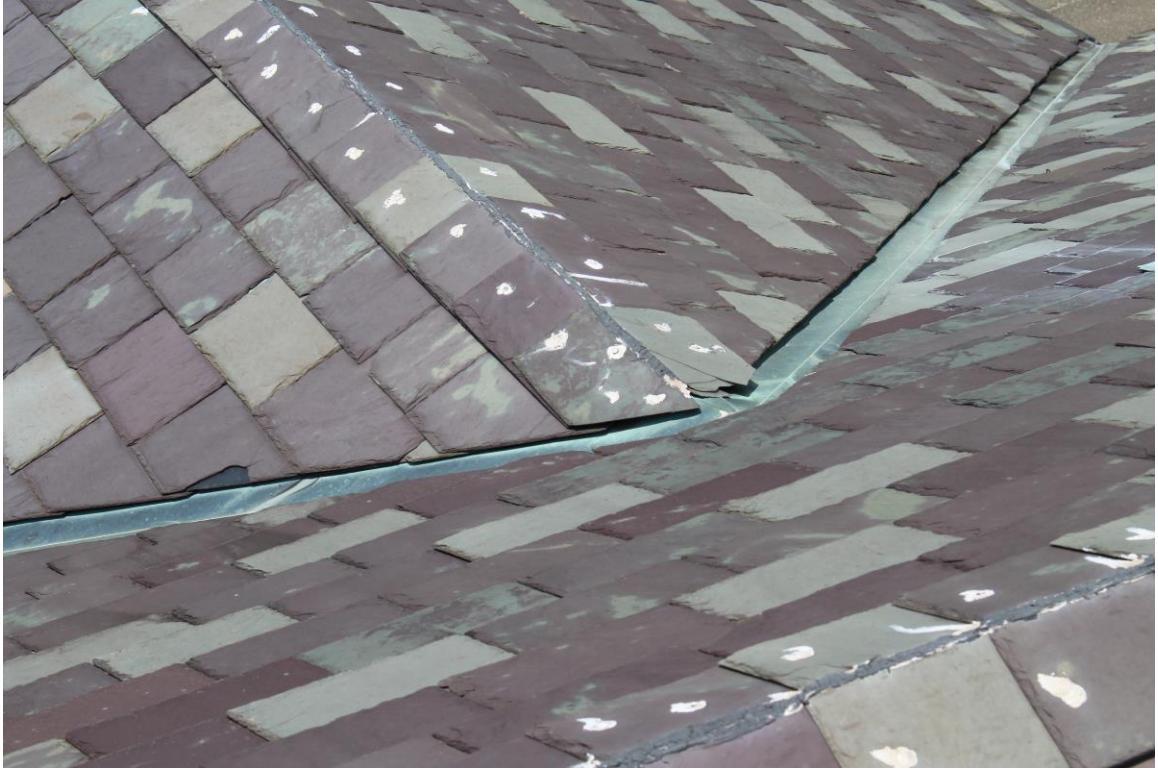
Figure 3-7

Slate roofing – North roof slope. Deteriorated ridge tiles, deteriorated copper valley flashing, broken tiles.

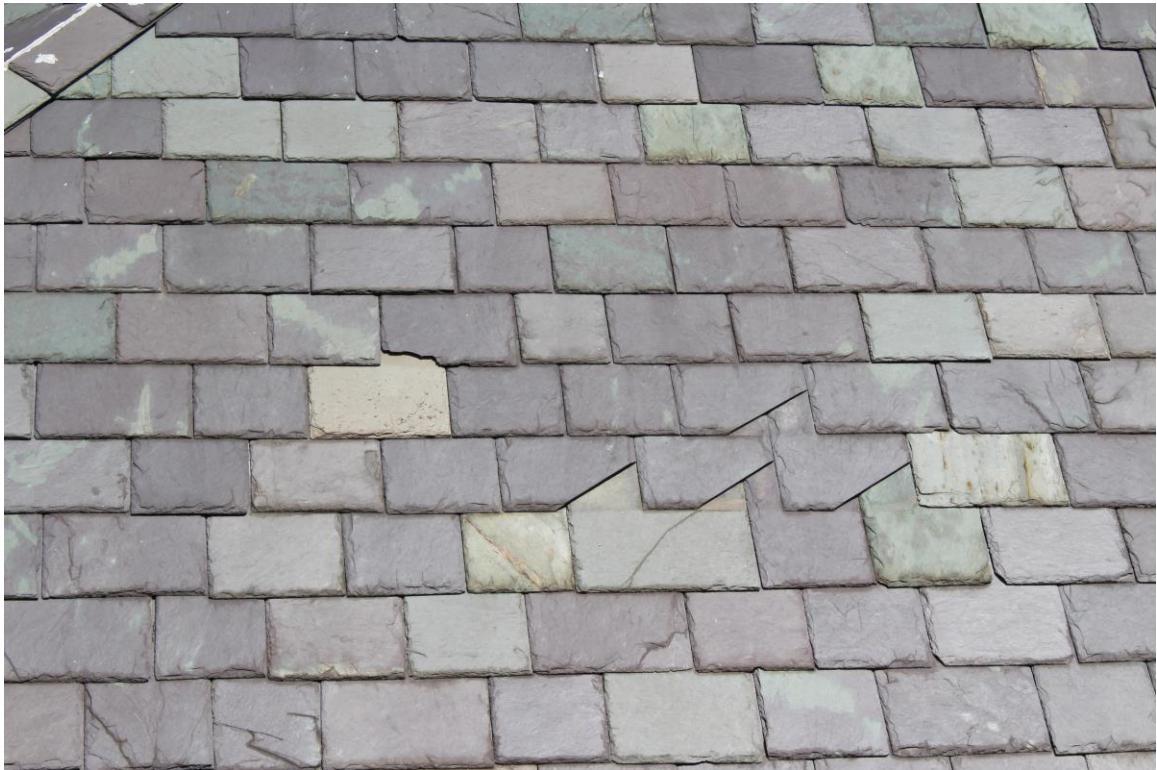
Figure 3-9 Slate roofing – South roof slope. Deteriorated tiles.

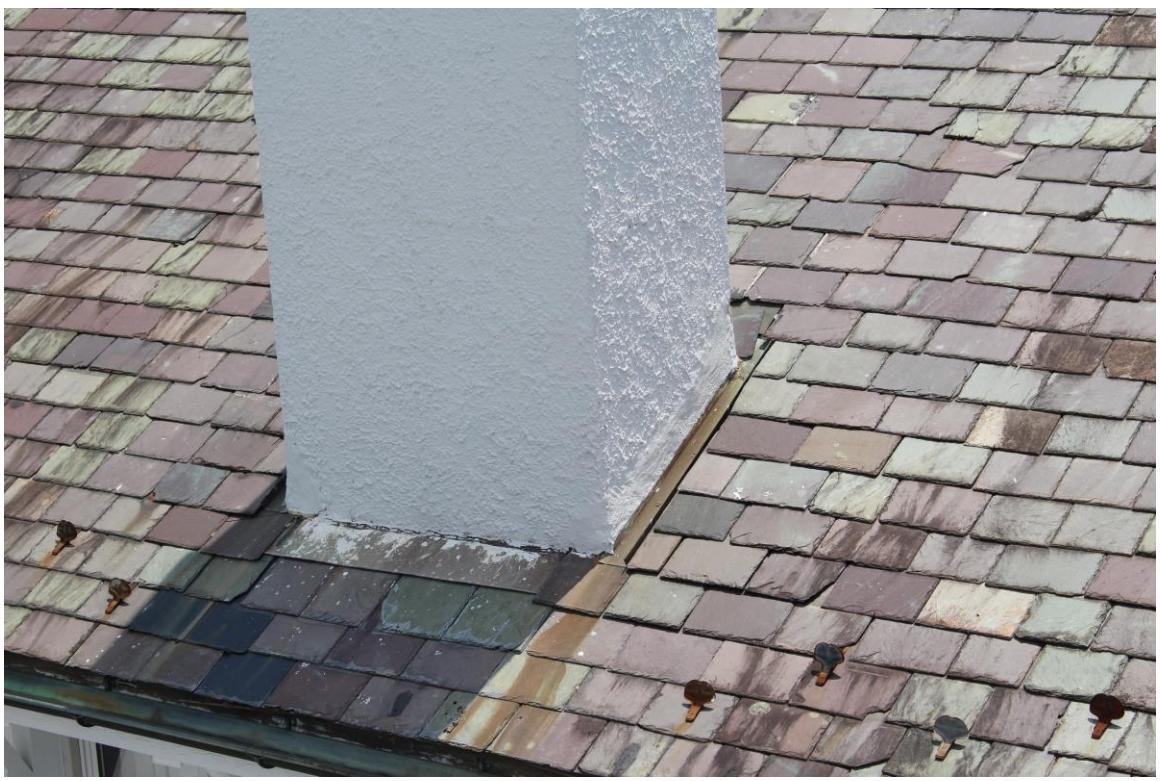
Figure 3-14 Slate roofing – Masonry chimney. Deteriorated copper skirt flashing, deteriorated tiles, deteriorated snow guards.

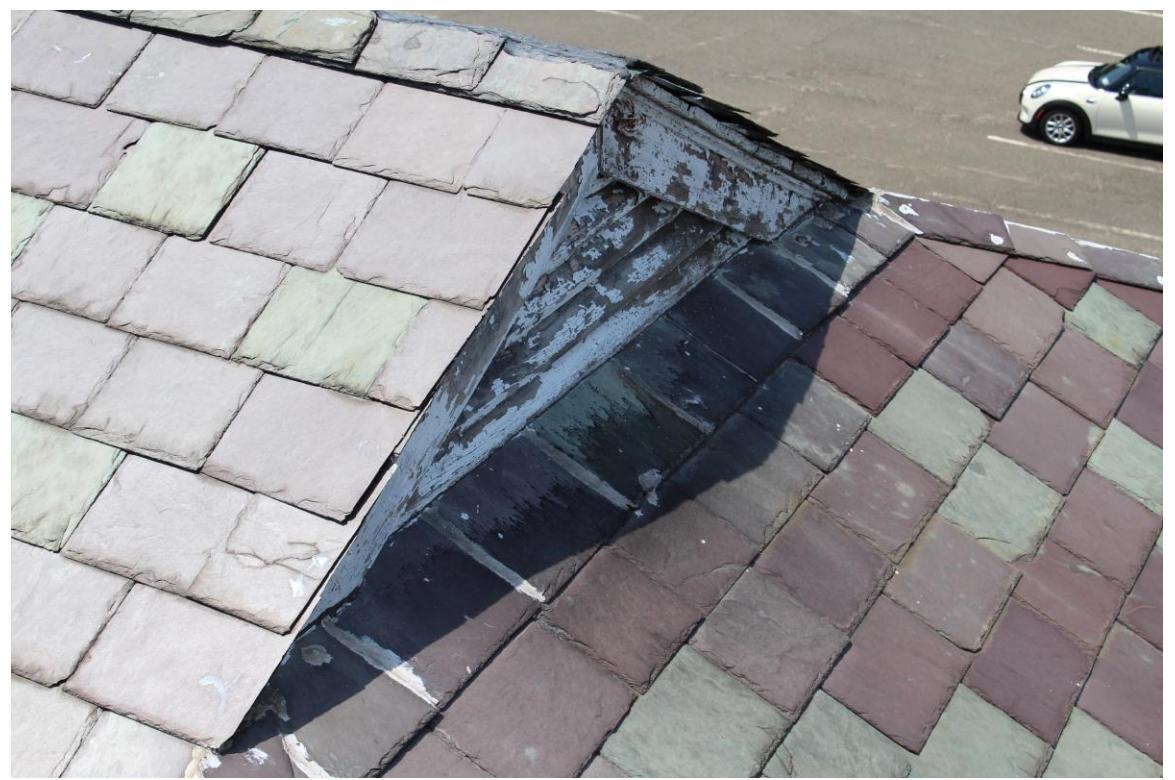
Figure 3-15 Slate roofing – East-facing gable end. Deteriorated wood vent, missing flashing, deteriorated tiles.

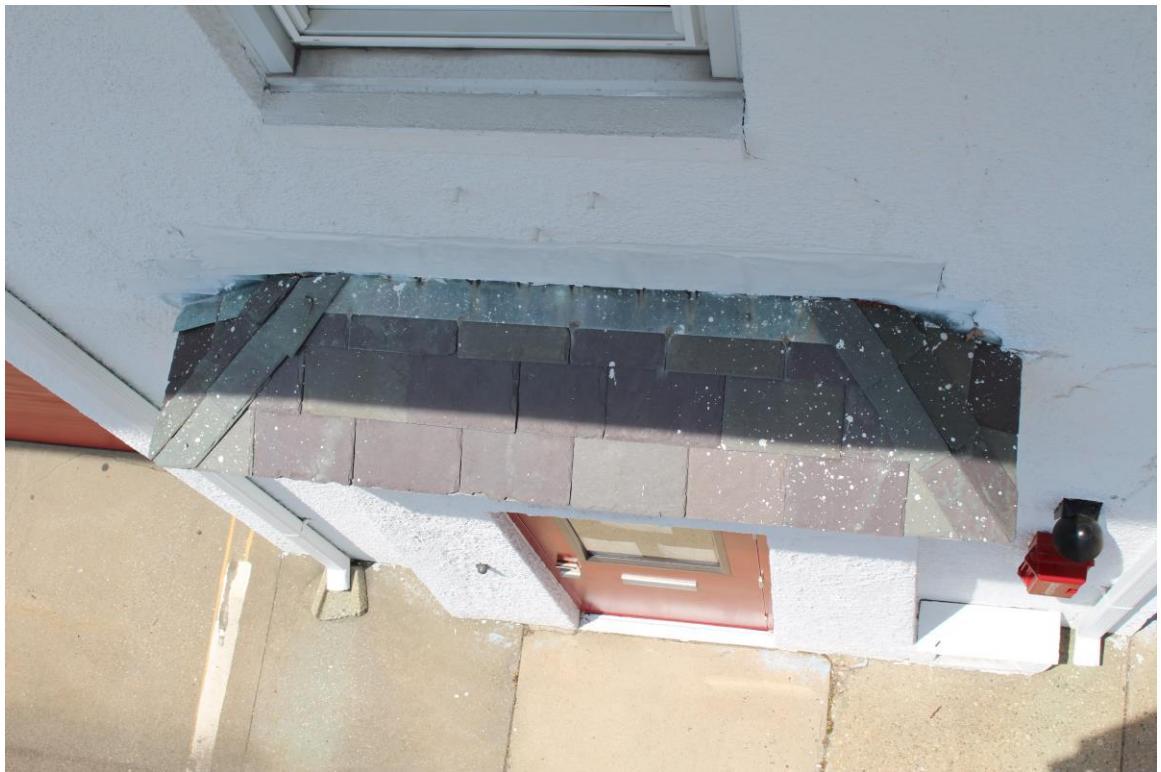
Figure 3-17

Slate roofing – Roof above main entrance. Deteriorated hip tiles, deteriorated stepped flashing.

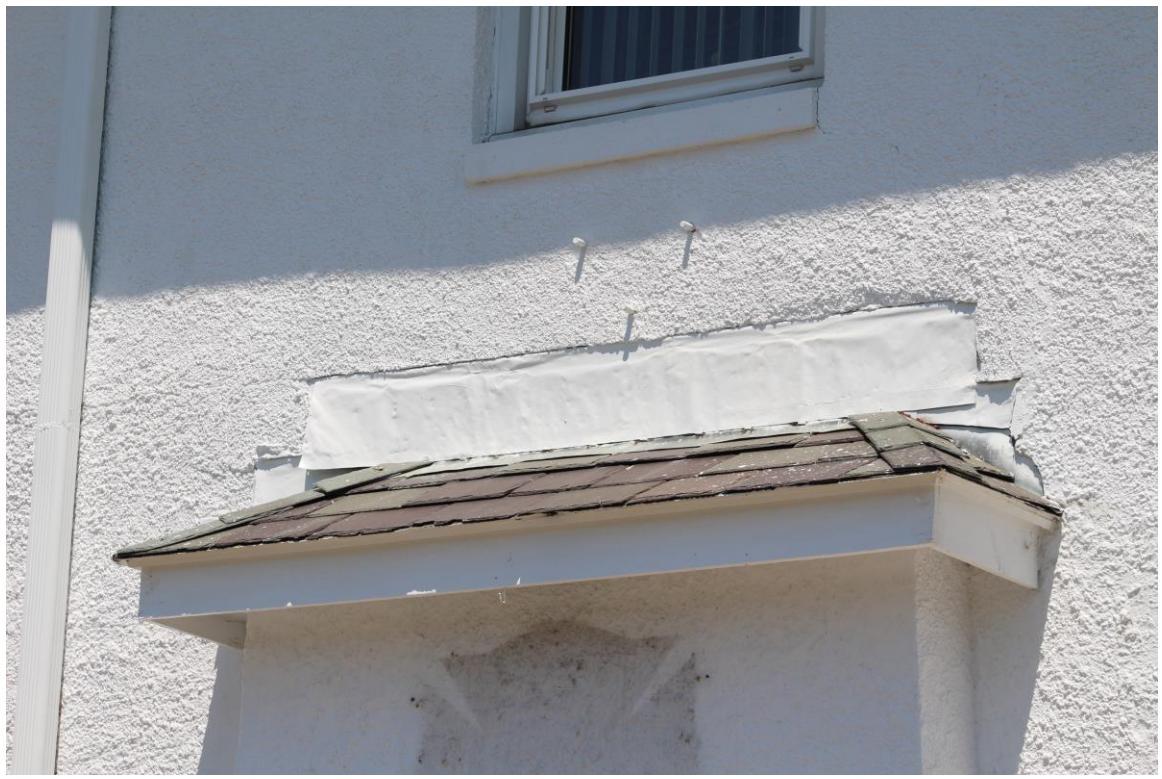
Figure 3-18 Slate roofing – Roof above main entrance. Deteriorated hip tiles, deteriorated stepped flashing.

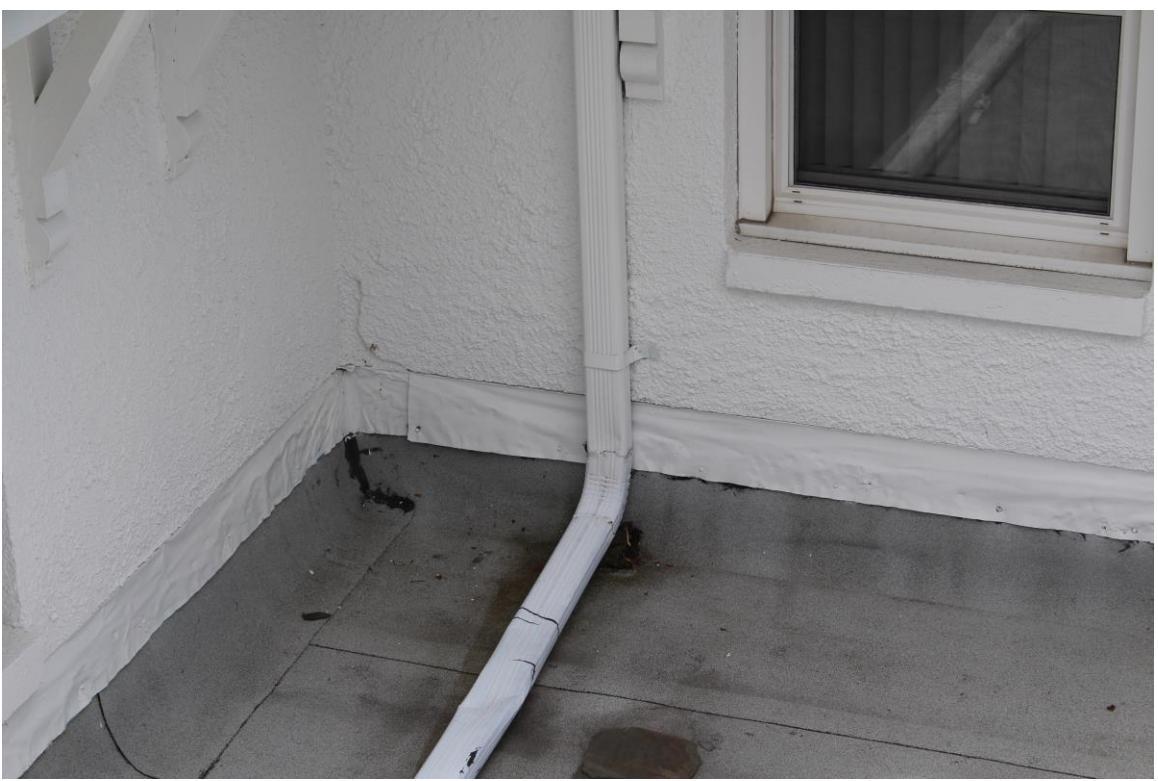
Figure 3-20 Modified-bitumen roofing – West of the stair tower. Deteriorated counter-flashing.

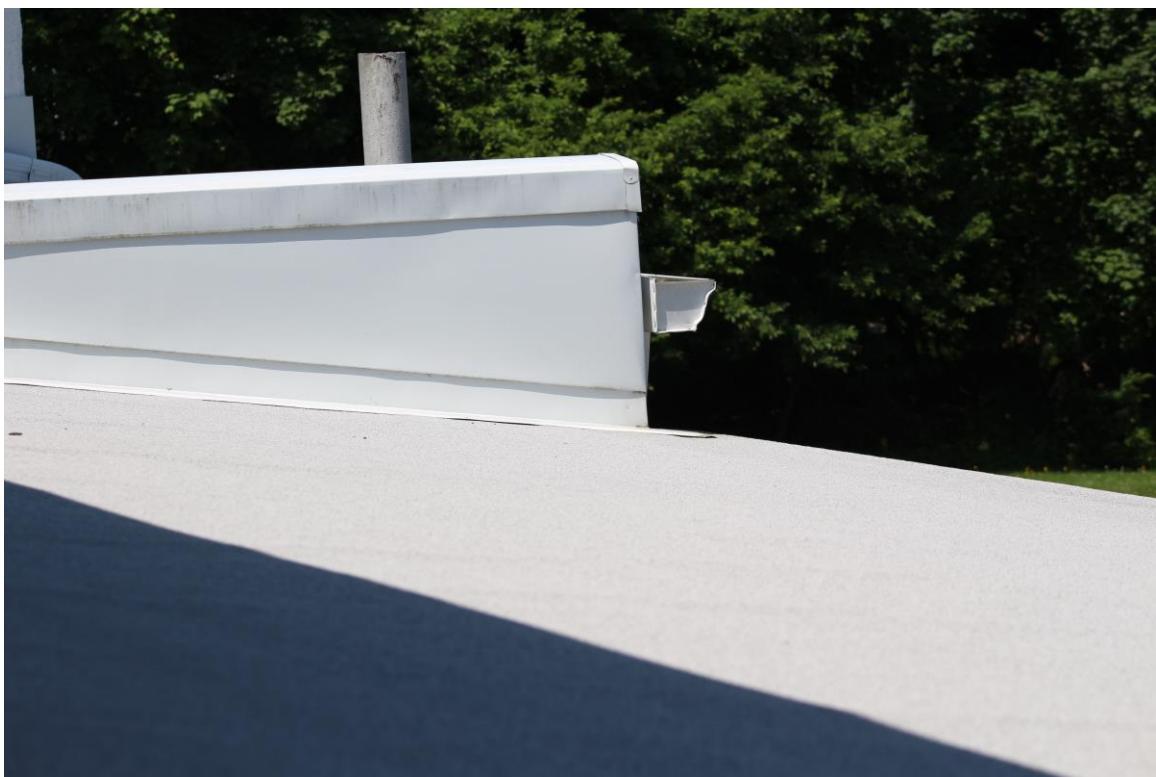
Figure 3-22 Modified-bitumen roofing – East of the stair tower. Deteriorated base and cap flashing.

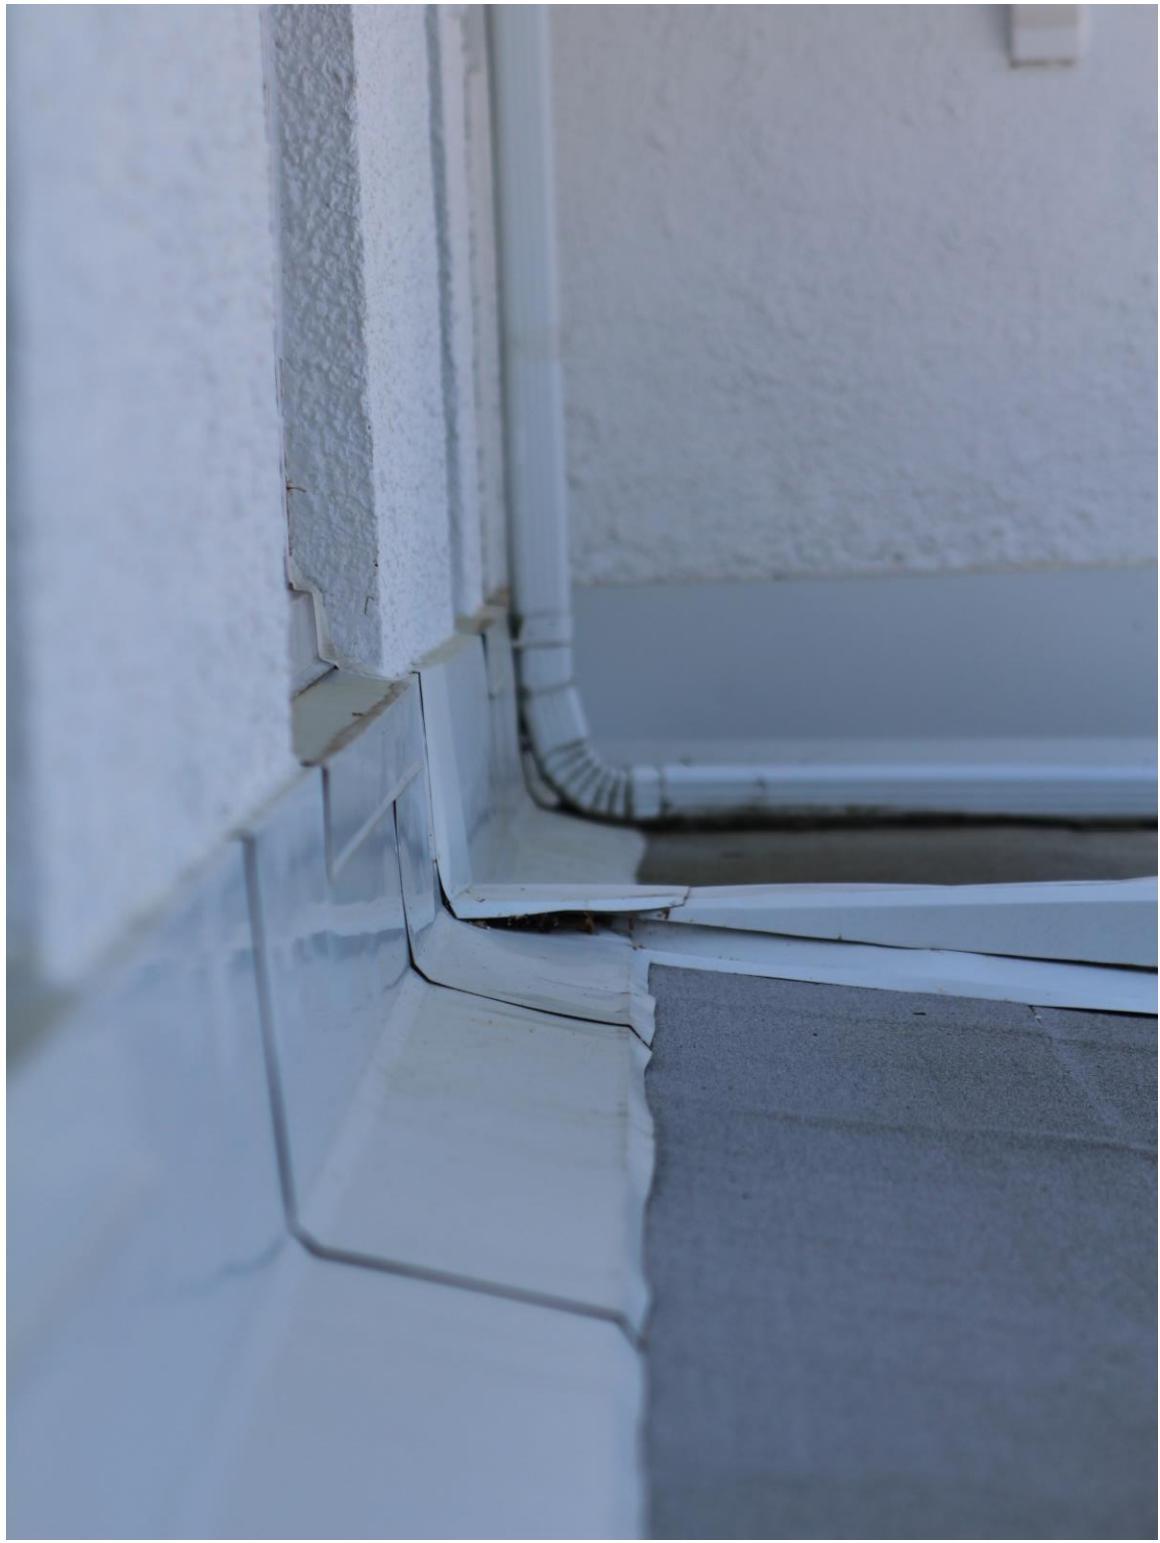
Figure 3-23 Modified-bitumen roofing – East of the stair tower. Deteriorated base flashing, improper saddle flashing.

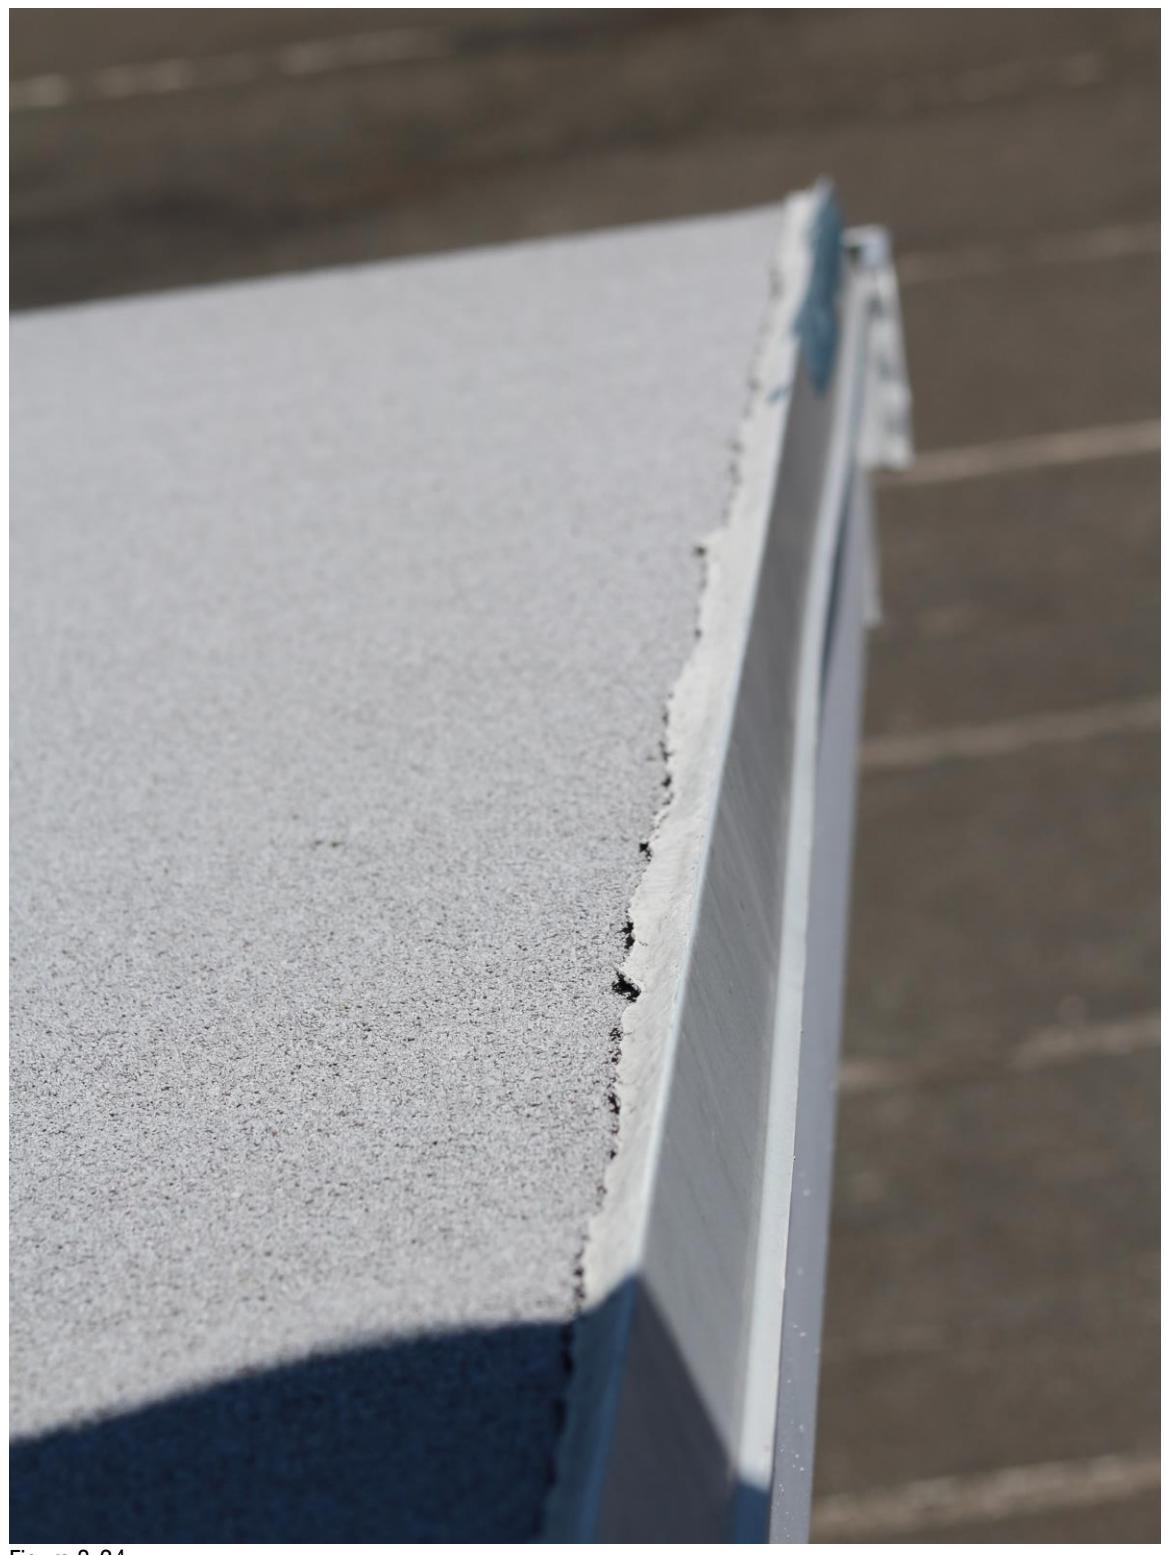
Figure 3-24 Modified-bitumen roofing – East of the stair tower. Deteriorated metal edge and sealant.

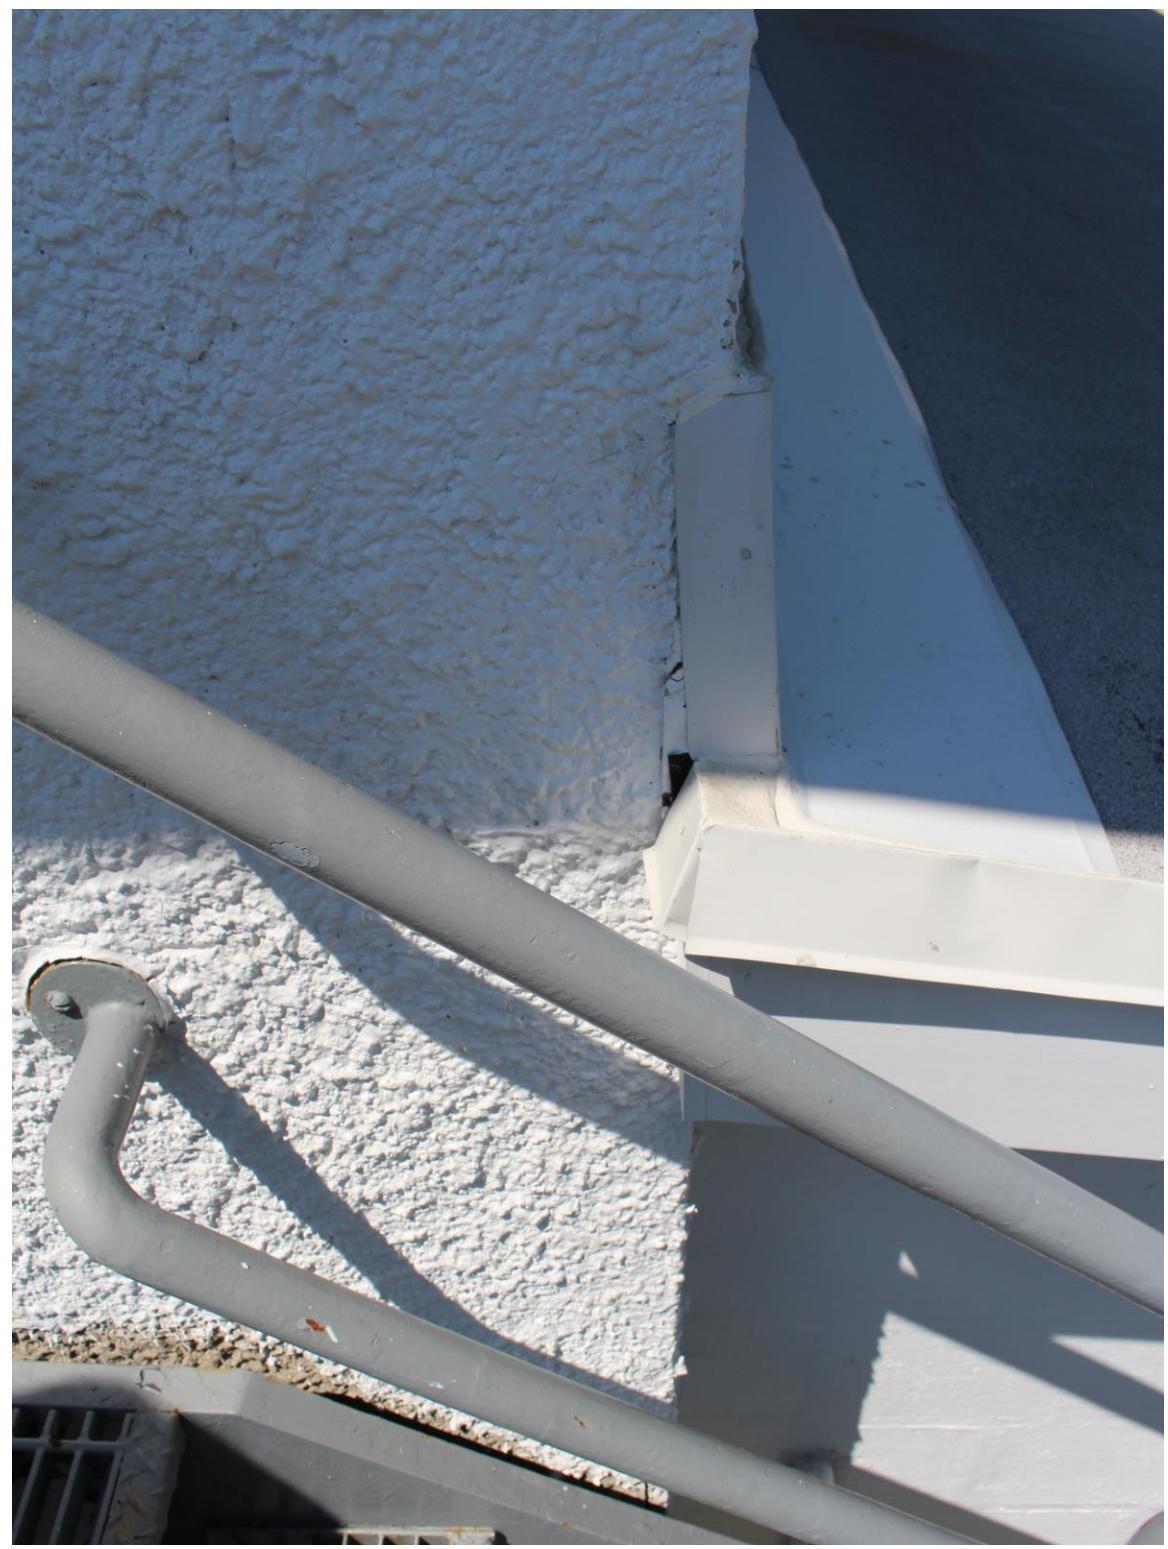
Figure 3-25 Modified-bitumen roofing – East of the stair tower. Deteriorated base flashing and metal edge, improper flashing termination.

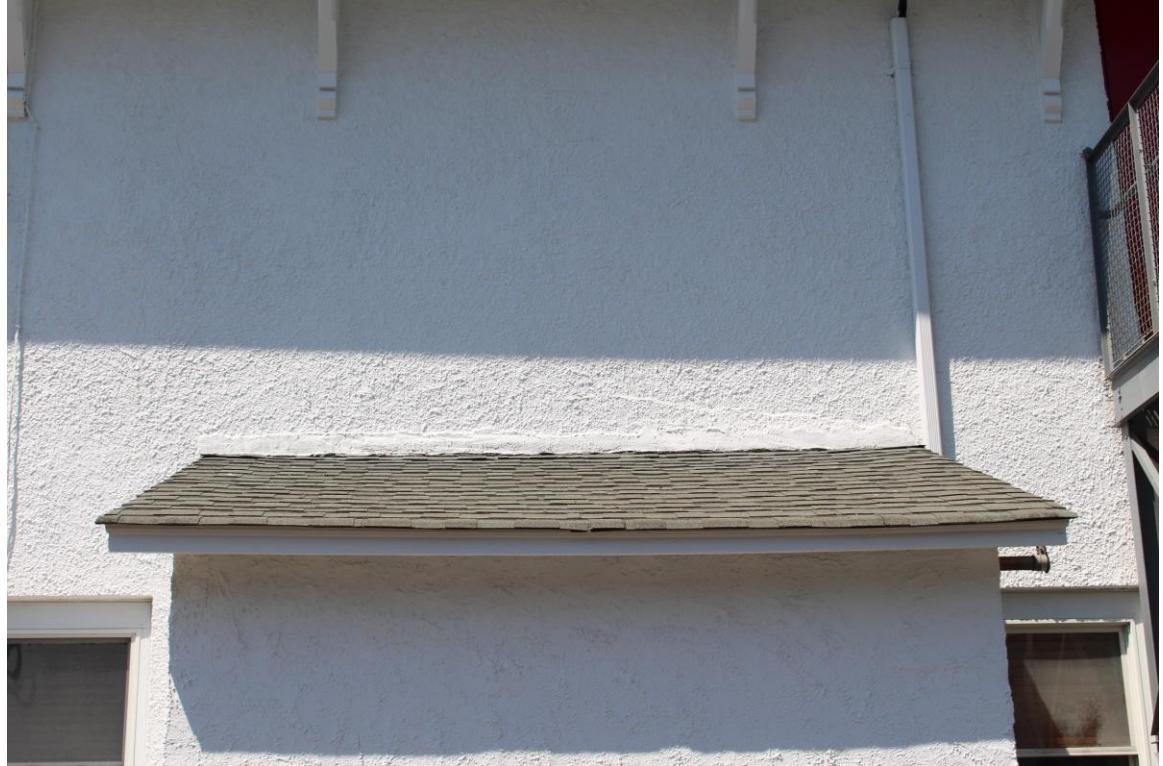
Figure 3-26 Asphalt-shingle roofing – Missing flashing.

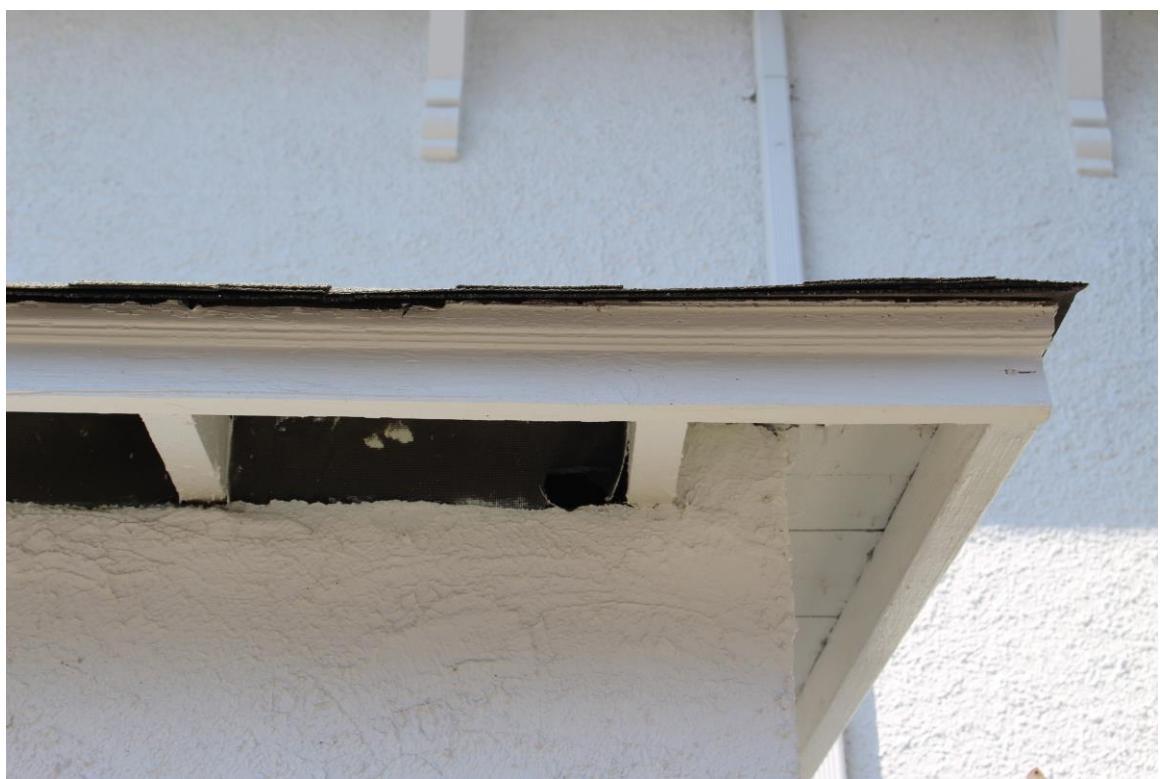
Figure 3-27 Asphalt-shingle roofing – Deteriorated mesh-wire infill between rafters.

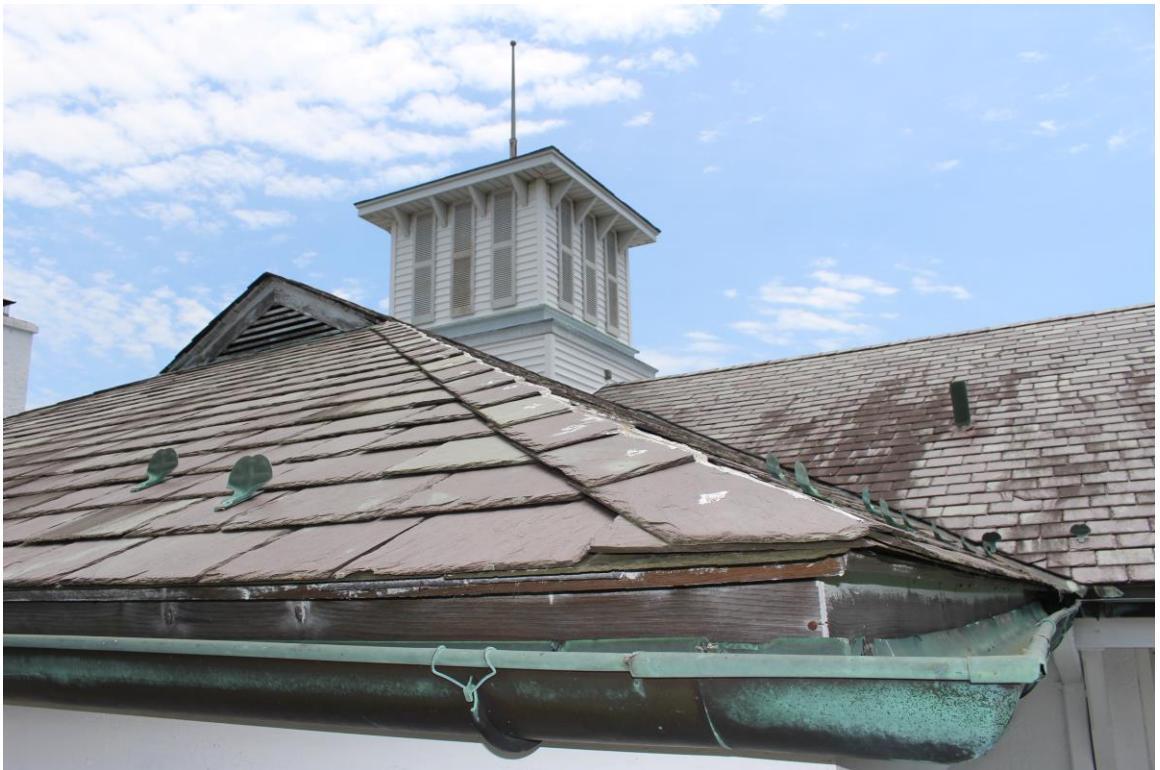
Figure 3-28 Copper gutter – Deteriorated copper gutter, deteriorated gutter hanger, unprotected wood fascia.

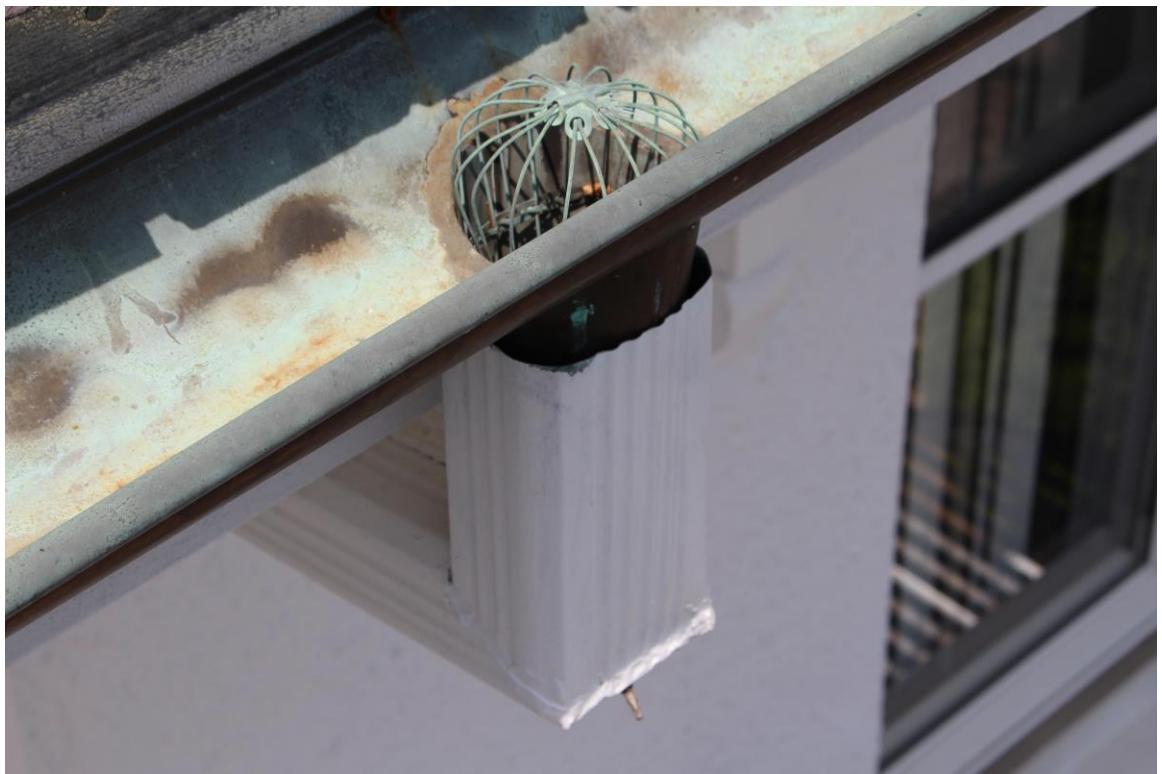
Figure 3-30 Copper gutter – Deteriorated copper gutter, improper aluminum/copper connection.

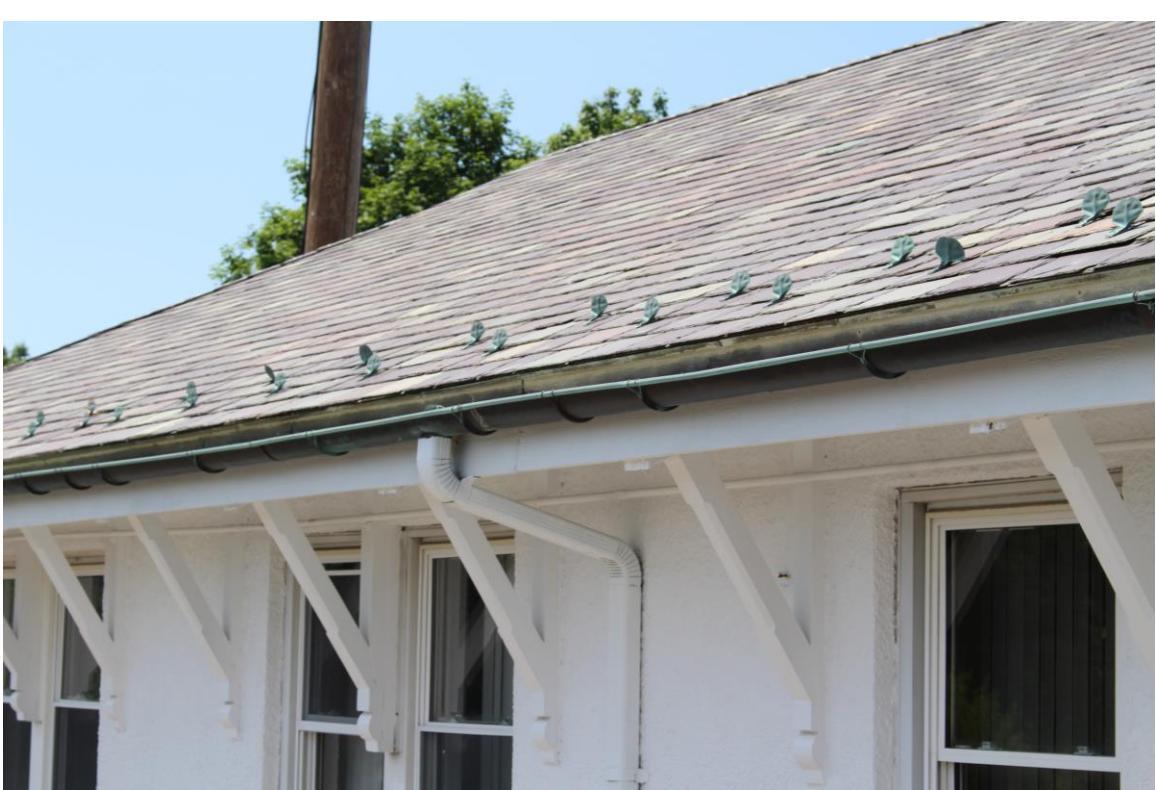
Figure 3-31 Copper gutter – Deteriorated copper gutter, deteriorated gutter hangers, improper aluminum/copper connection.

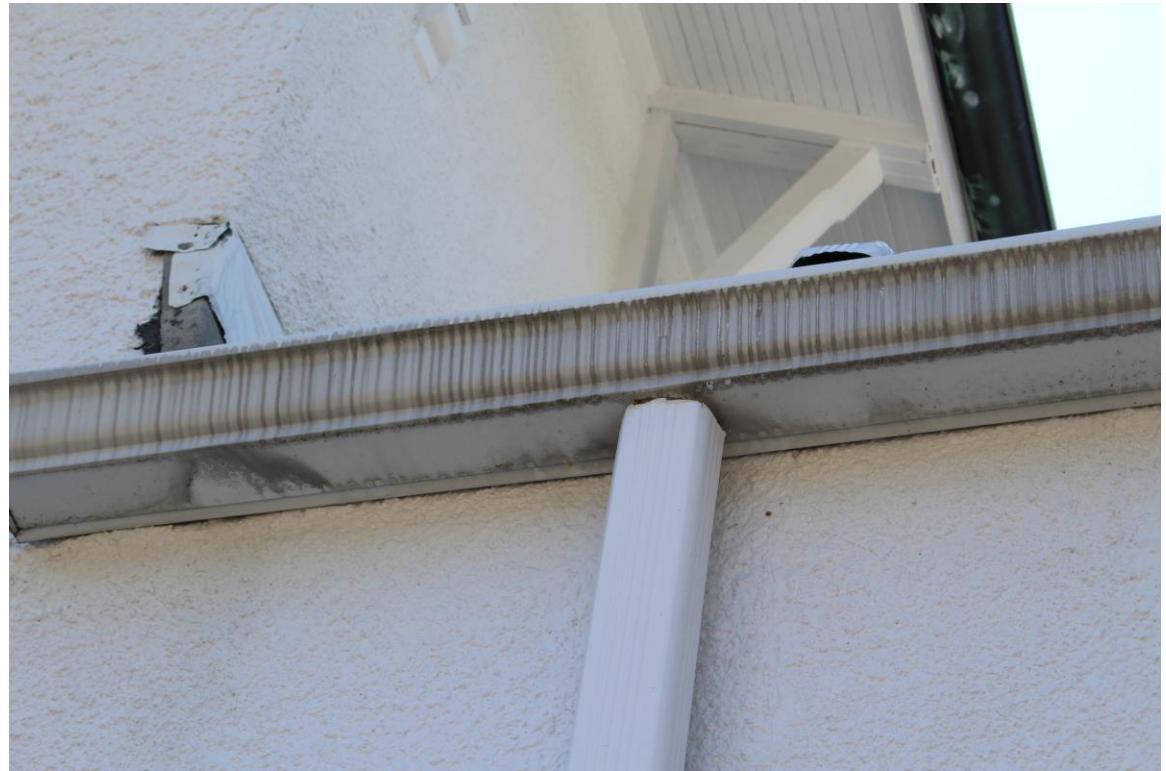
Figure 3-32 Aluminum gutter – Deteriorated aluminum gutter, improper gutter/downspout connection.

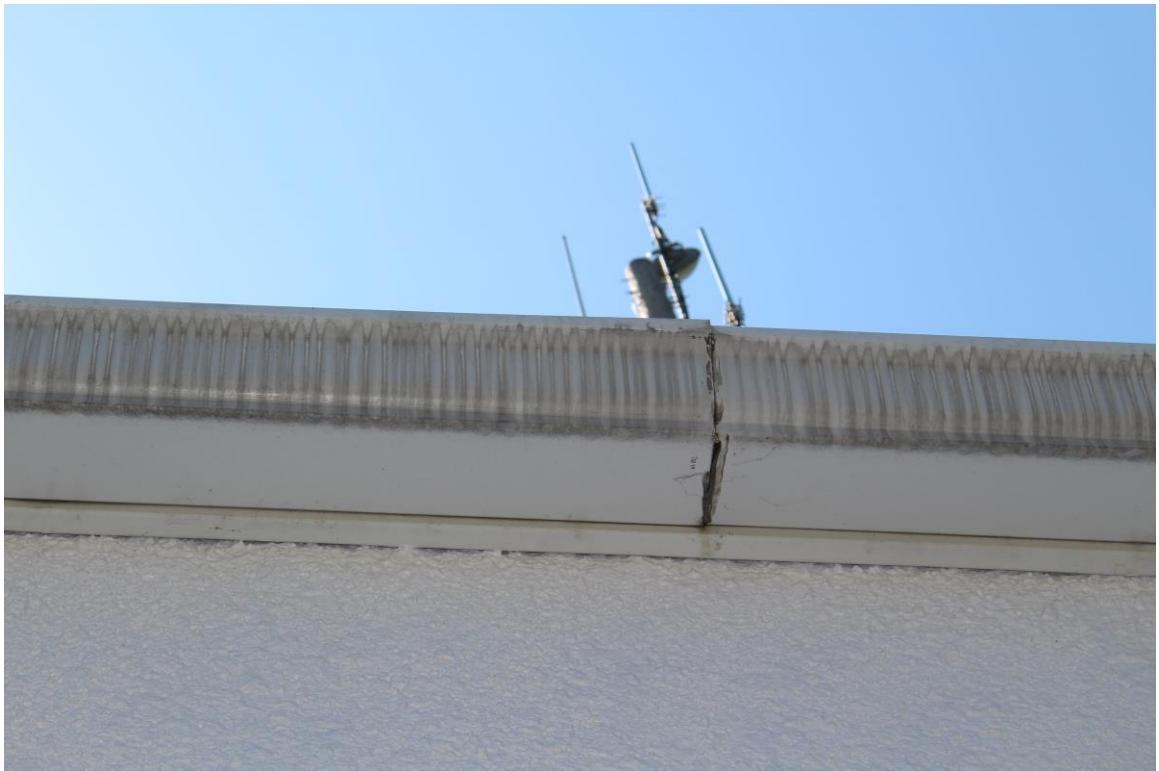
Figure 3-33 Aluminum gutter – Deteriorated aluminum gutter.
