ST. JAMES FIREHOUSE CONDITIONS ASSESSMENT REPORT

533 NY-25A ST. JAMES, NY 11780

ISSUED: 08 September 2020

APS PROJECT NO: 20-018

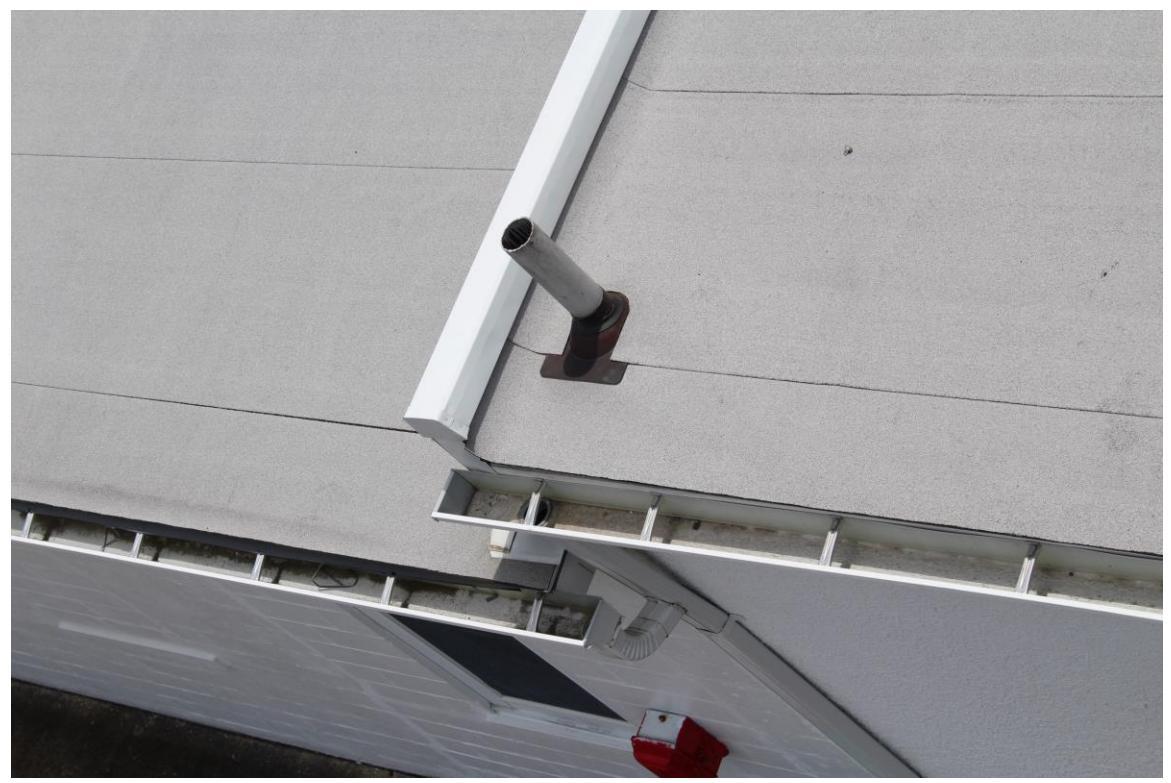
Figure 3-34 Aluminum gutter – Deteriorated aluminum gutter, improper gutter/downspout connection.

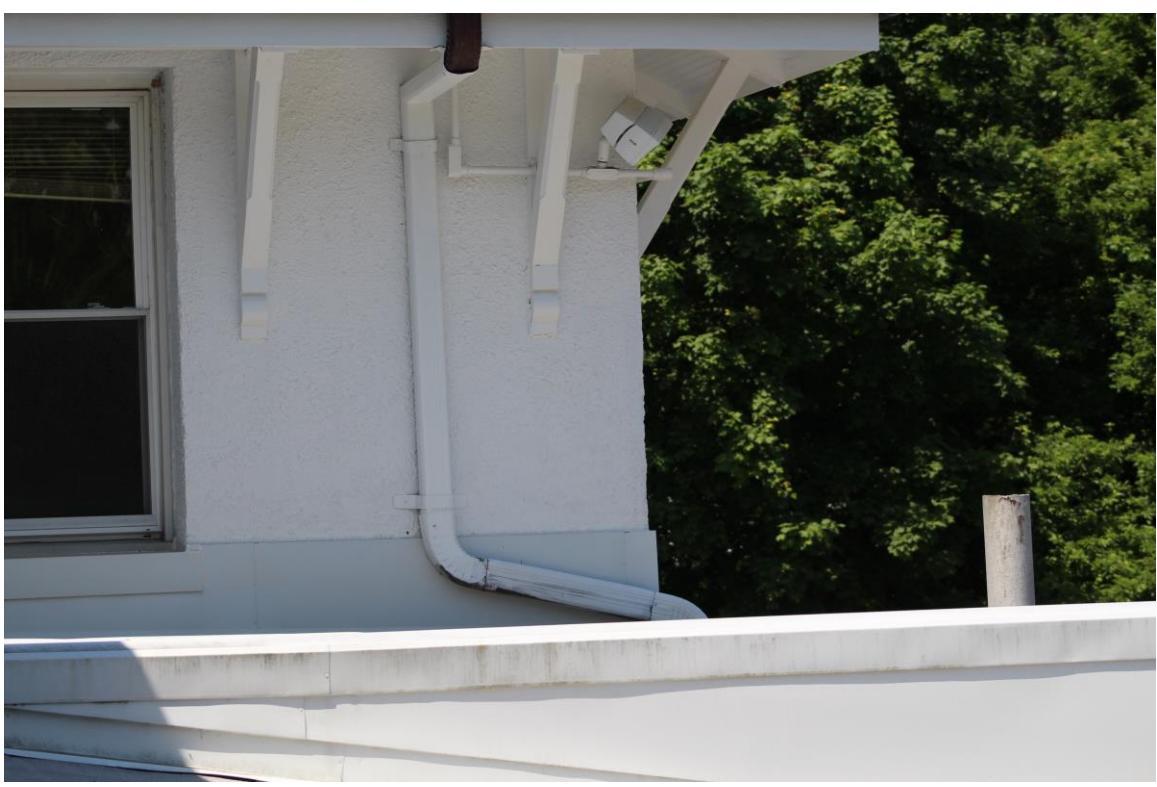
Figure 3-35 Aluminum downspout – Deteriorated aluminum downspout extension, improper aluminum/copper connection.

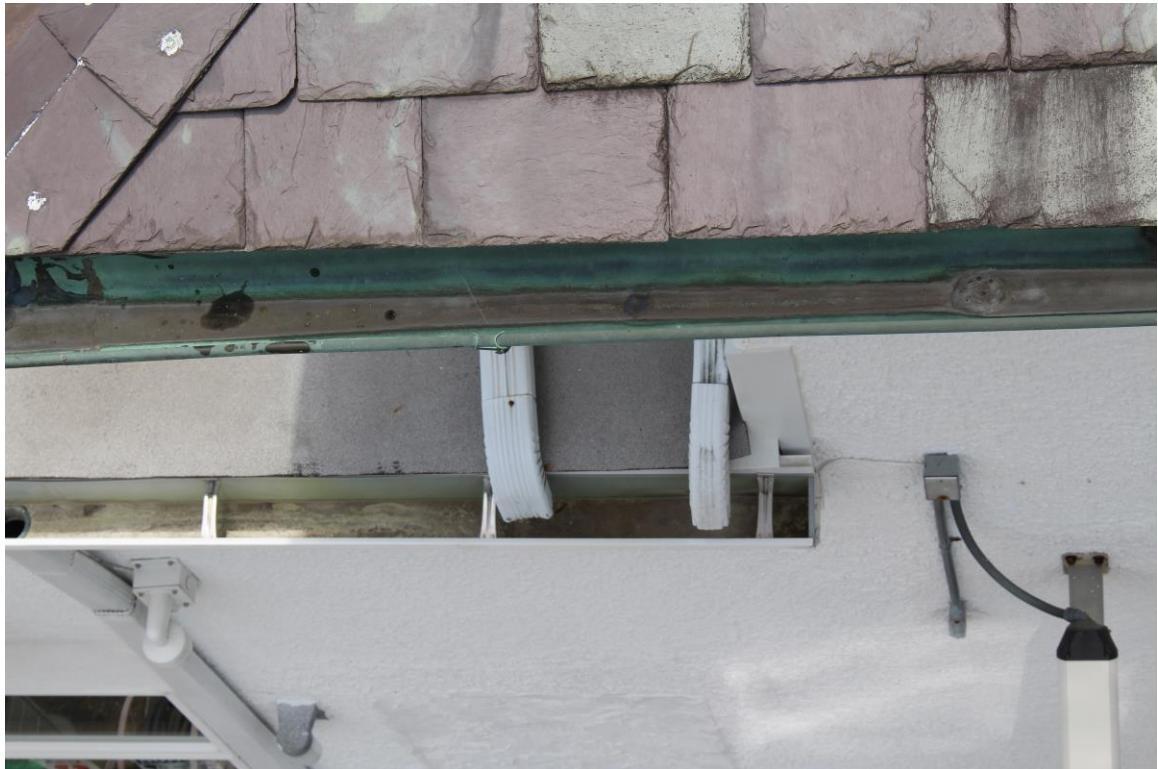
Figure 3-36

Aluminum downspout – Deteriorated aluminum downspout extension, deteriorated copper gutter.

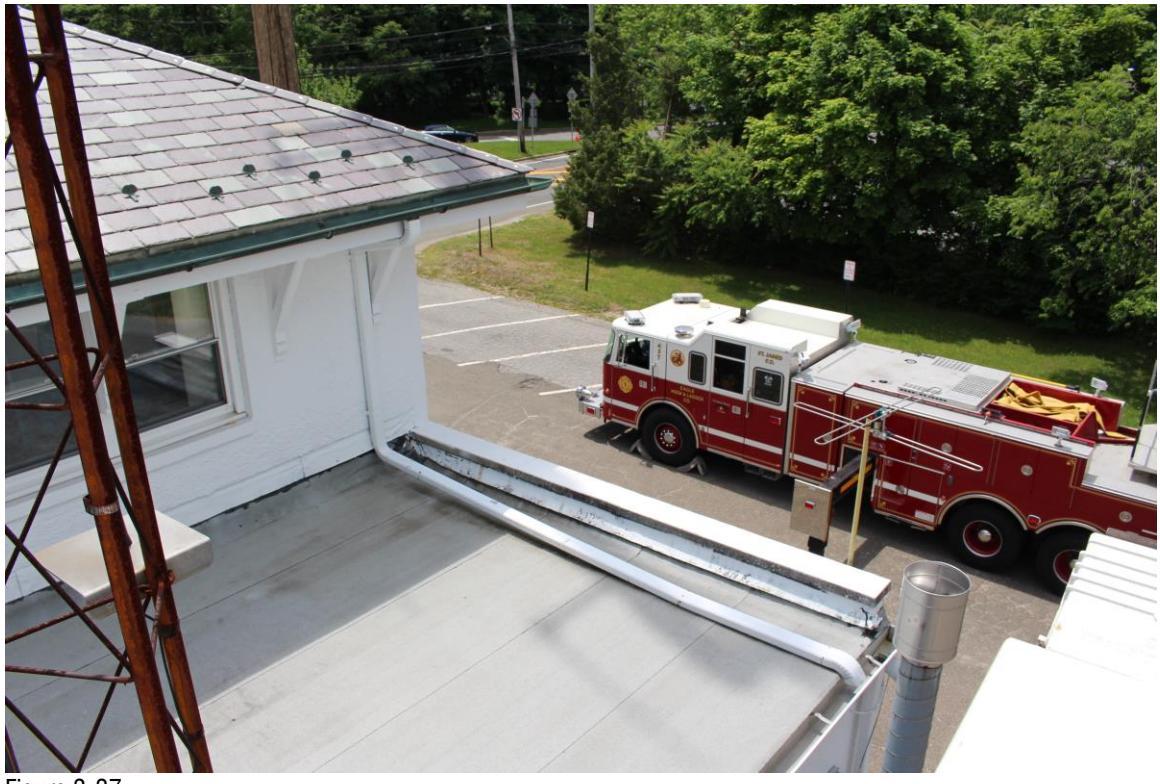
Figure 3-37 Aluminum downspout – Deteriorated aluminum downspout extension, deteriorated copper gutter.

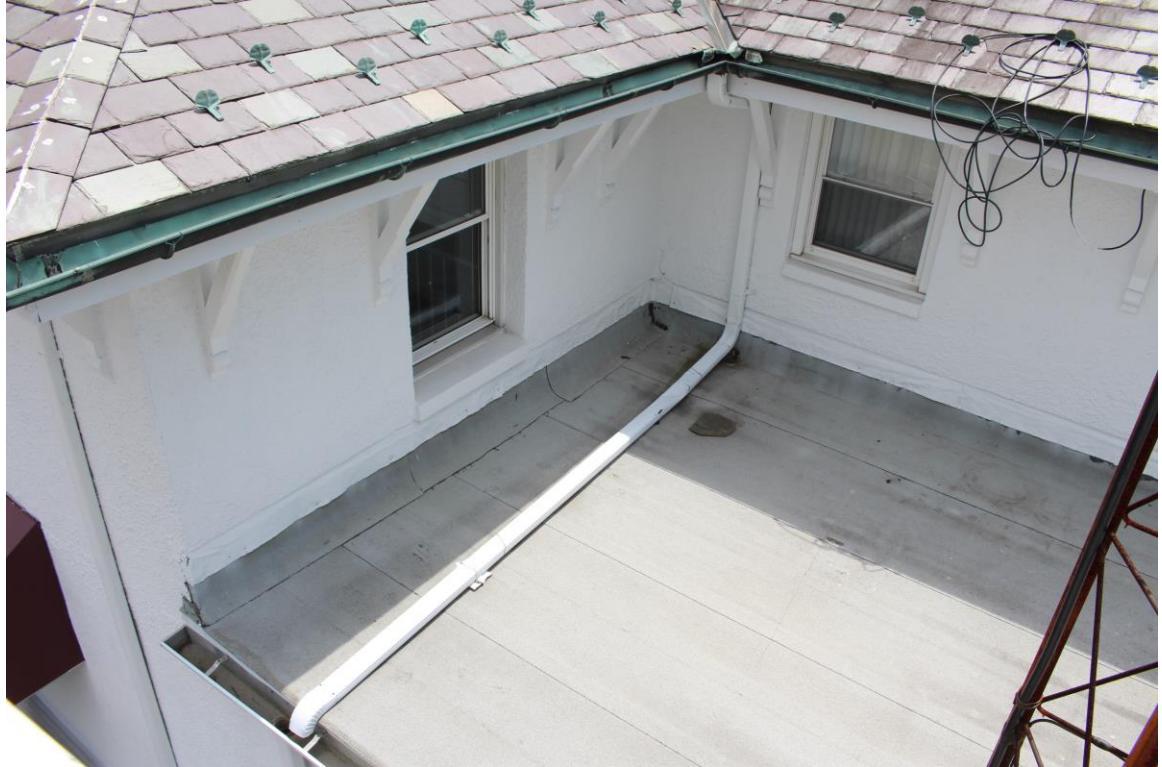
Figure 3-38 Aluminum downspout – Deteriorated aluminum downspout extension, deteriorated copper gutter.

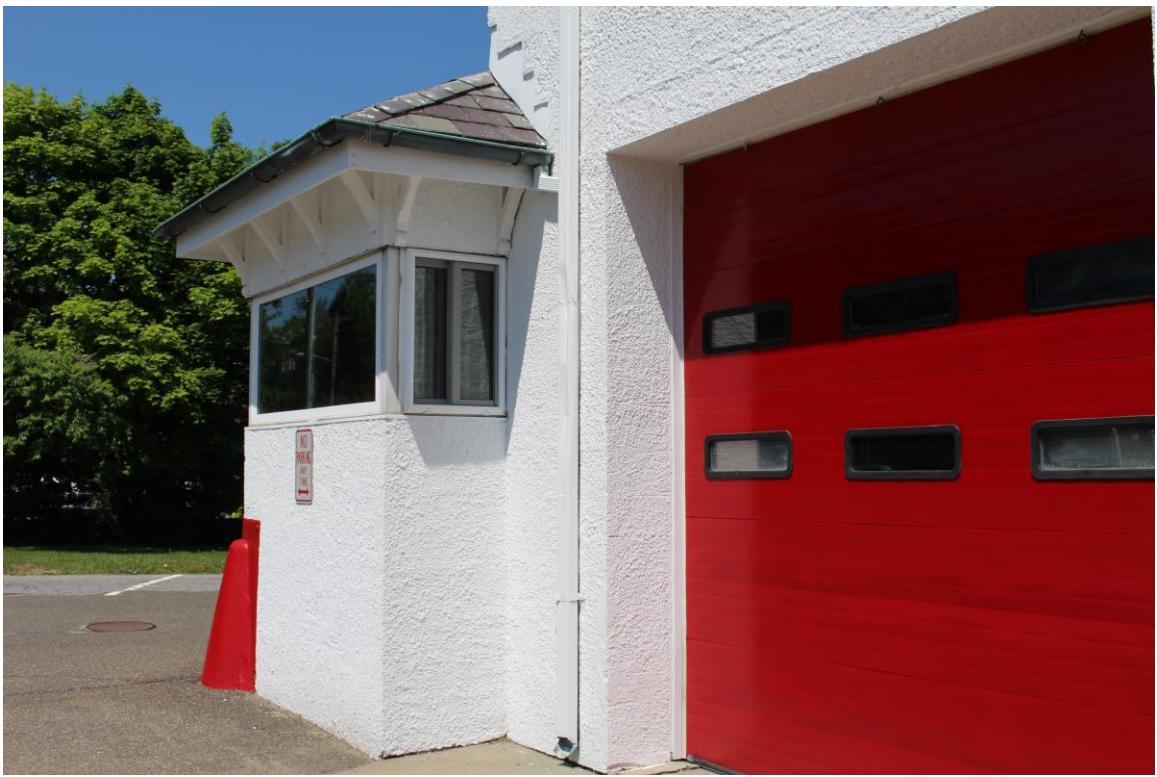
Figure 3-39 Aluminum downspout – Deteriorated aluminum downspout, missing splash block.

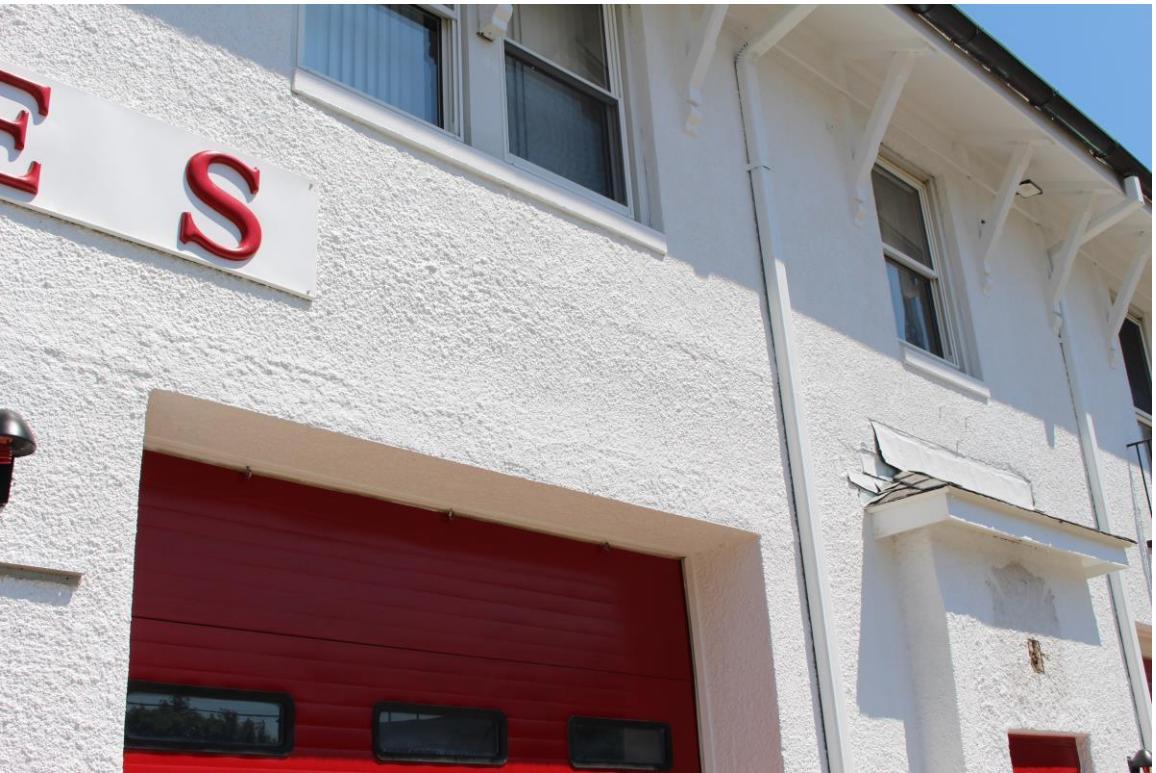
Figure 3-41 Masonry – Continuous horizontal crack.

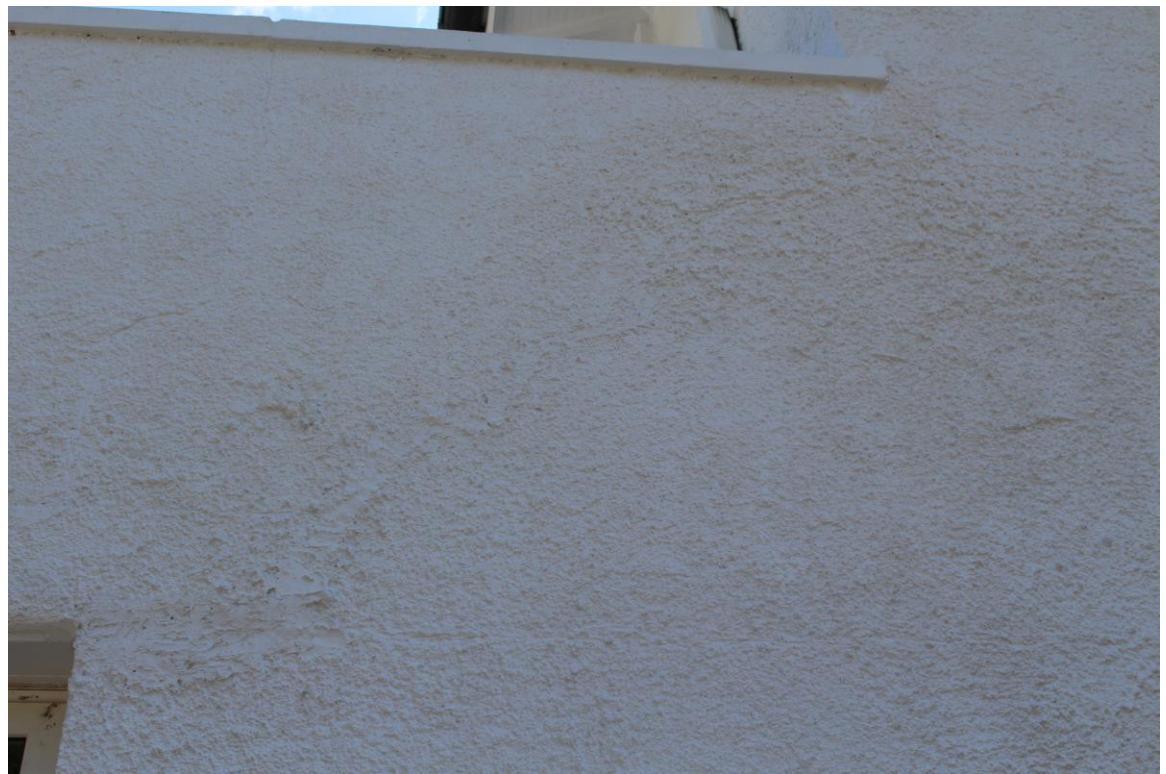
Figure 3-42 Masonry – Continuous stepped crack.

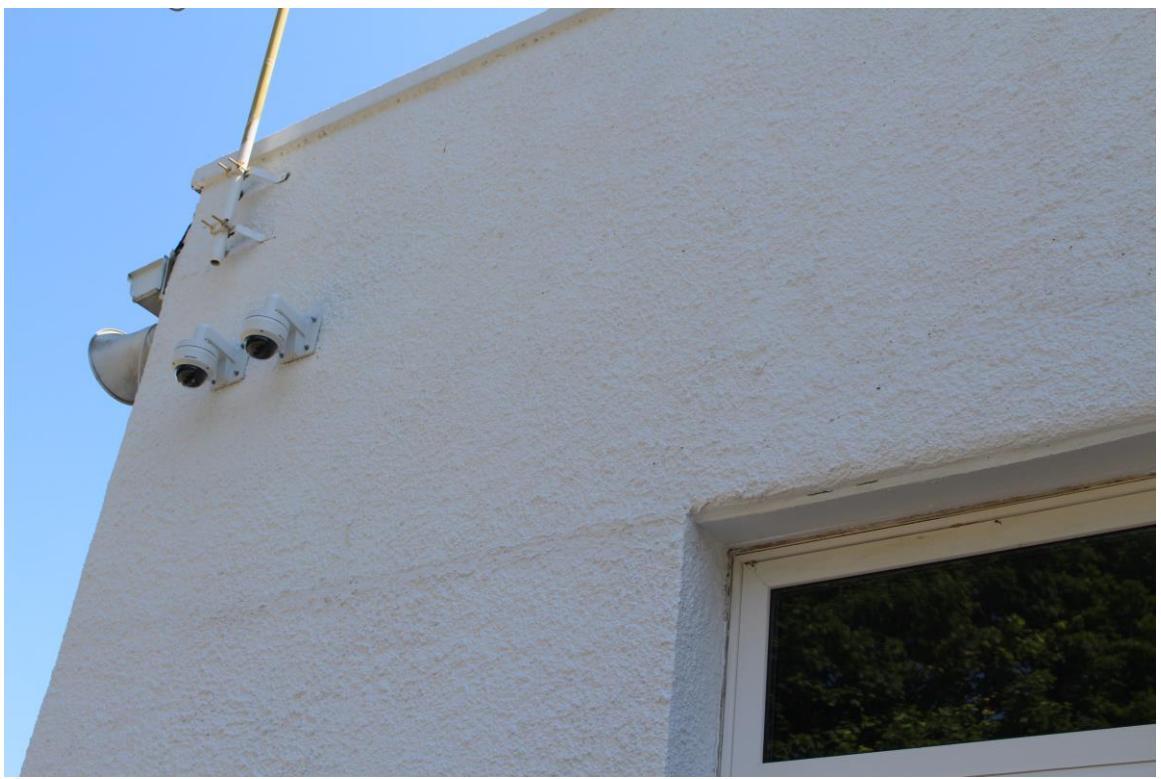
Figure 3-43 Masonry – Continuous horizontal crack.

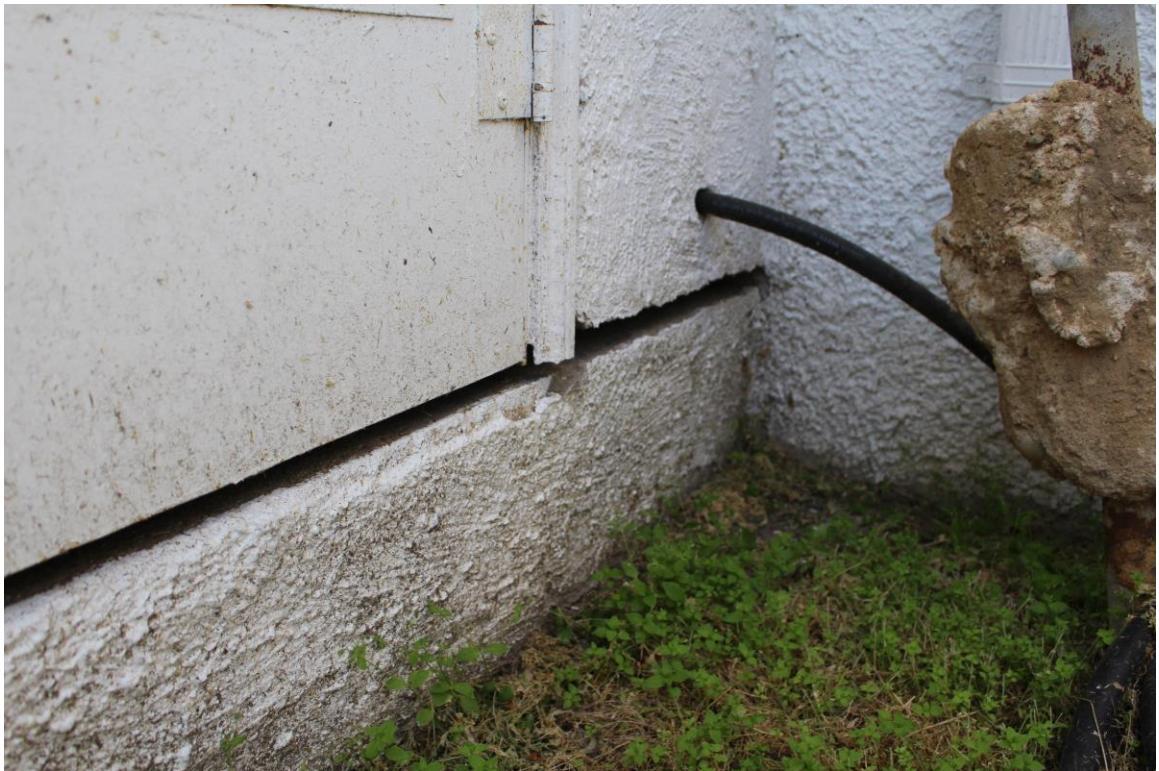
Figure 3-44 Masonry – Foundation crack.

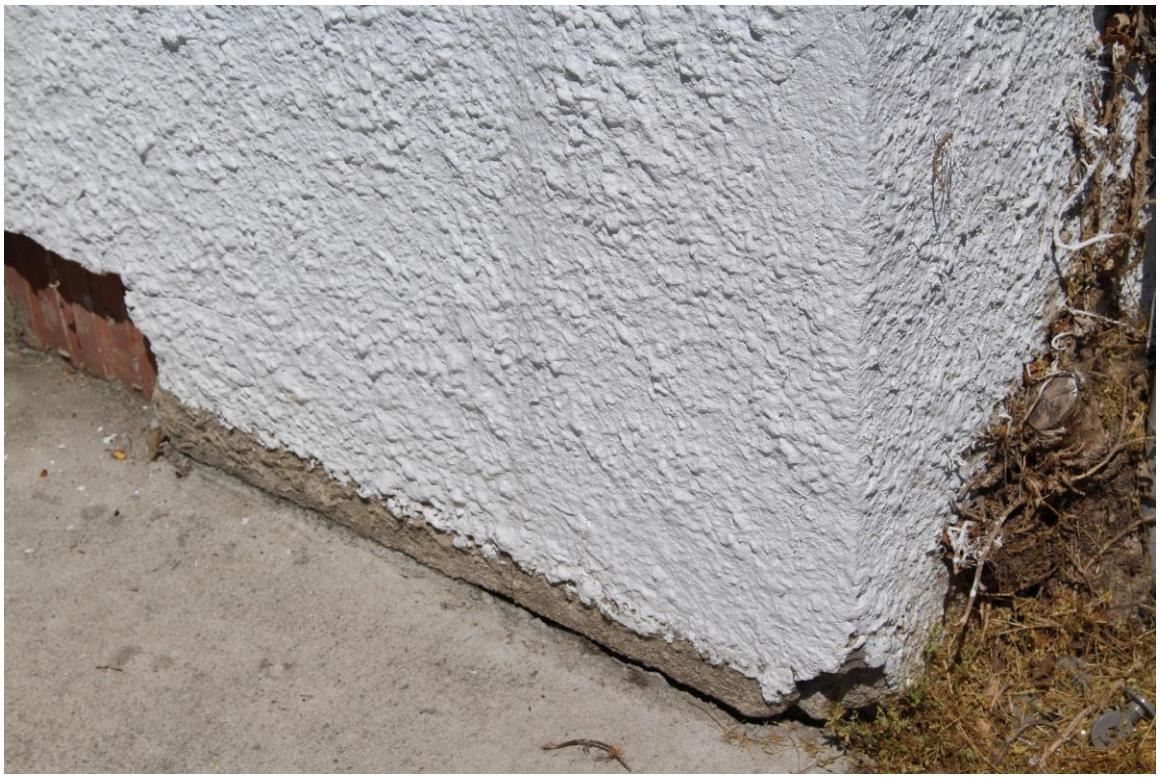
Figure 3-45 Masonry – Deteriorated coating at foundation.

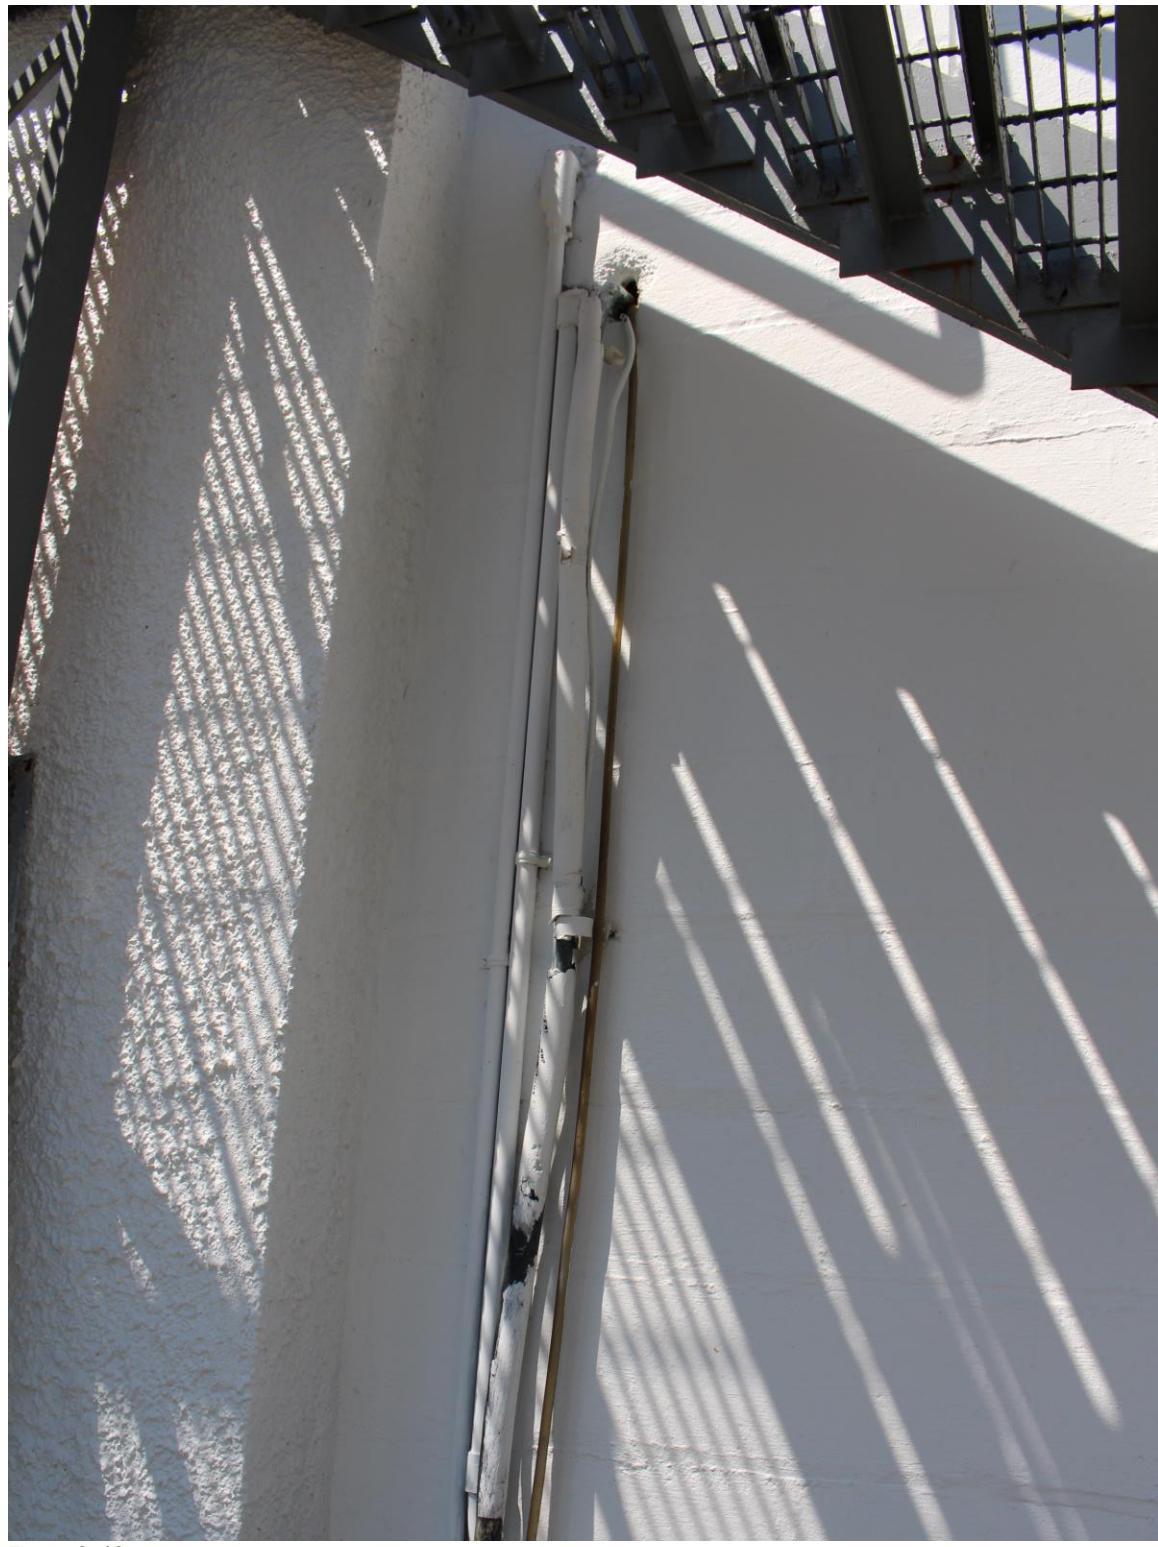
Figure 3-46 Masonry – Un-flashed pipe penetration.

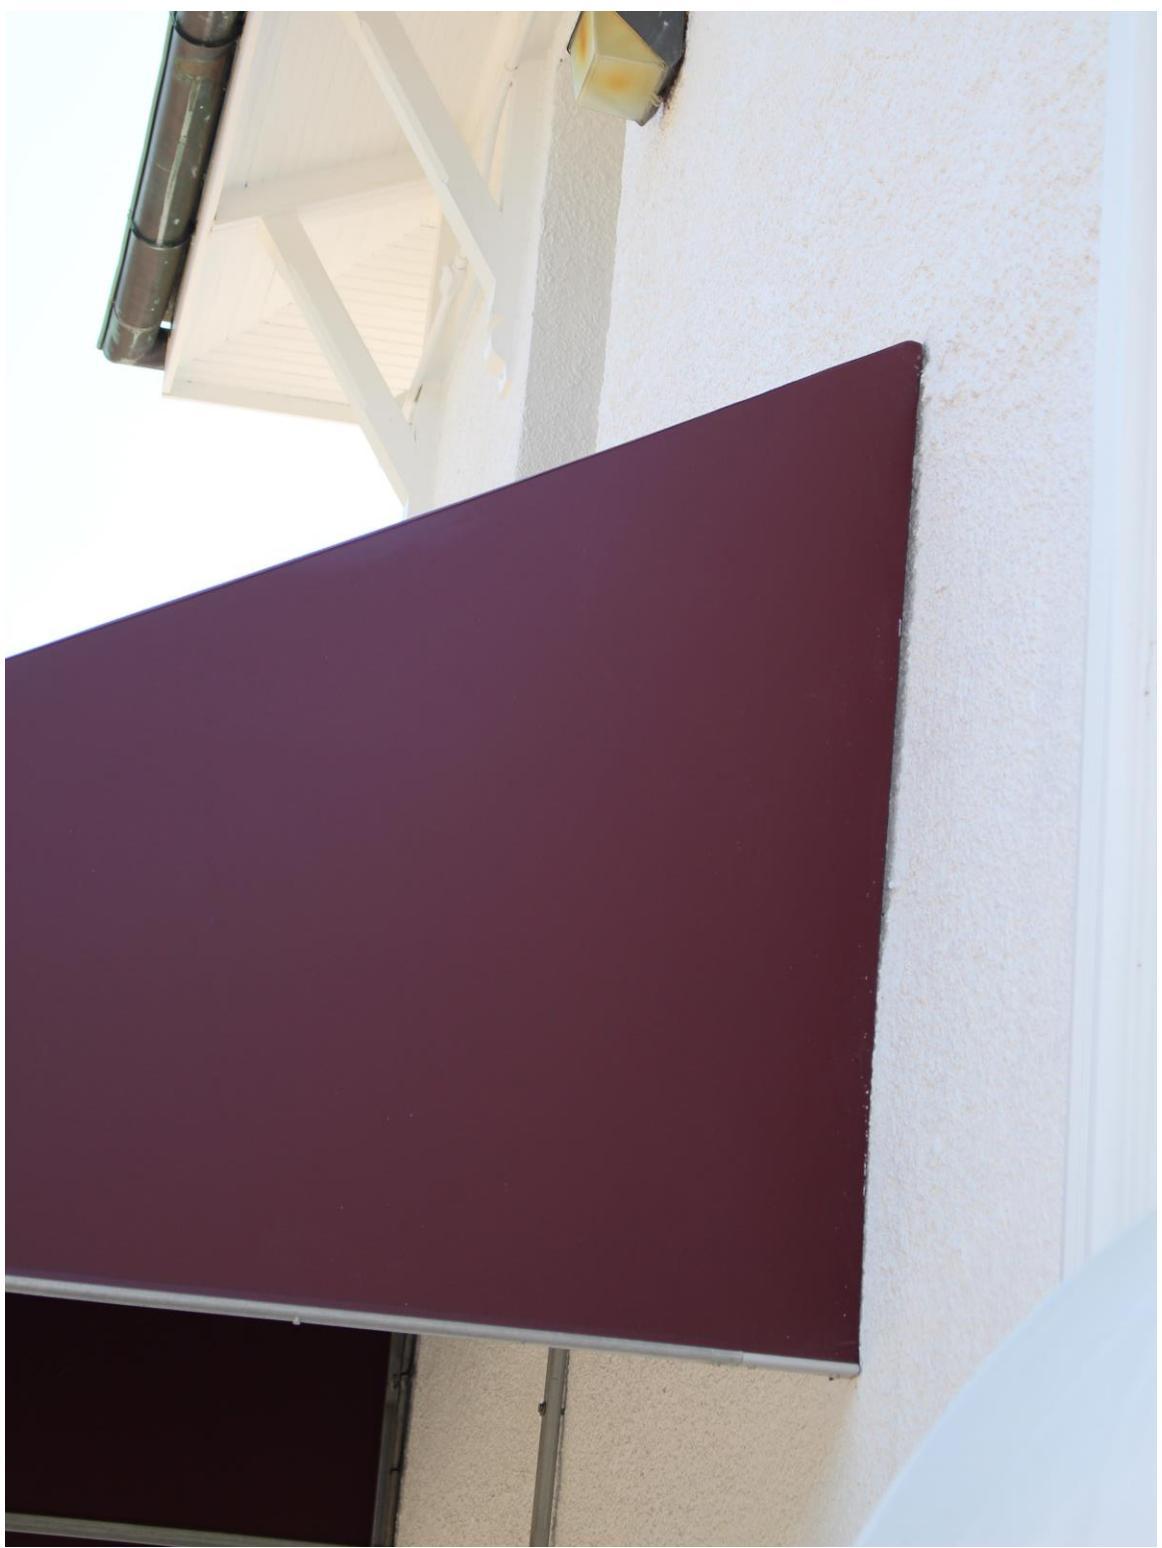
Figure 3-52 Awning – Missing flashing at awning-to-wall connection.

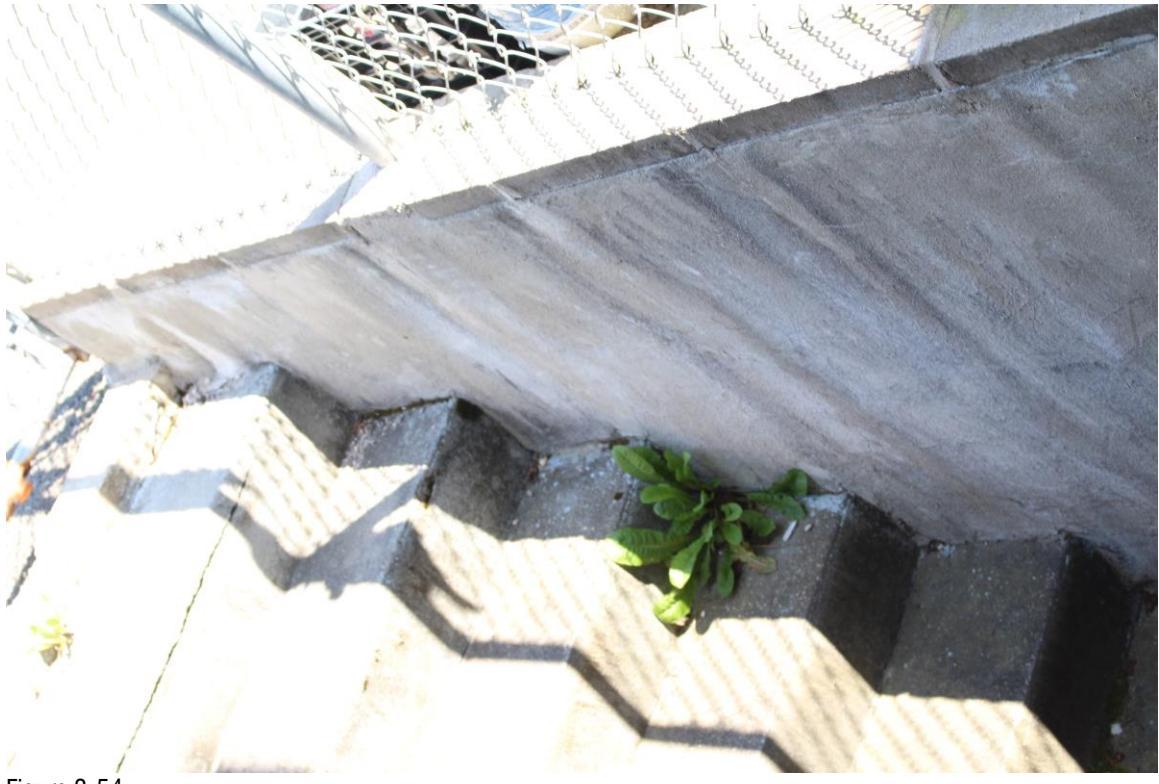
Figure 3-54 Cement coating – Deteriorated cementitious coating and biological growth at exterior basement stair.

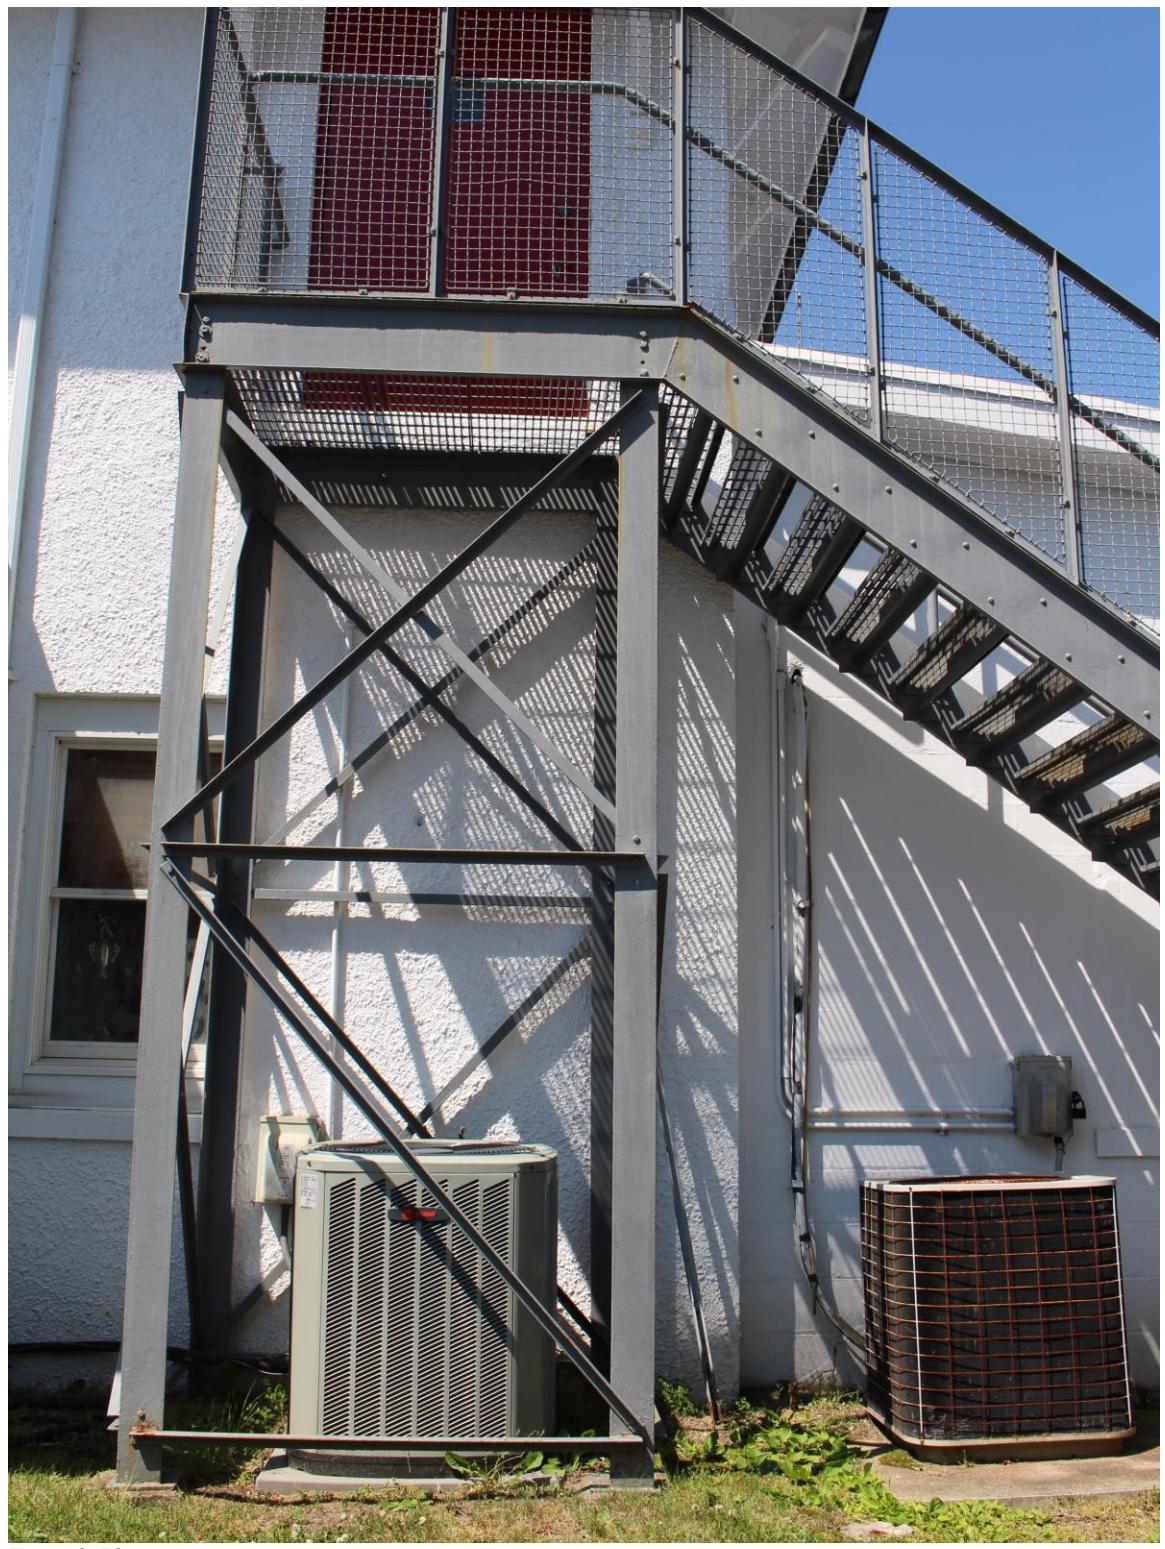
Figure 3-59 Exterior metal stair – Deteriorated paint coating, missing cross brace.

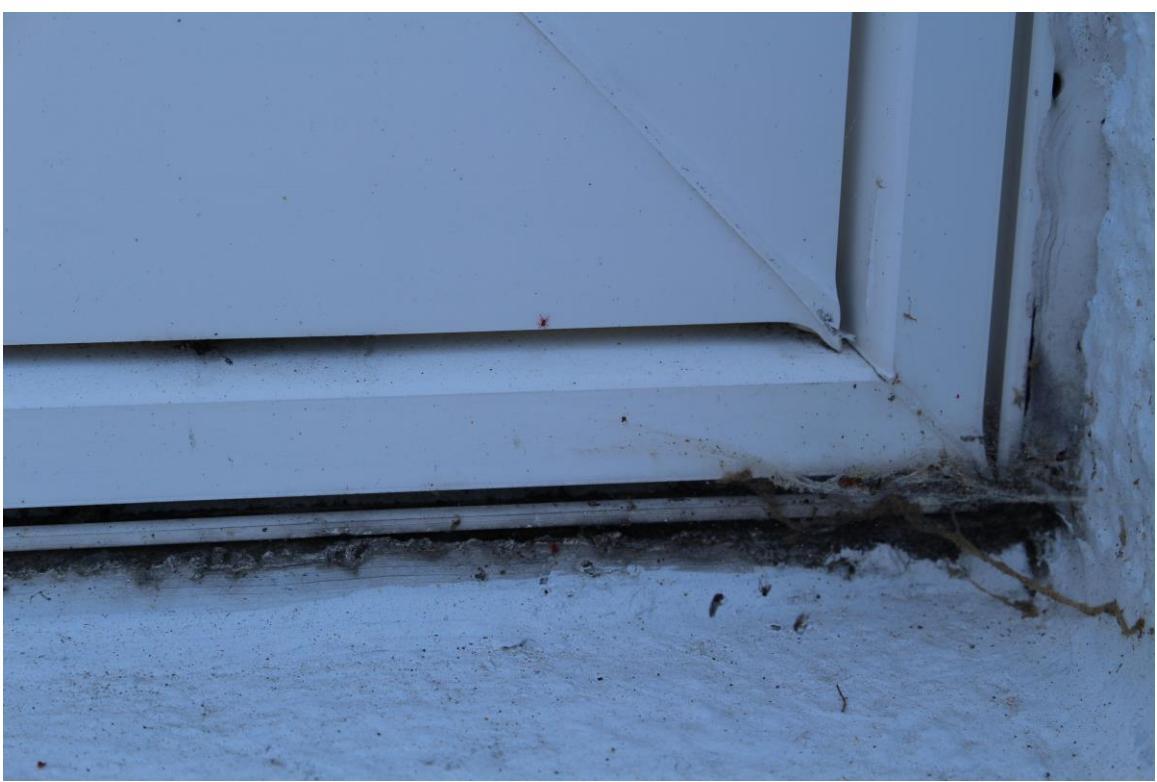
Figure 3-68 Windows – Deteriorated sealant.

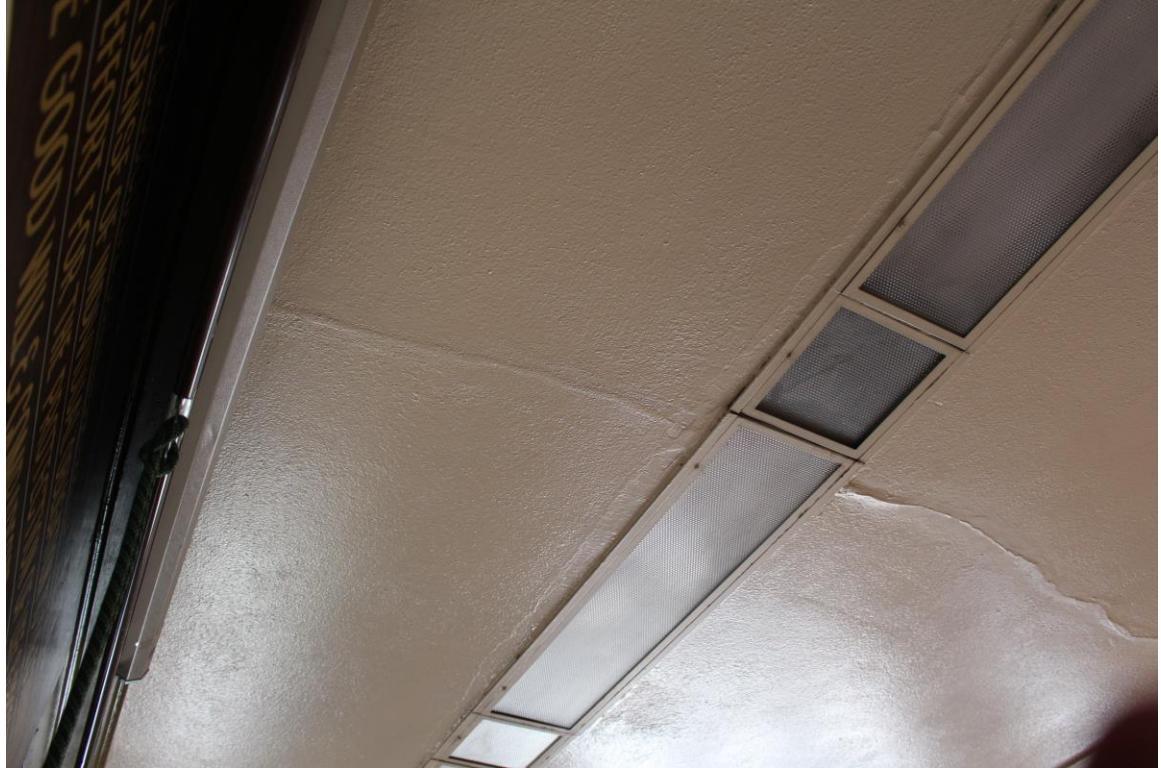
Figure 3-71 Auditorium – Water damage at ceiling (refer to Figure 3-15 for related exterior condition).

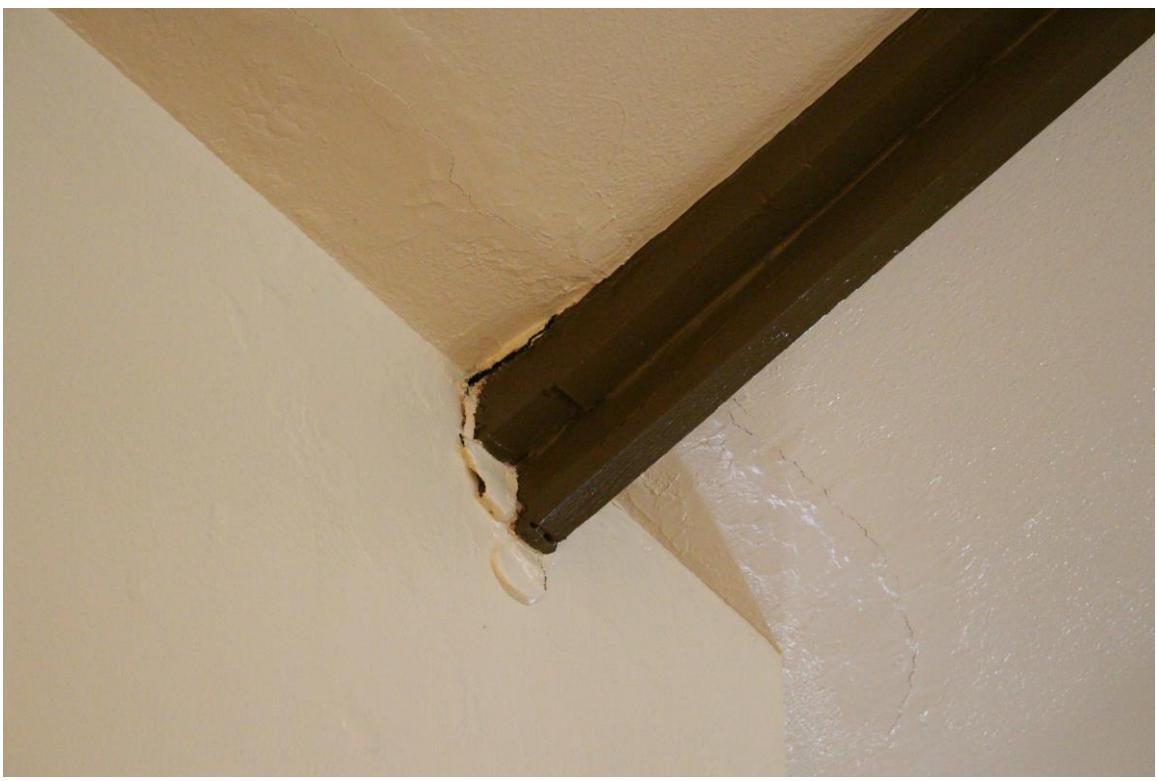
Figure 3-72 Auditorium – Water damage at ceiling (refer to Figure 3-2 and Figure 3-14 for related exterior conditions).

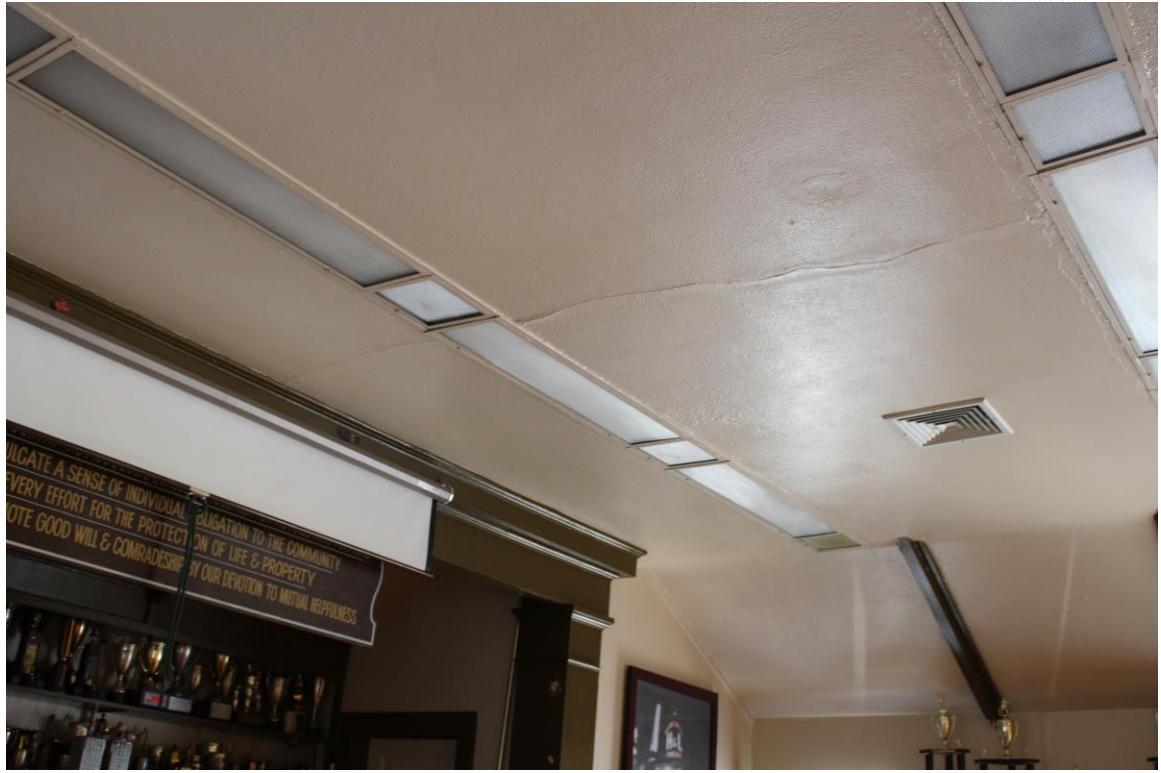
Figure 3-73

Auditorium – Water damage at ceiling (refer to Figure 3-15 for related exterior condition).

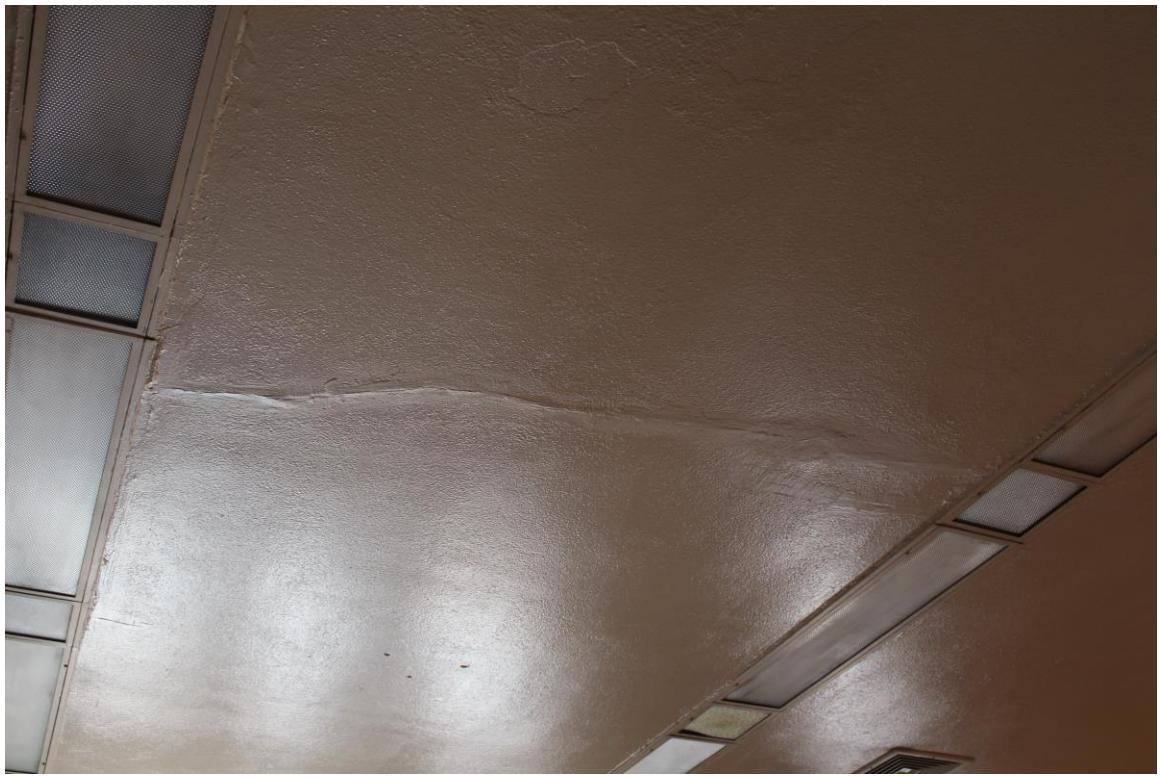
Figure 3-74 Auditorium – Water damage at ceiling (refer to Figure 3-15 for related exterior condition).

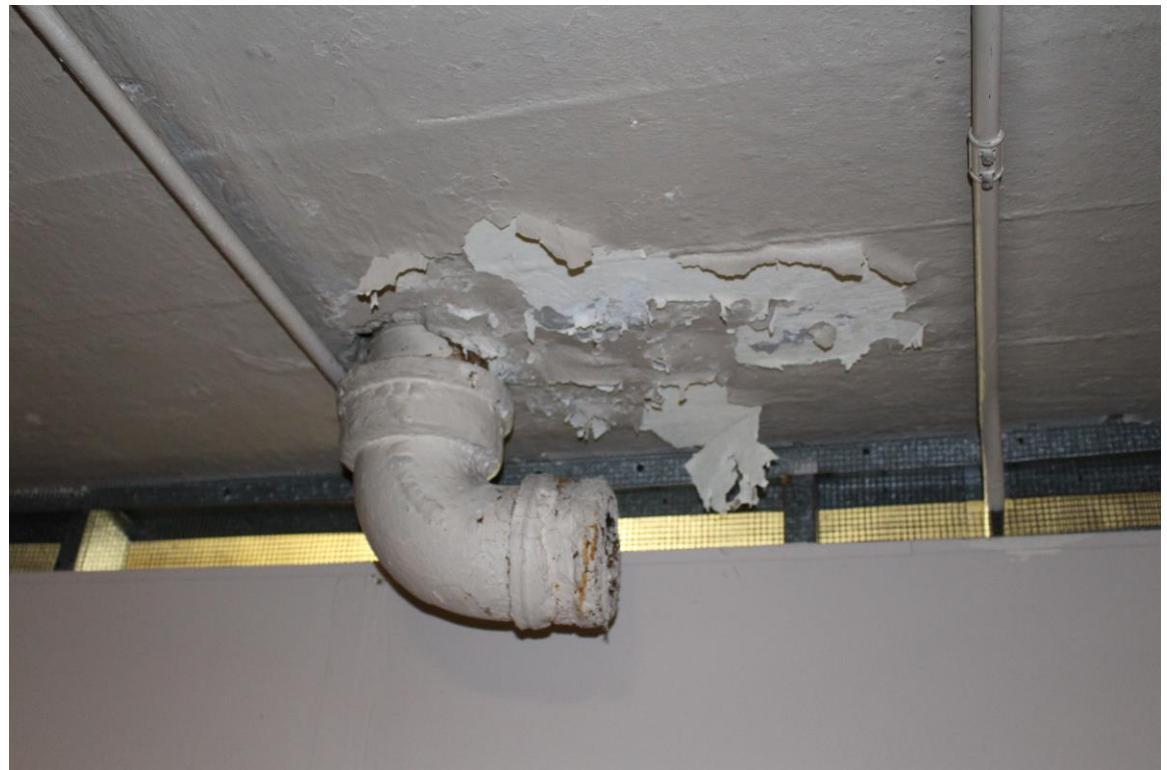
Figure 3-75 Basement – Deteriorated finish at ceiling.

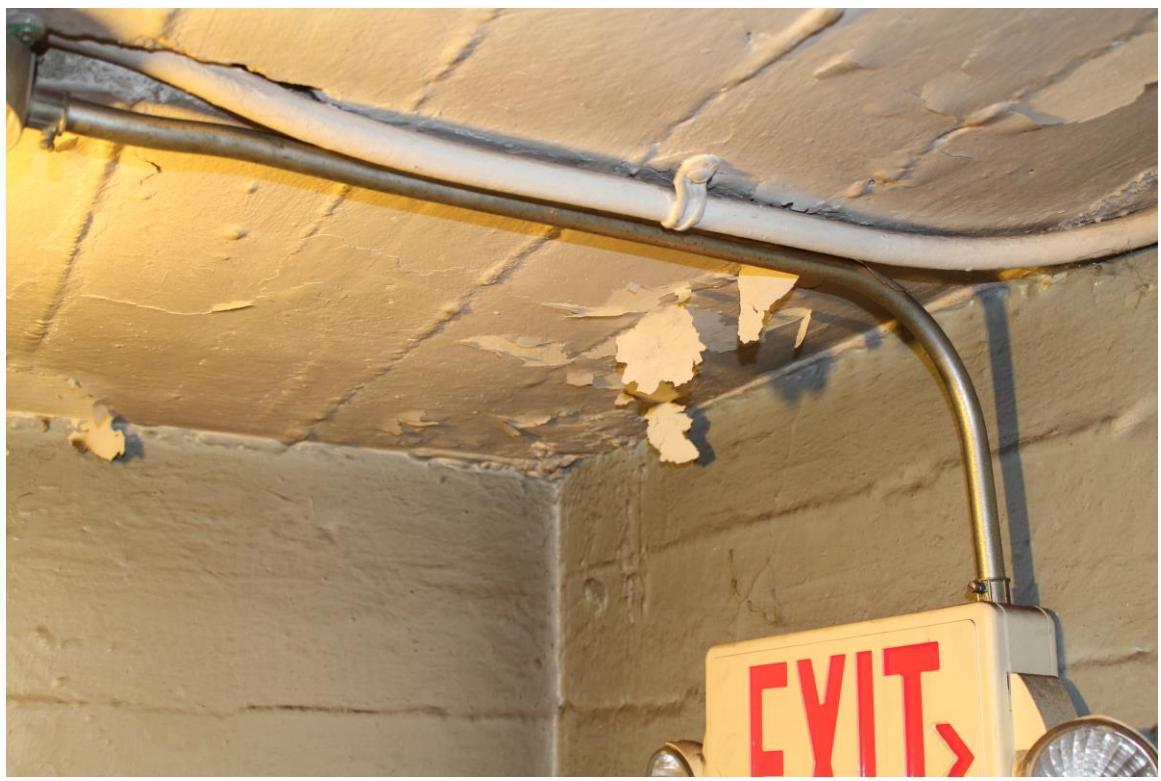
Figure 3-76 Basement – Deteriorated finish at ceiling.
