ST. JAMES FIREHOUSE CONDITIONS ASSESSMENT REPORT

533 NY-25A ST. JAMES, NY 11780

ISSUED: 08 September 2020

APS PROJECT NO: 20-018

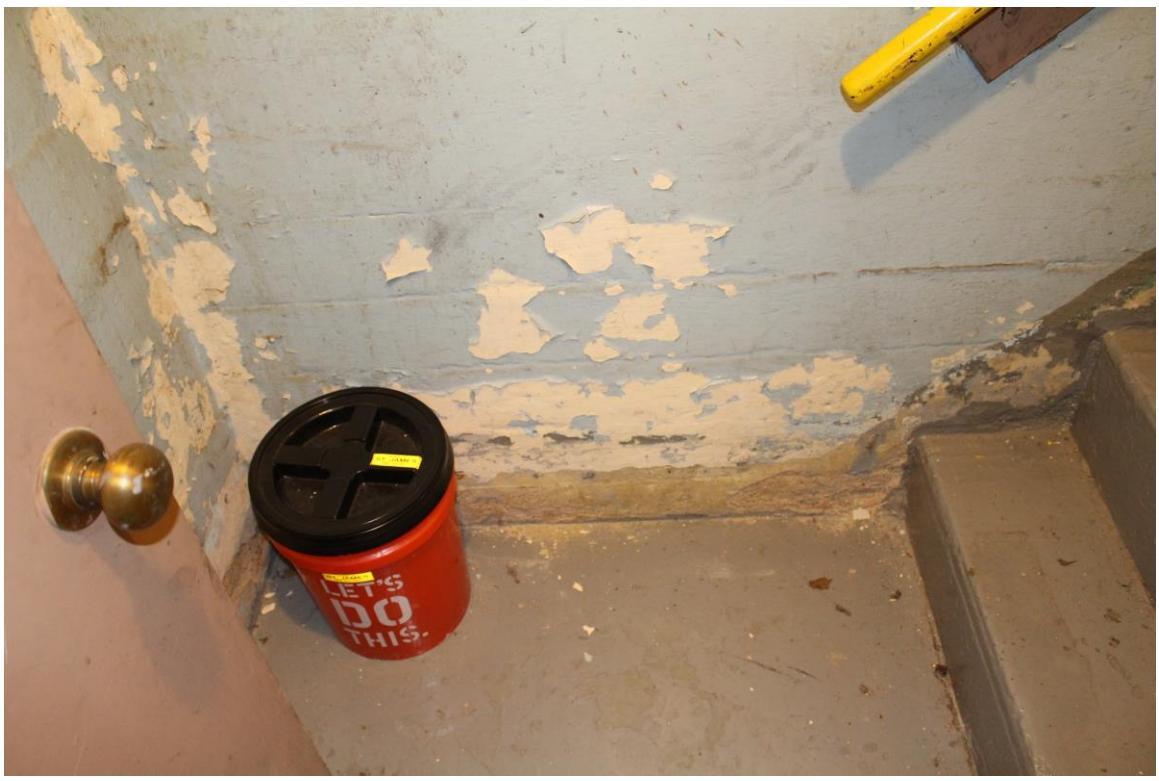
Figure 3-78 Basement – Deteriorated finish at walls.

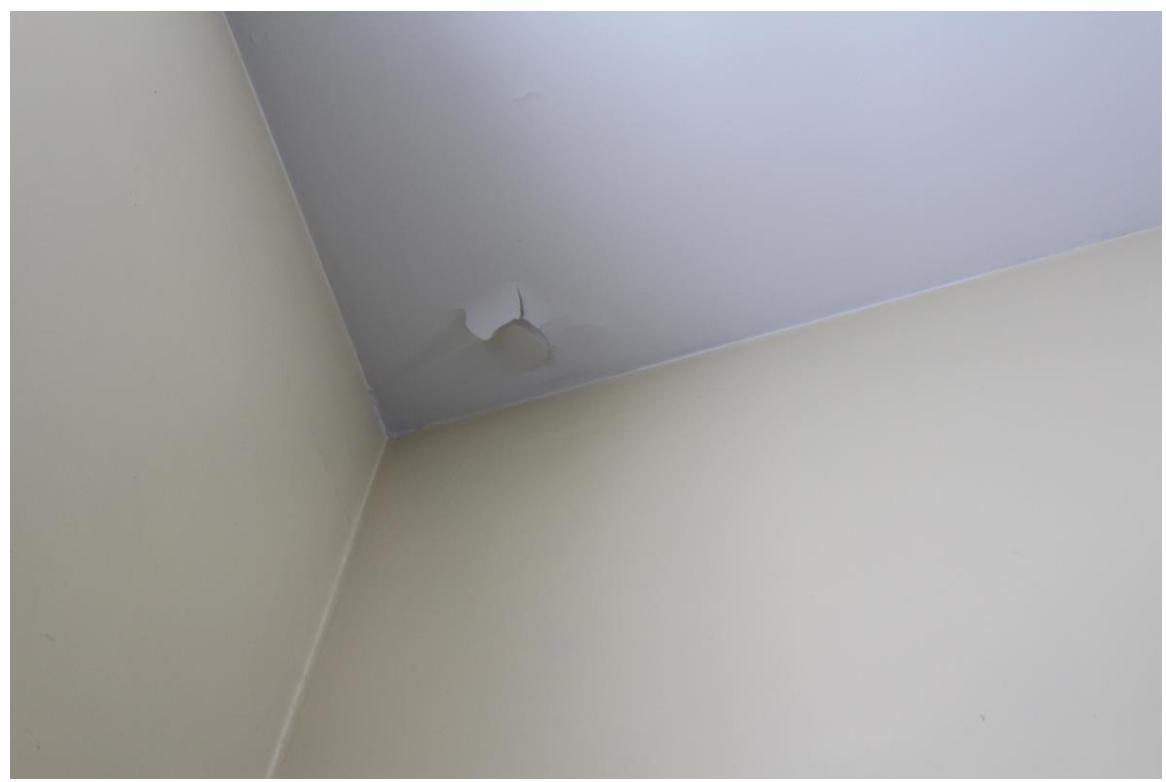
Figure 3-79 Stair tower – Water damage at ceiling (refer to Figure 3-13 for related exterior condition).

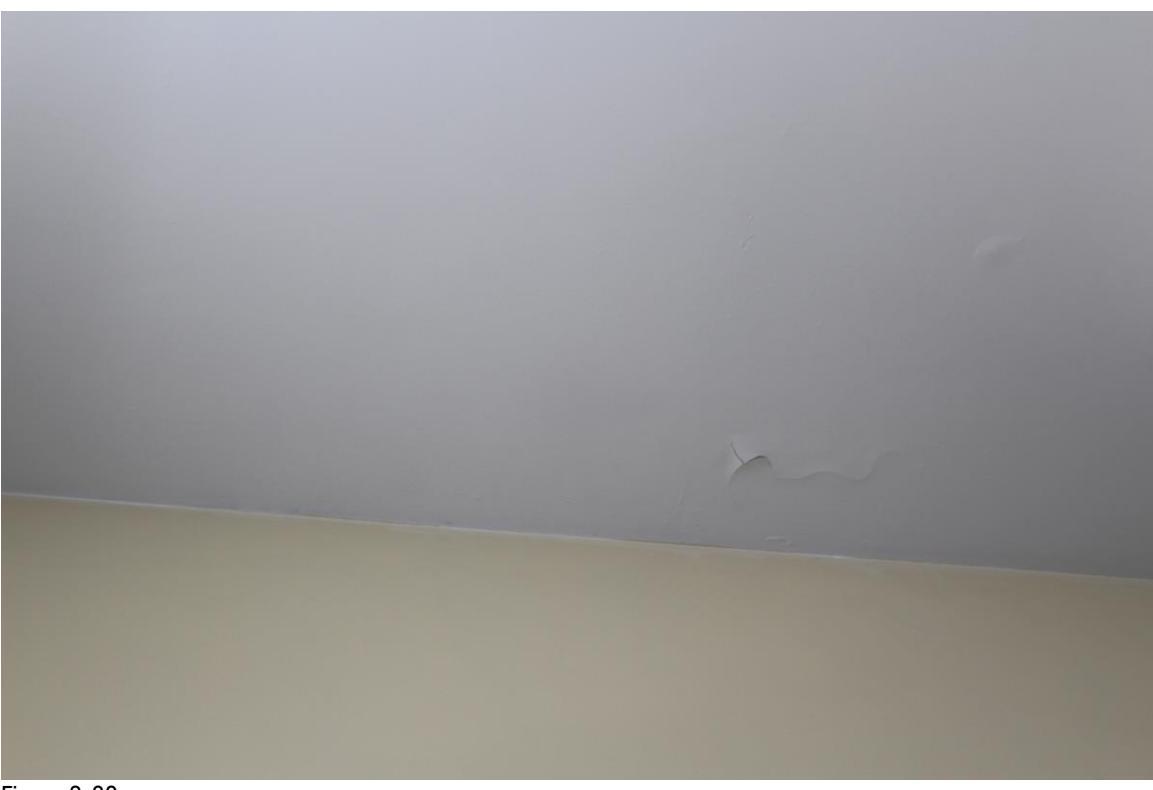
Figure 3-80 Stair tower – Water damage at ceiling (refer to Figure 3-13 for related exterior condition).

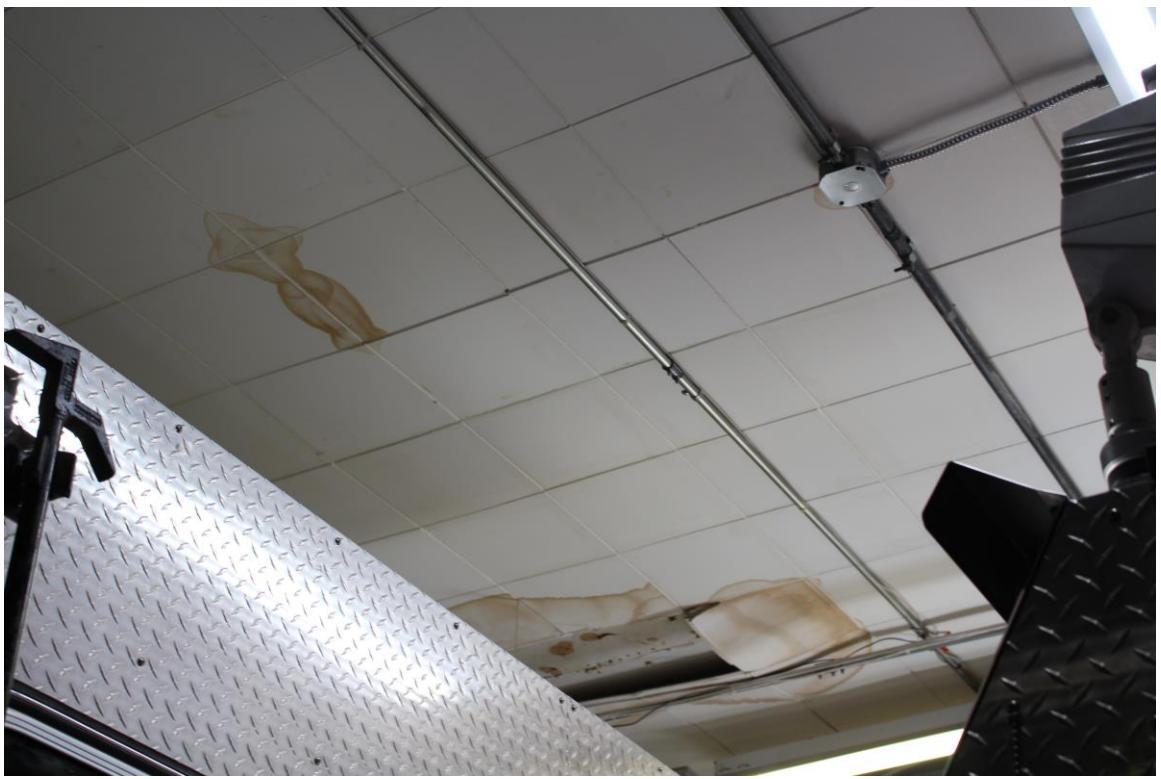
Figure 3-82 Truck bay – Water damage at ceiling.

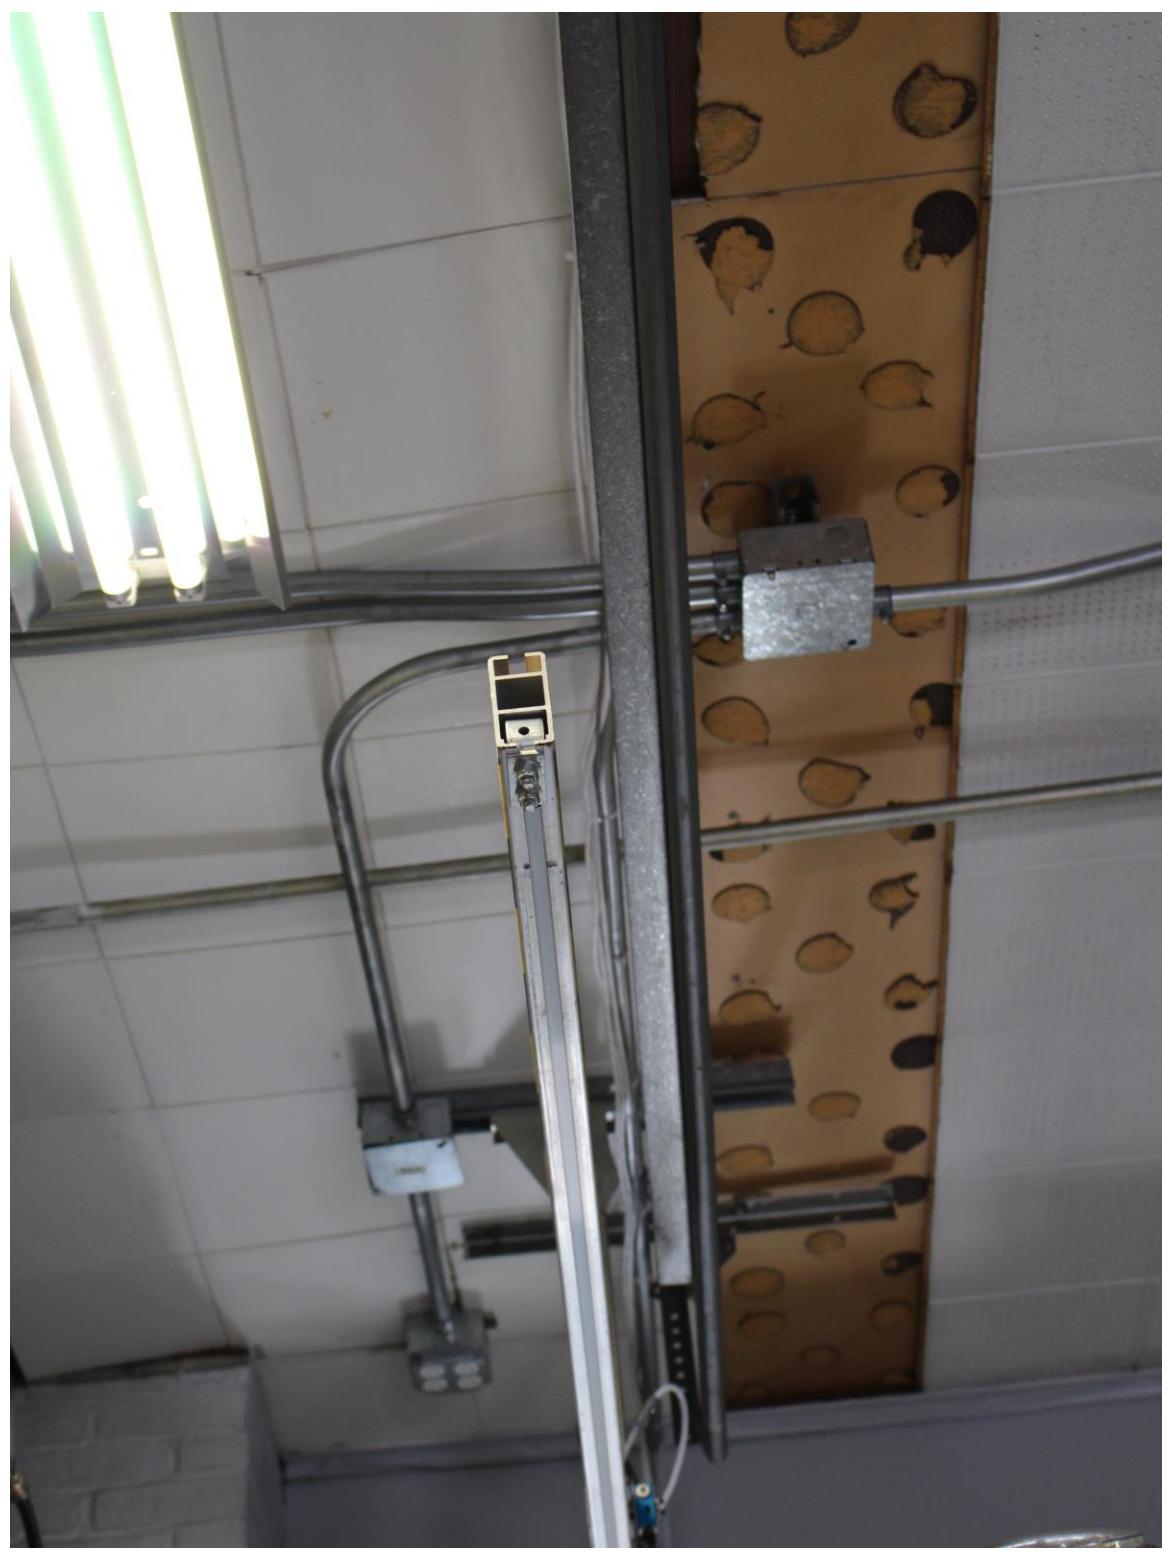
Figure 3-83 Truck bay – Missing tiles at ceiling.
