ST. JAMES FIREHOUSE CONDITIONS ASSESSMENT REPORT

533 NY-25A ST. JAMES, NY 11780

ISSUED: 08 September 2020

APS PROJECT NO: 20-018

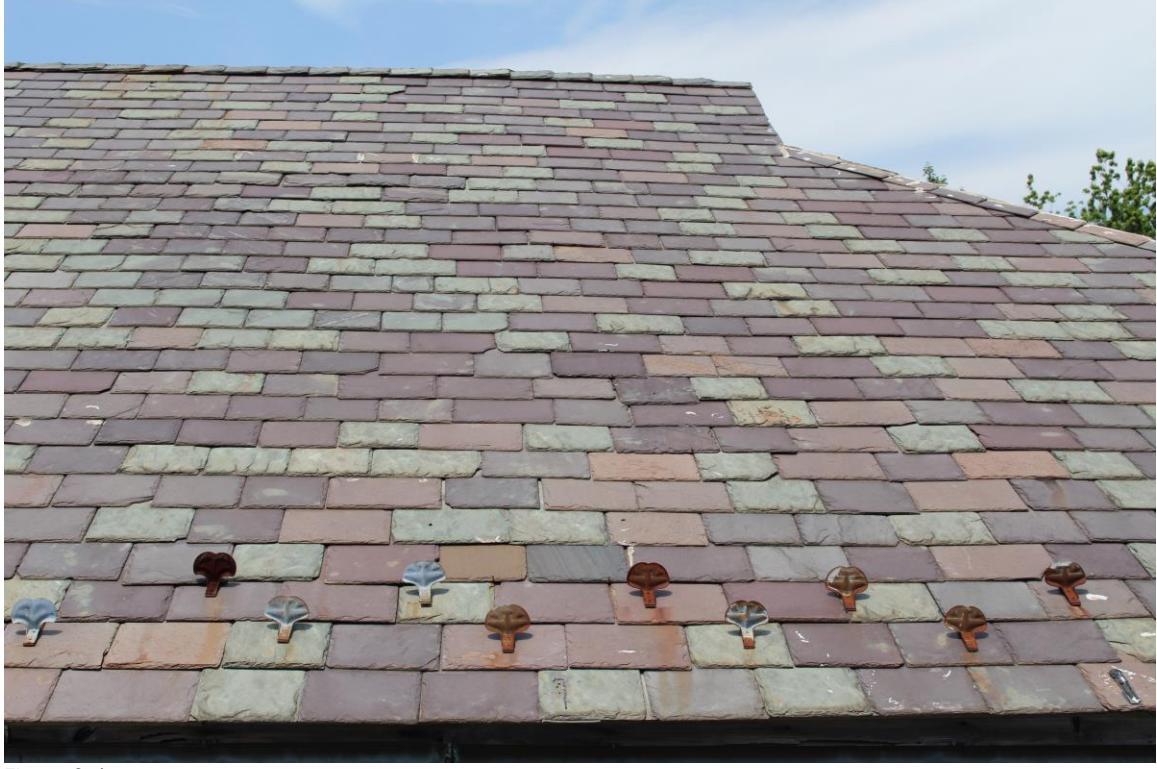
Broken, displaced, and missing slate tiles were observed across the various roofs and the metal snow guards have rusted. Areas of rust-colored and white-colored water staining were visible on the north and south roof slopes. The roof ridges and hips are fitted with paired slate tiles. No flashing is visible. Sealant has been applied over the nail attachment locations and along the joint where the paired tiles meet. Additional applications of remedial sealant were observed at various roof tiles across the roof.

Slate roofing – South roof slope. Deteriorated hip and ridge tiles, broken and displaced tiles, deteriorated snow guards.

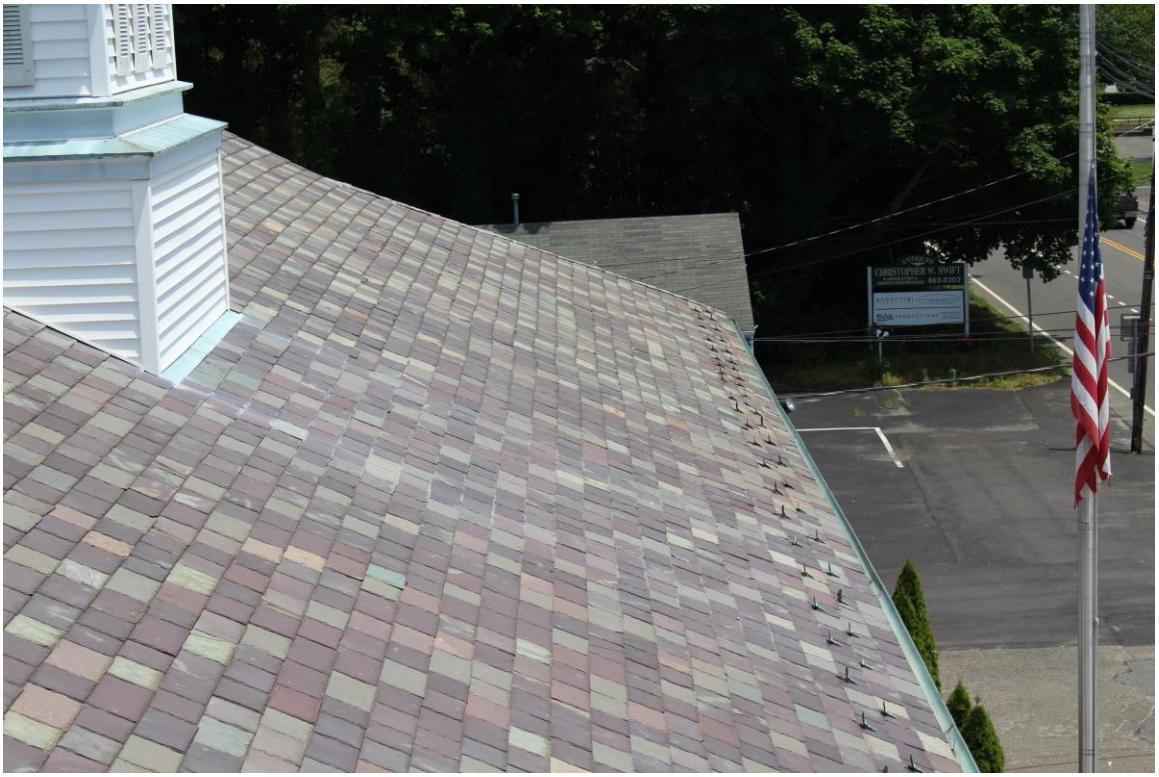
Figure 3-9 Slate roofing – South roof slope. Deteriorated tiles.

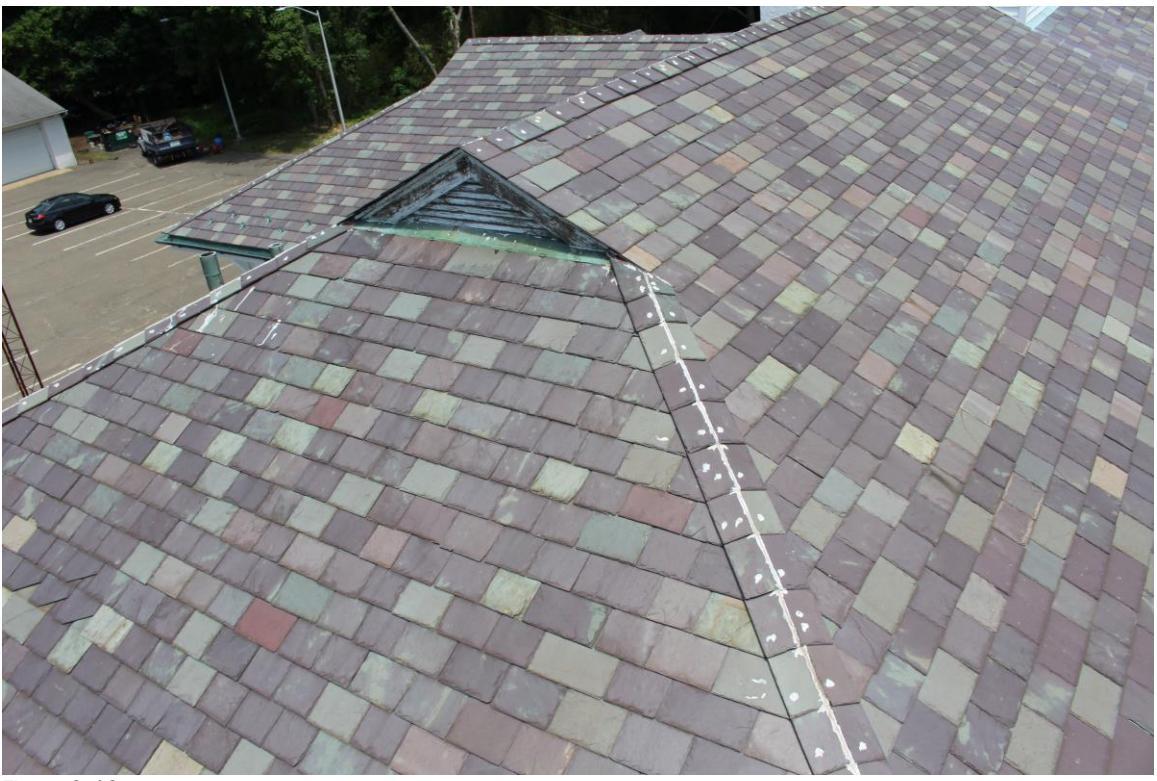
Slate roofing – West-facing gable end. Deteriorated wood vent and copper flashing, missing flashing at rake, deteriorated hip and ridge tiles.

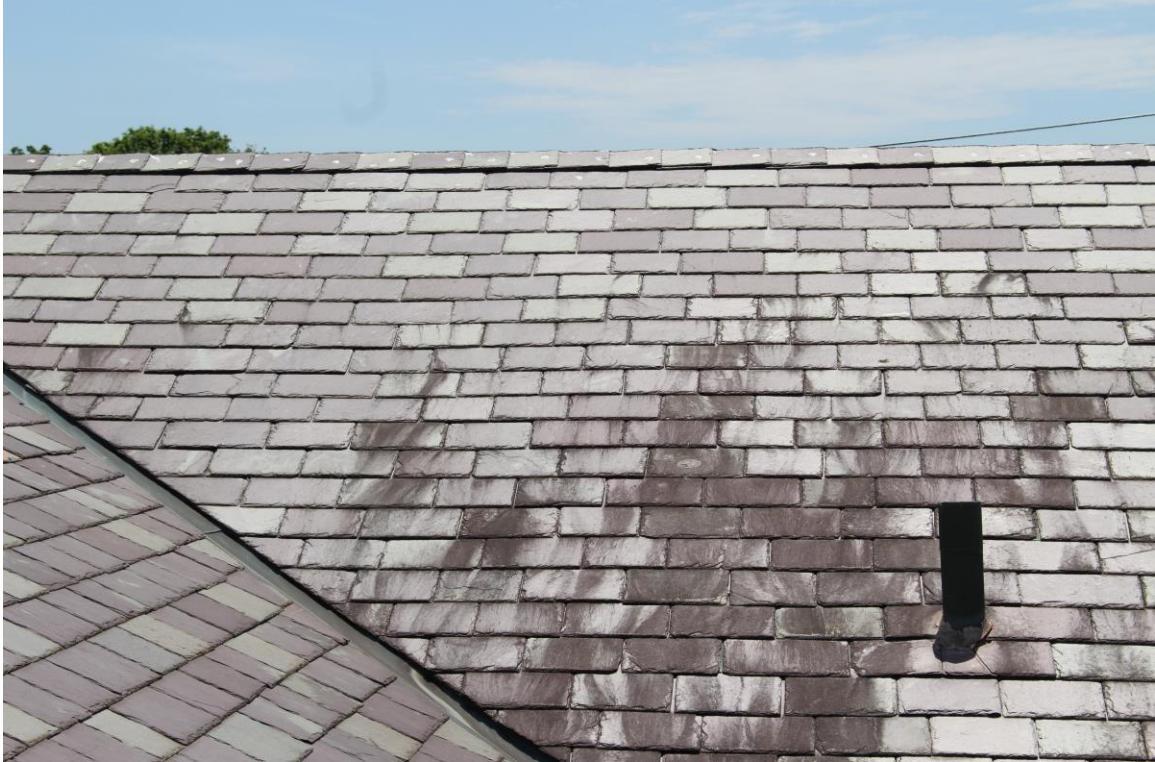
Slate roofing – North slope. Aged and broken tiles, deteriorated penetration flashing.

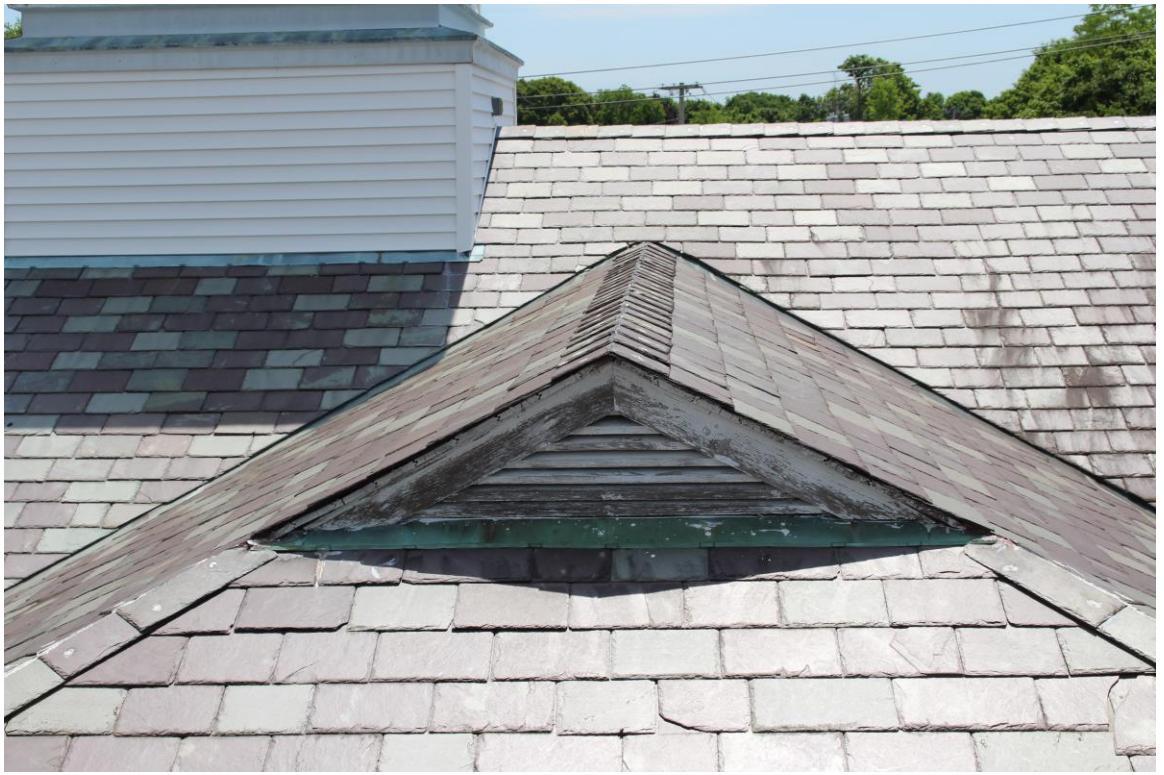
Slate roofing – North-facing gable end. Deteriorated wood vent and copper flashing, missing flashing at rake, deteriorated tiles.

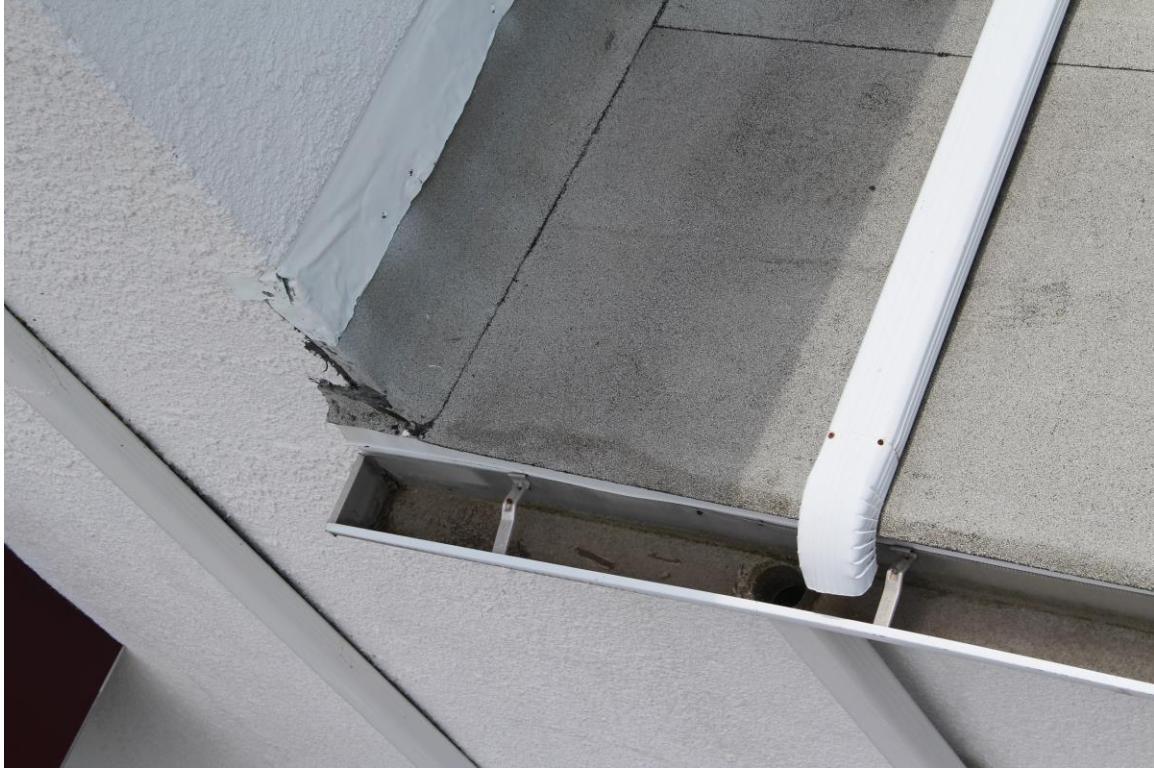
Modified-bitumen roofing – West of the stair tower. Deteriorated counter-flashing, improper flashing termination, lack of integration of roof edge with gutter.

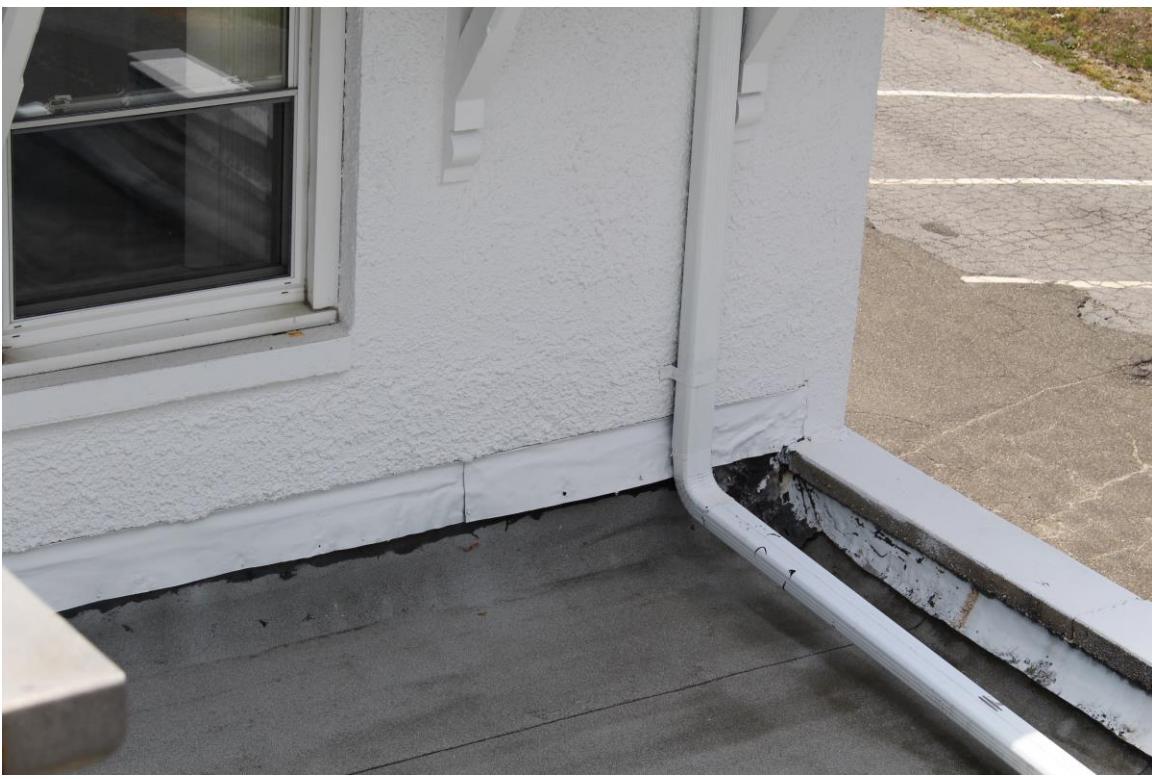
Modified-bitumen roofing – West of the stair tower. Deteriorated counter-flashing, improper flashing termination.

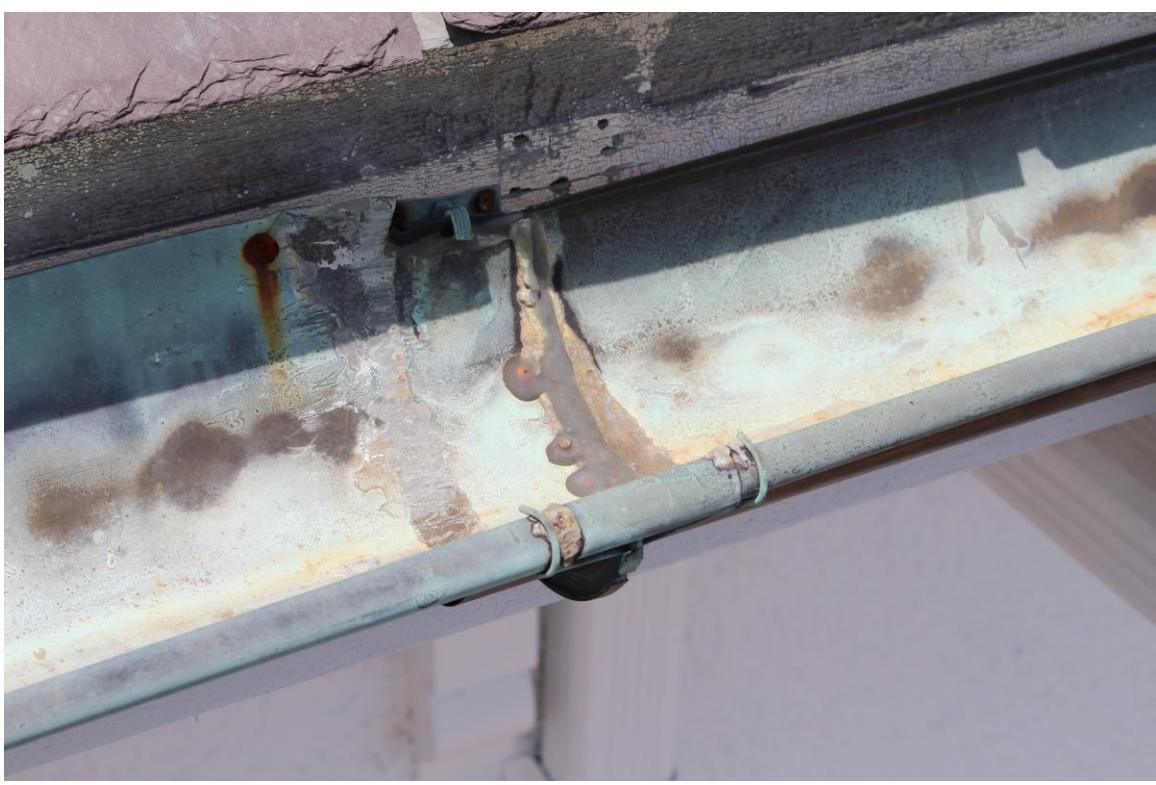
Figure 3-28 Copper gutter – Deteriorated copper gutter, deteriorated gutter hanger, unprotected wood fascia.

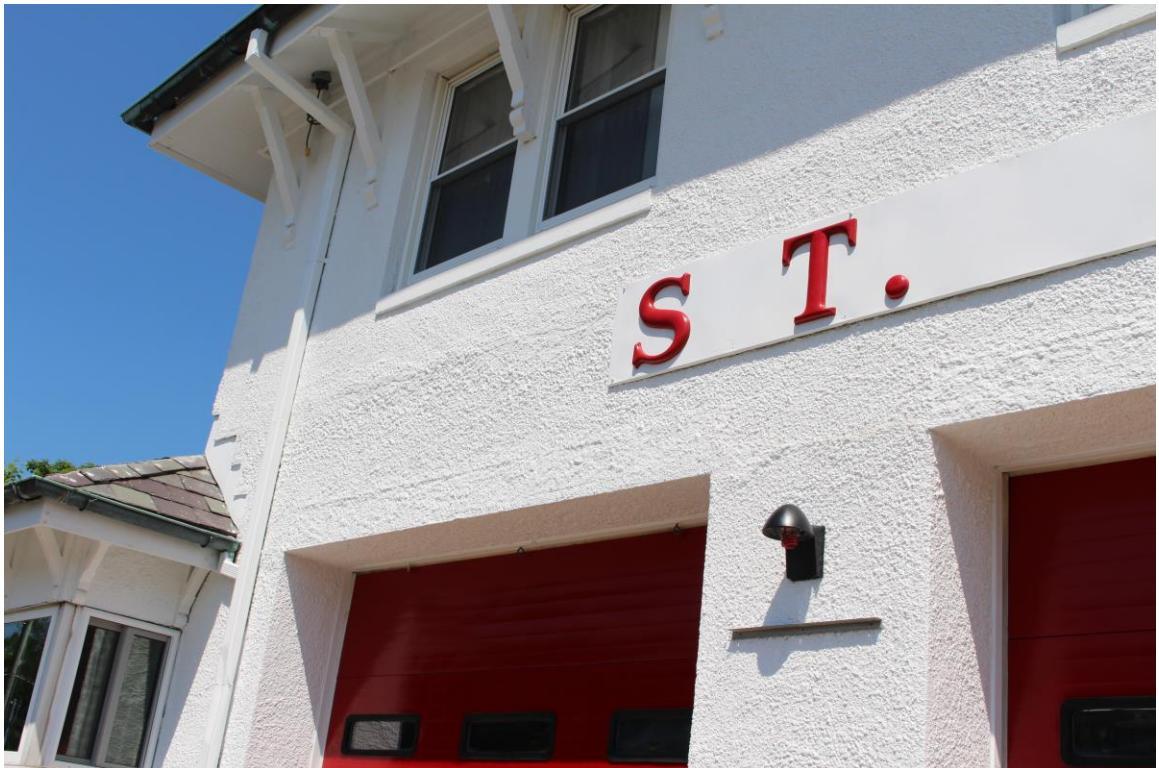
Figure 3-40 Masonry – Continuous horizontal crack.

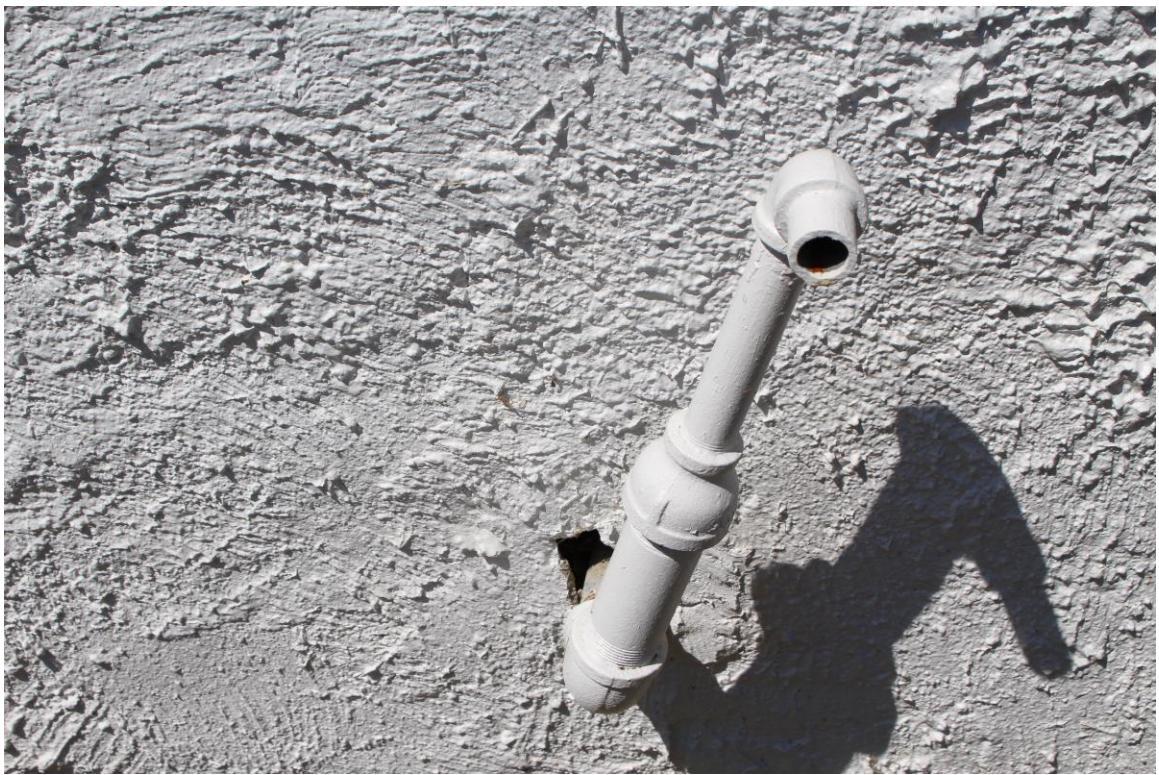
Figure 3-47 Masonry – Un-flashed pipe penetration.

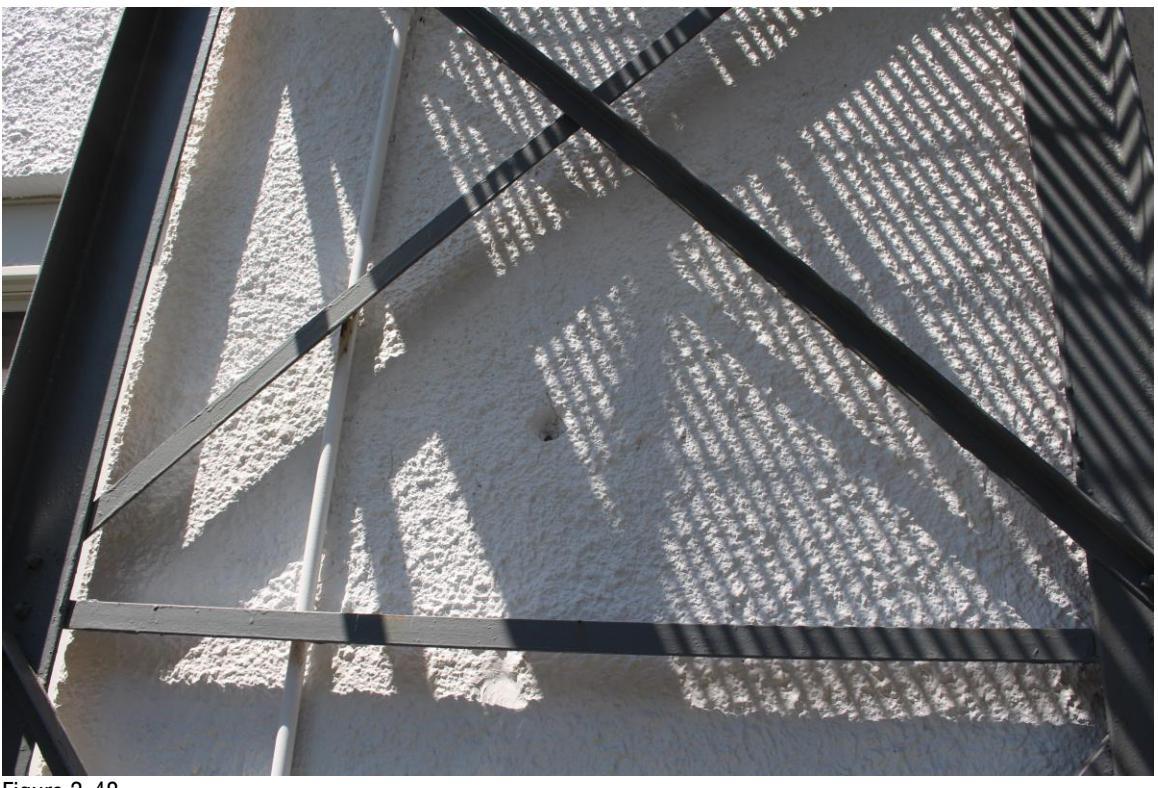
Figure 3-48 Masonry – Abandoned pipe penetration.

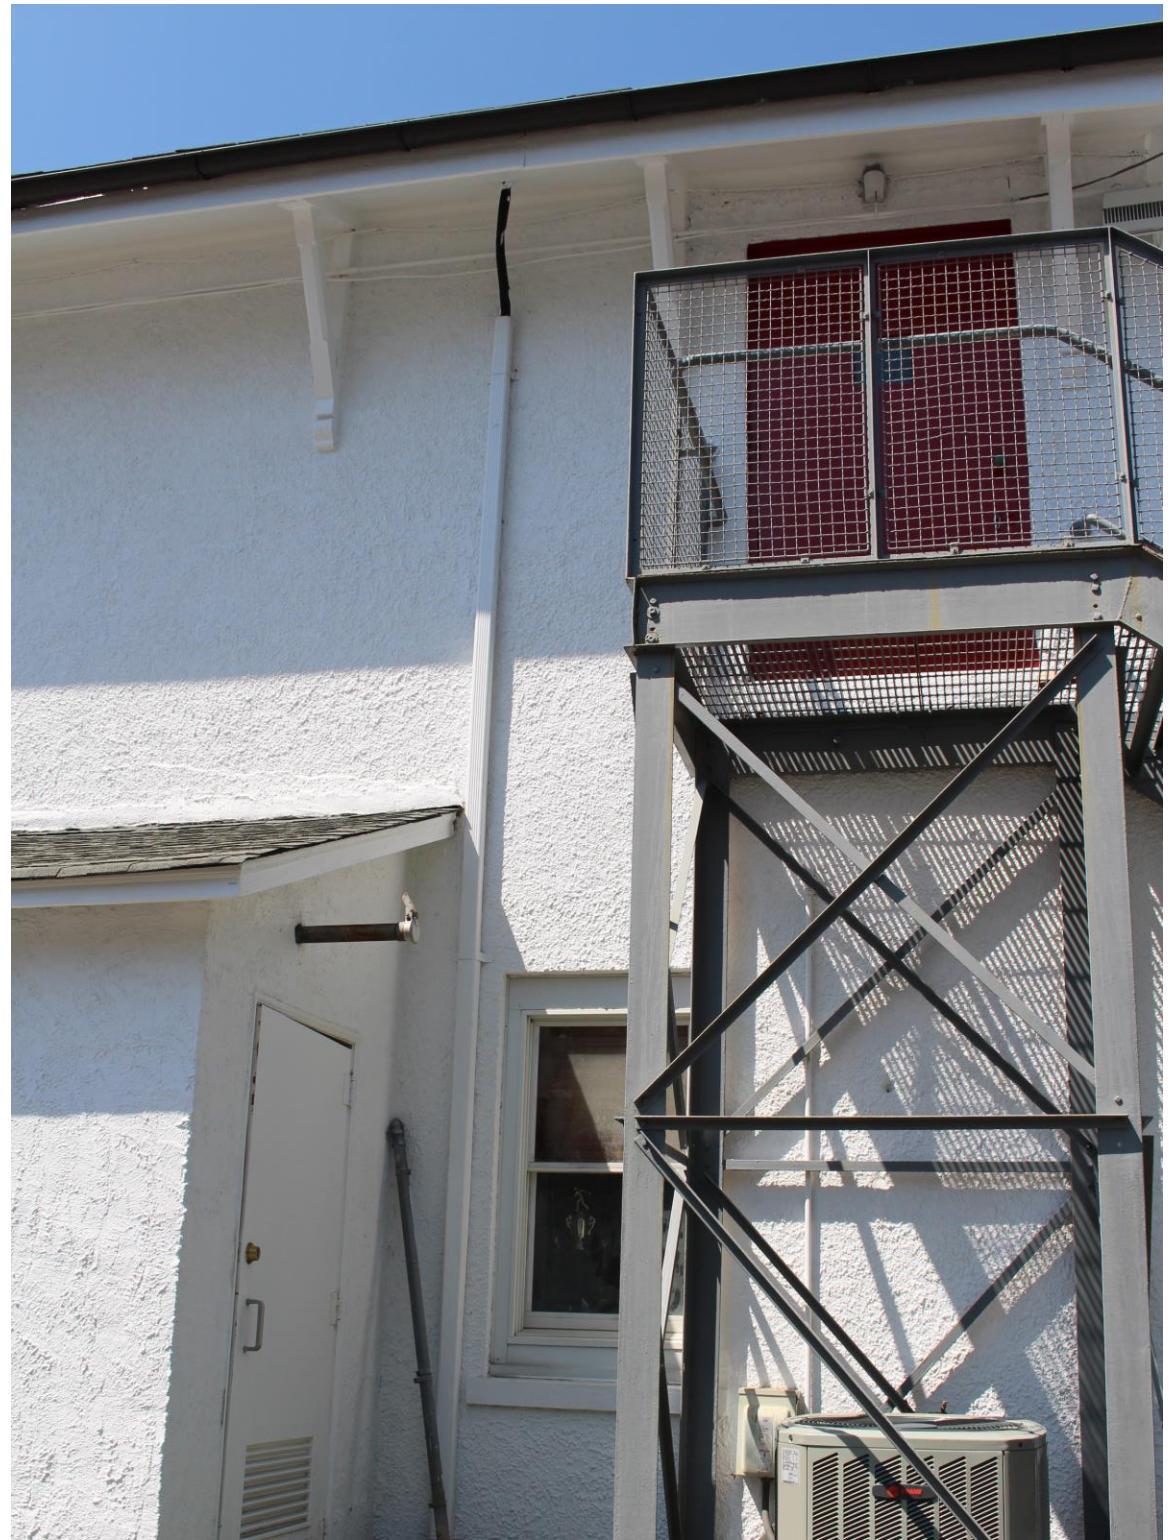
Figure 3-49 Masonry – Wiring in aluminum downspout.

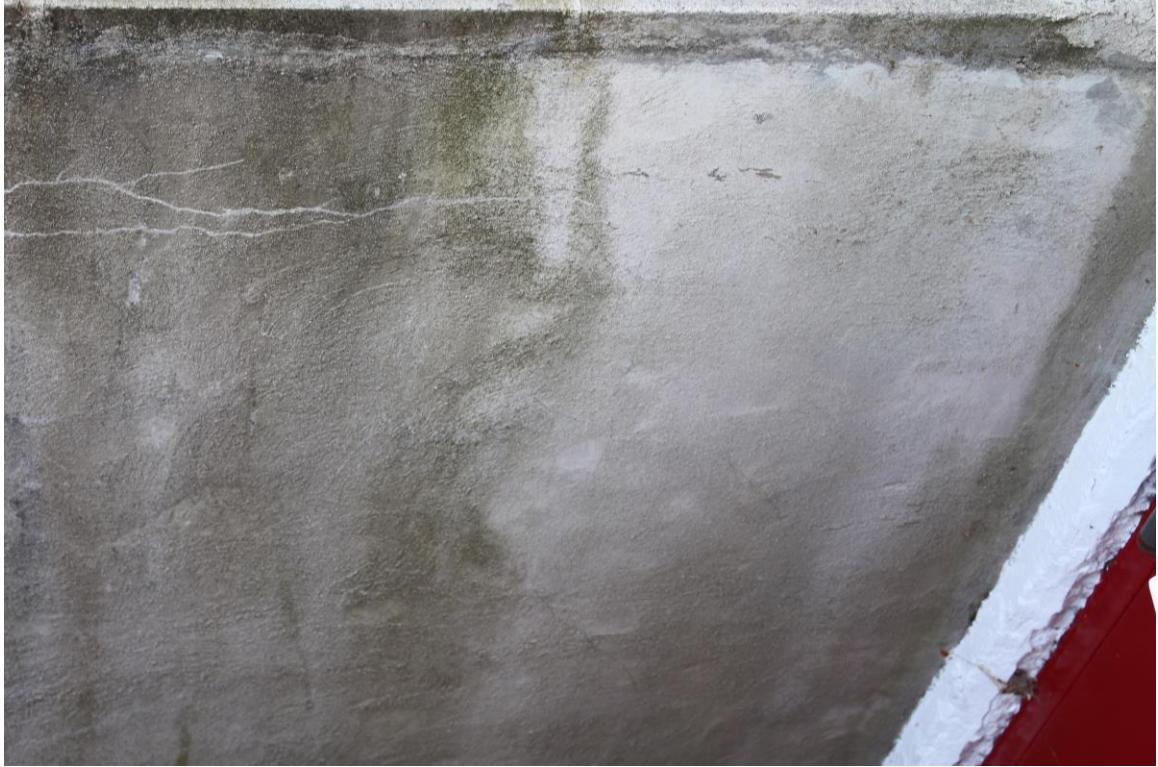
Figure 3-53 Cement coating – Deteriorated cementitious coating at exterior basement stair.

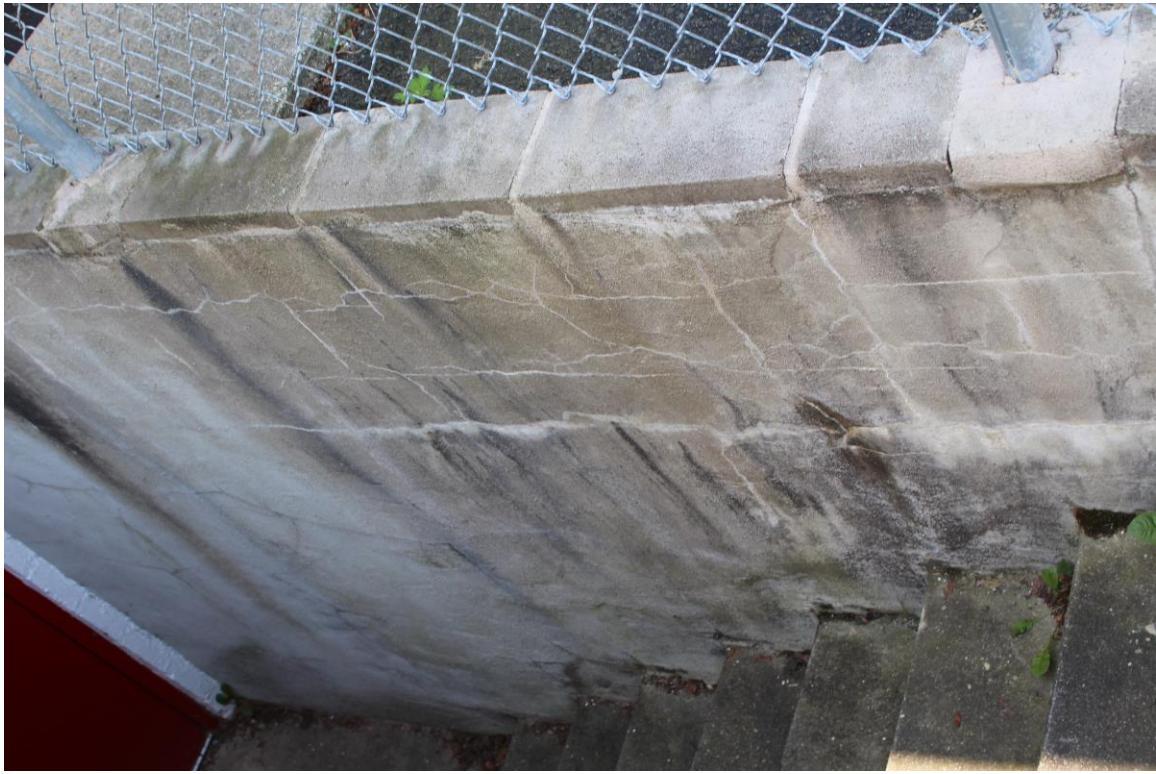
Cement coating – Deteriorated cementitious coating, deteriorated coping, and biological growth at exterior basement stair.

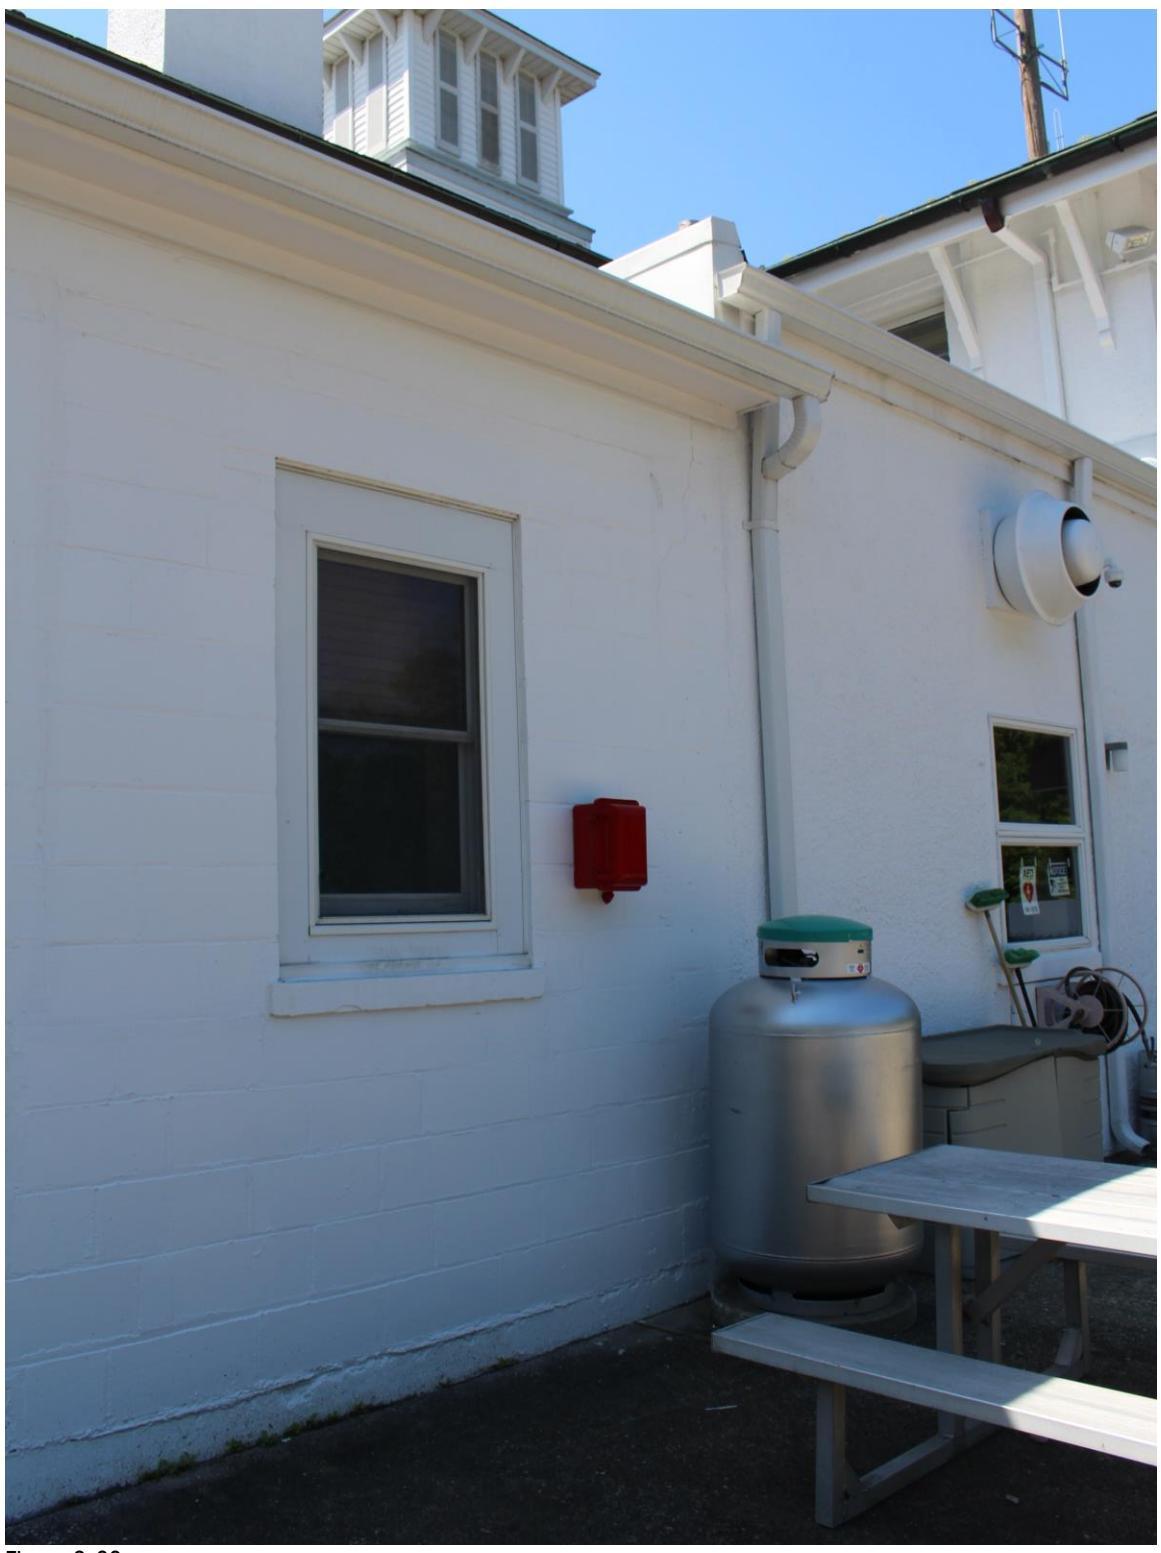
Figure 3-60 Windows – Replacement window in larger masonry opening.

- 1. Replace windows and doors on all façades with new wood windows and doors to match the historic configurations, in compliance with the most up-to-date edition of federal, state, and local building codes. Replace fire-rated openings with an assembly of the same or higher fire rating.
- 2. At the south façade, remove windows and masonry infill at two truck bays. Install a new infill to match the historic door configuration.

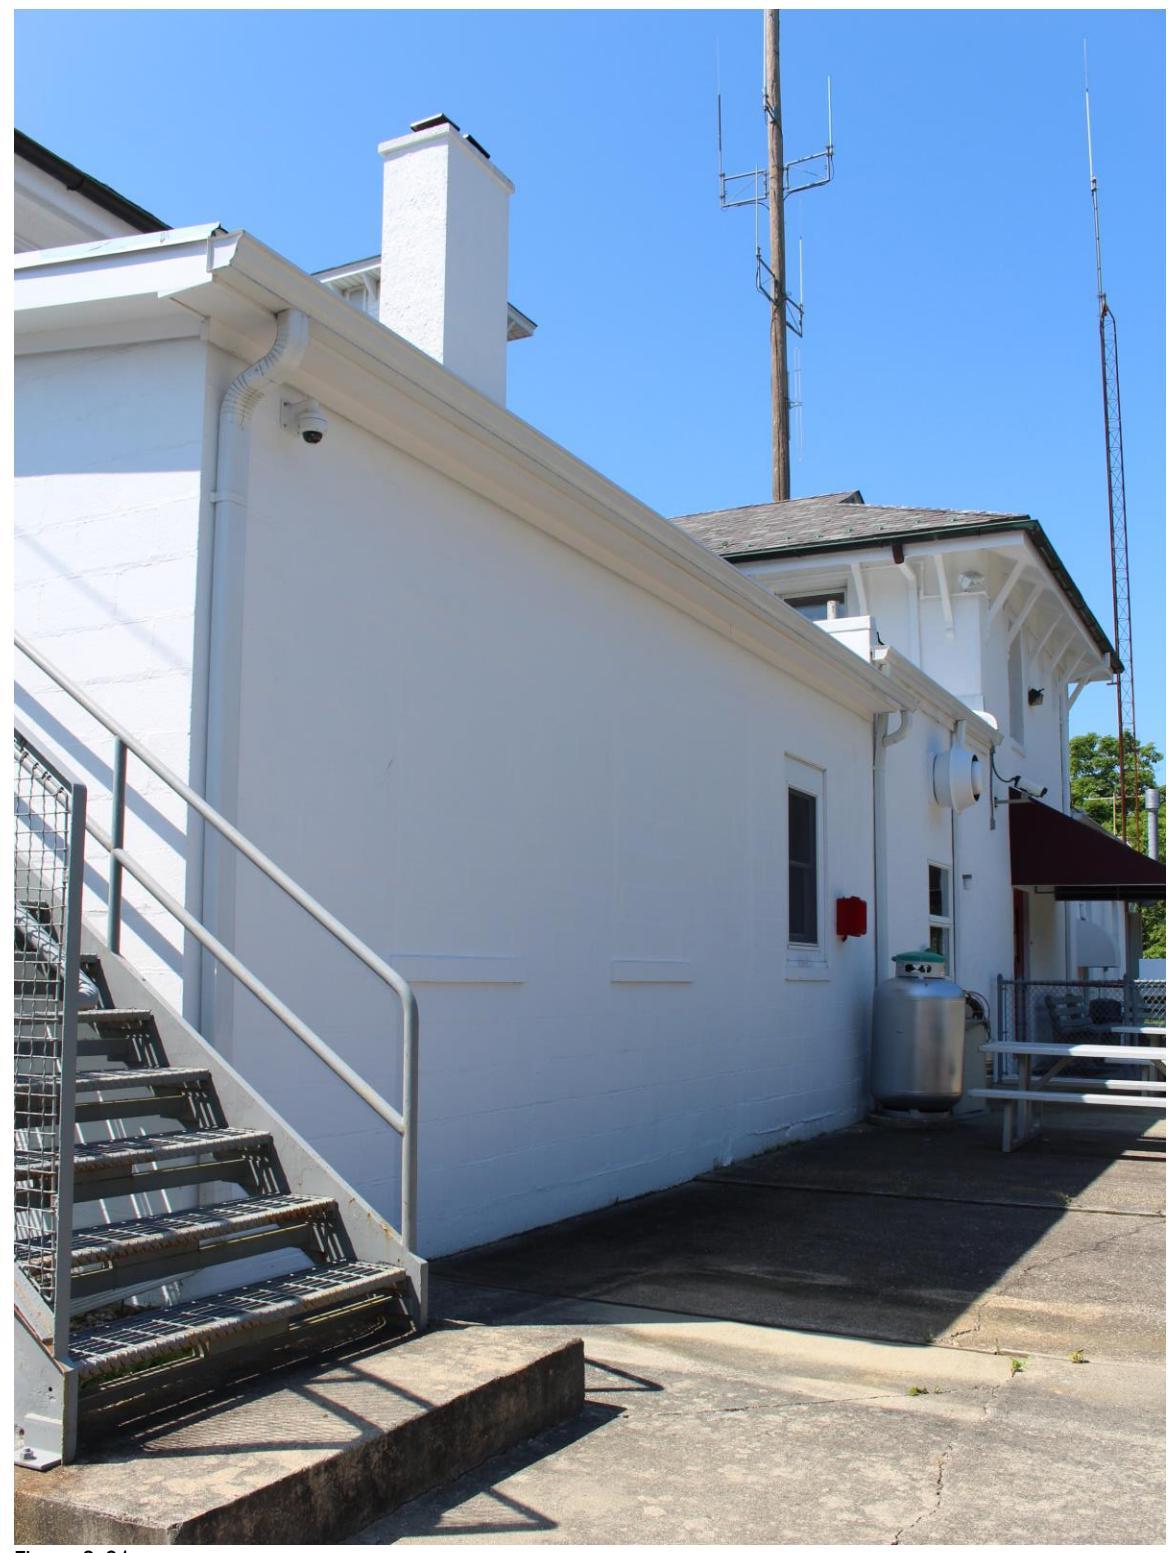
Figure 3-61 Windows – Former window opening with masonry infill.

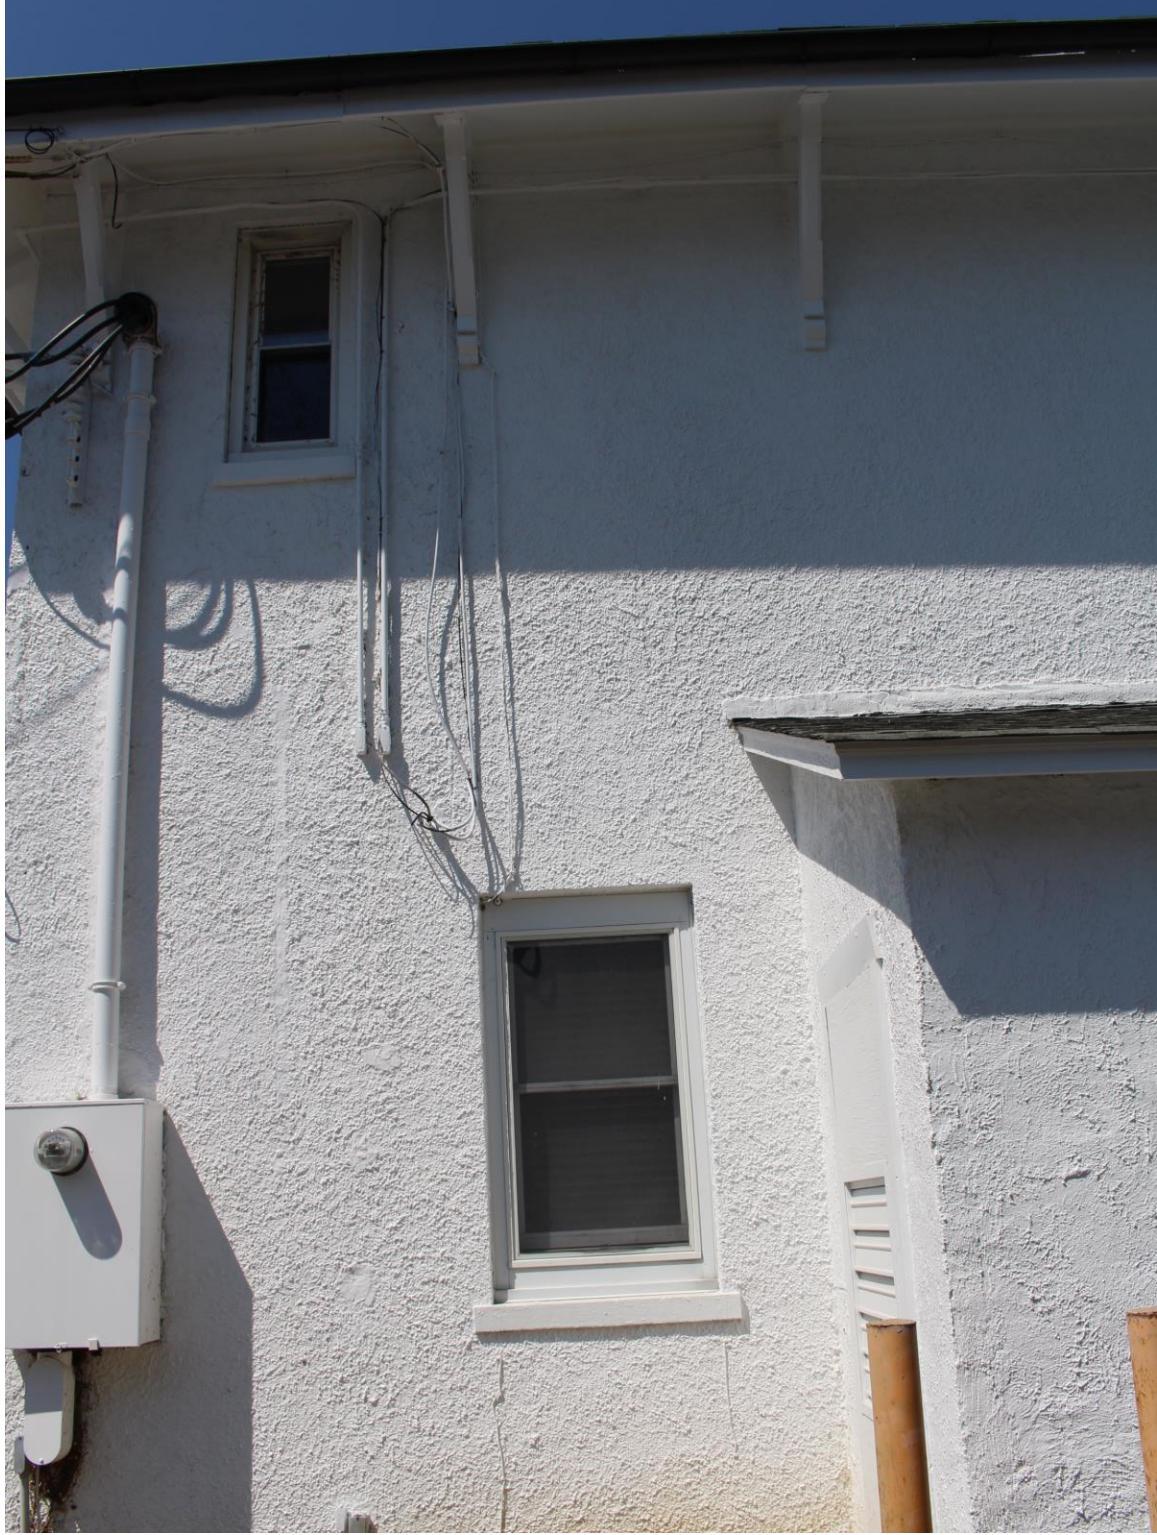
Figure 3-62 Windows – Replacement windows in larger masonry openings.

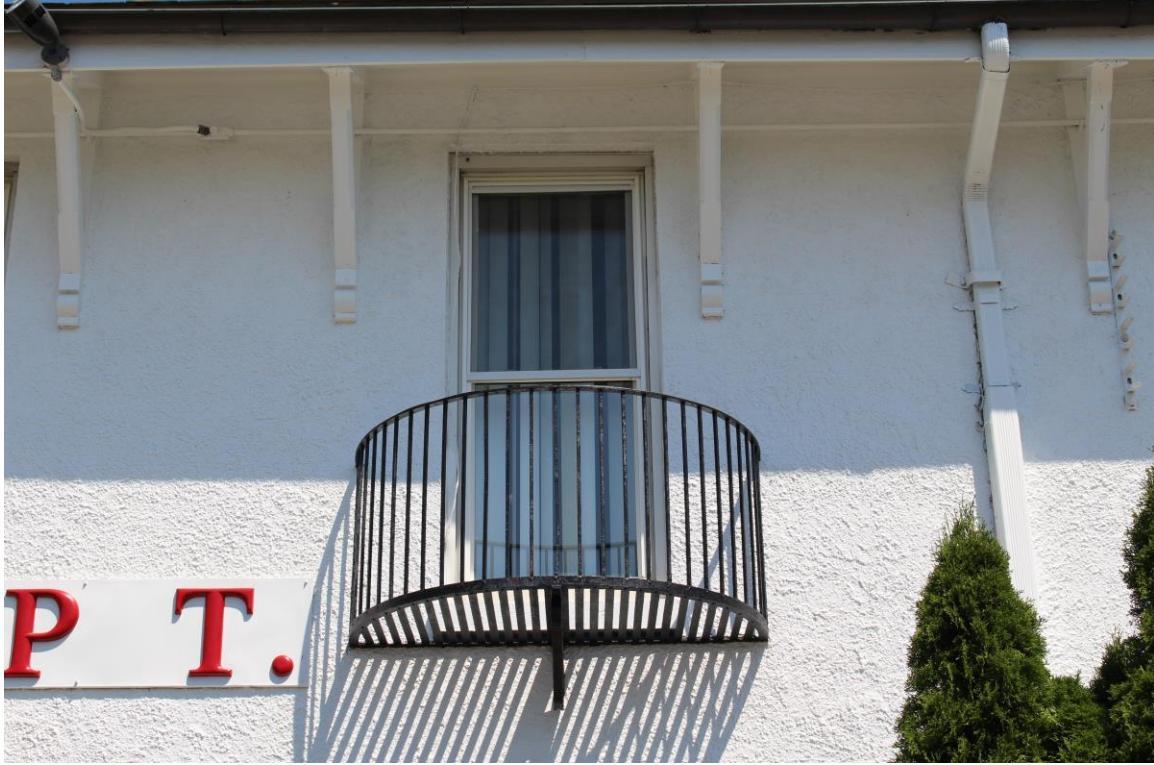
Figure 3-63 Windows – Replacement window in balcony door opening.

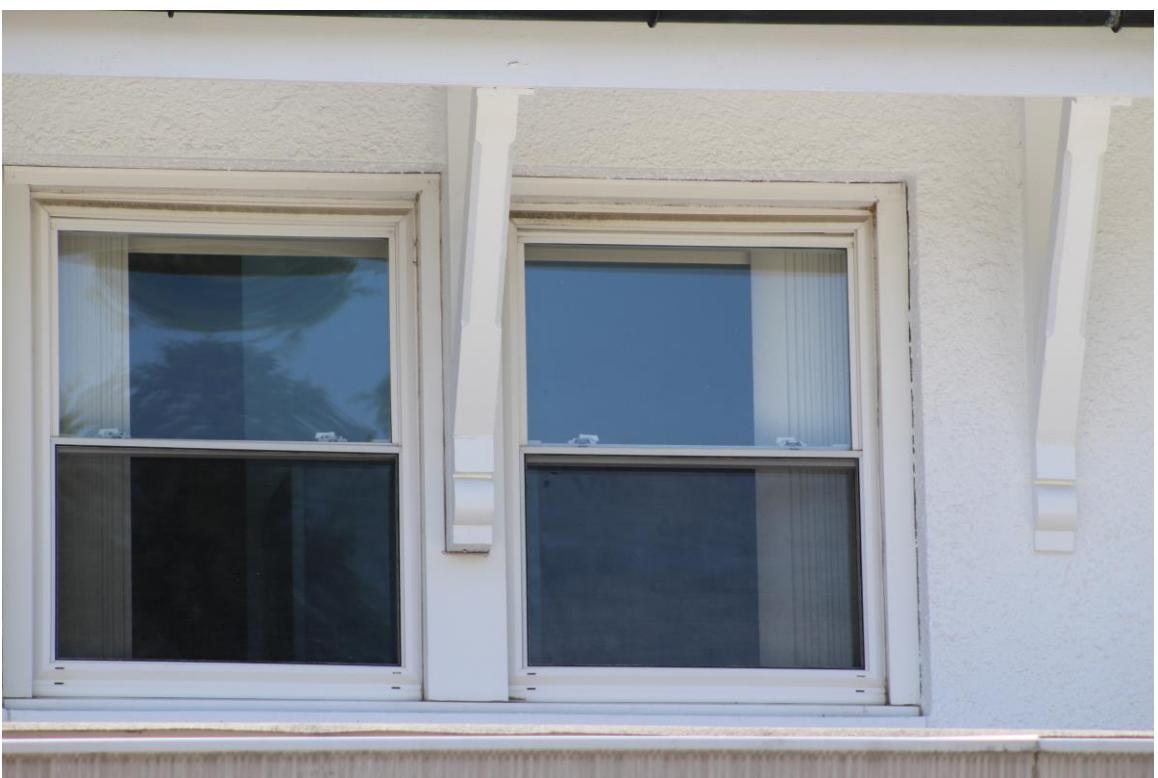
Figure 3-64 Windows – Replacement windows with non-historic configurations.

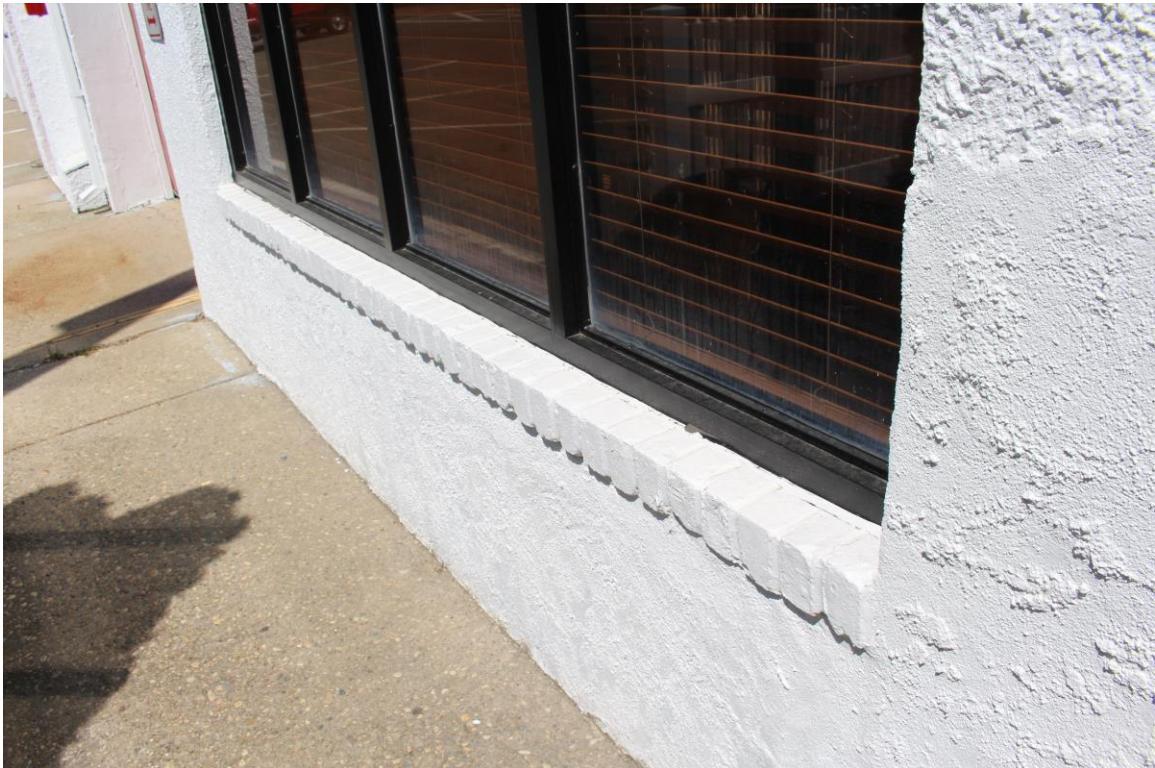
Figure 3-65 Doors – Masonry and window infill in truck-bay opening.

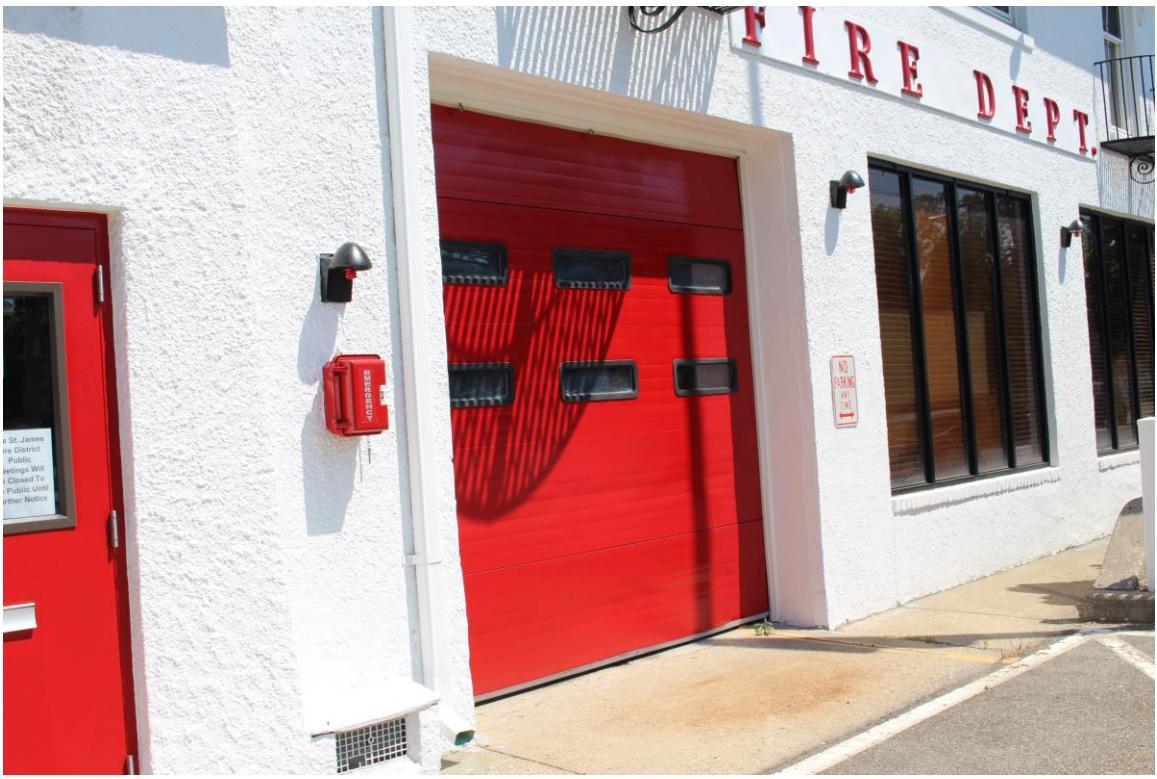
Figure 3-66 Doors – Replacement roll-up door in truck-bay opening.
