ST. JAMES FIREHOUSE CONDITIONS ASSESSMENT REPORT

533 NY-25A ST. JAMES, NY 11780

ISSUED: 08 September 2020

APS PROJECT NO: 20-018

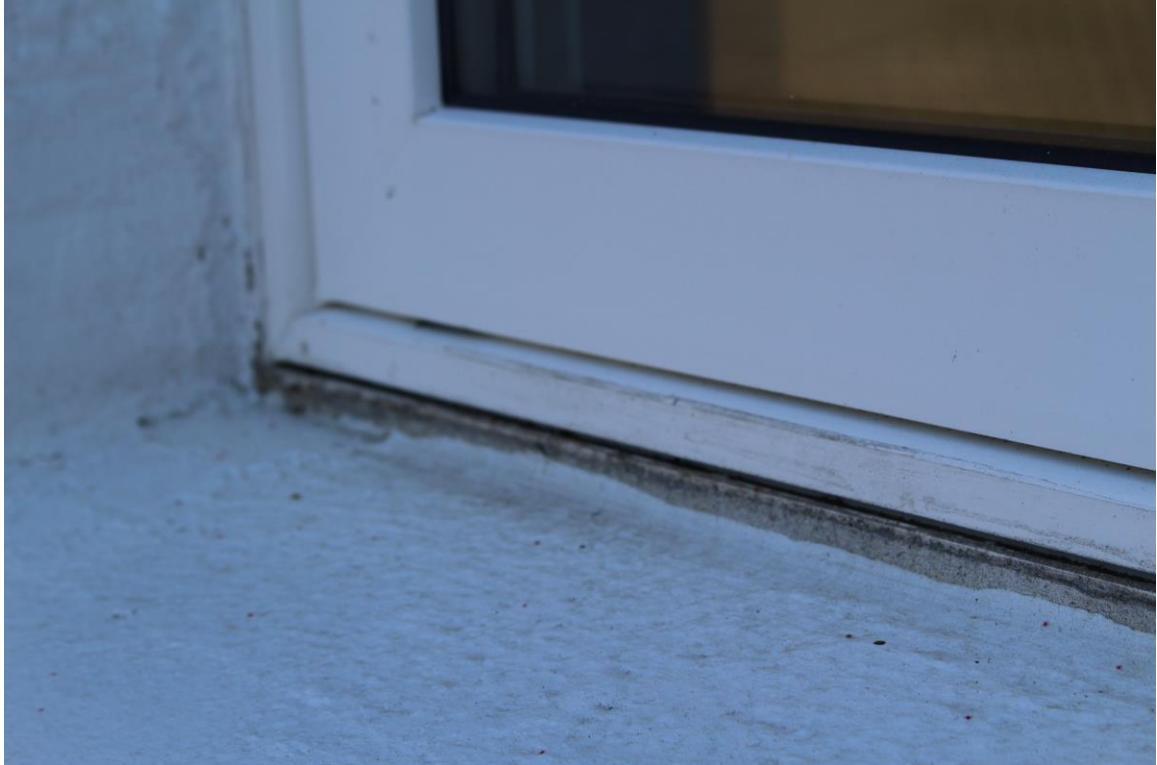
Figure 3-67 Windows – Deteriorated sealant.

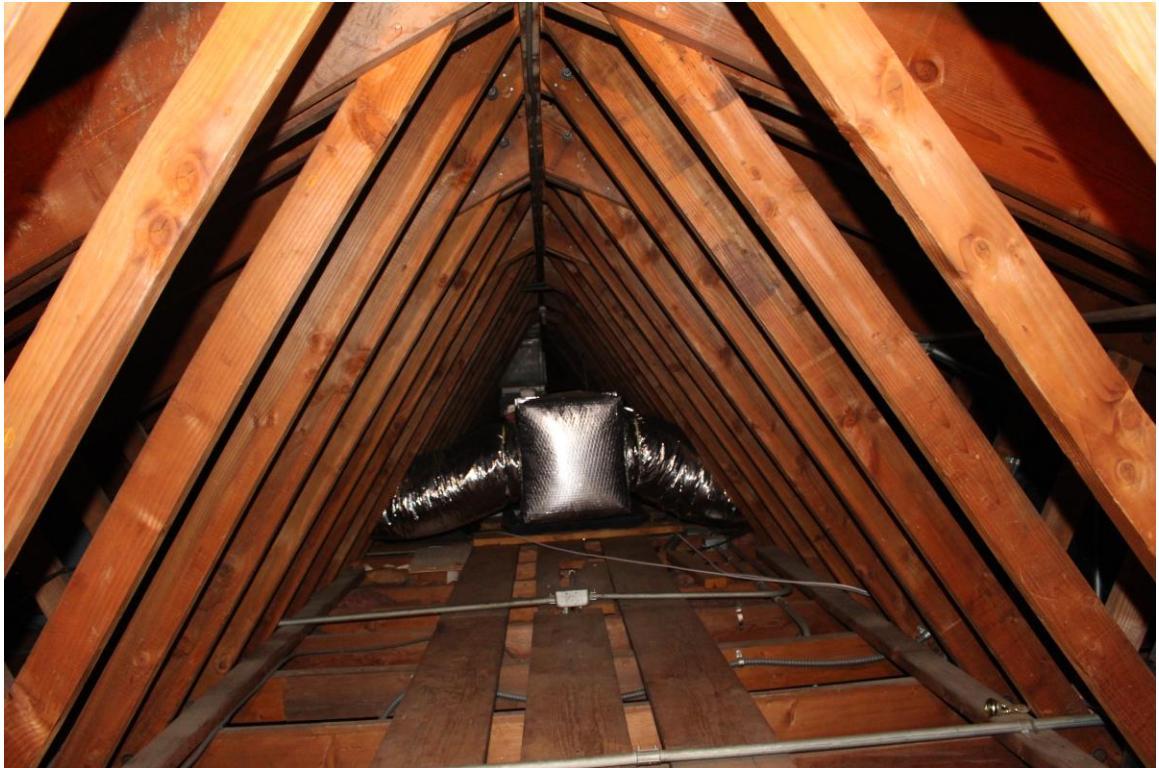
Figure 3-69 Attic – Typical wood roof framing.

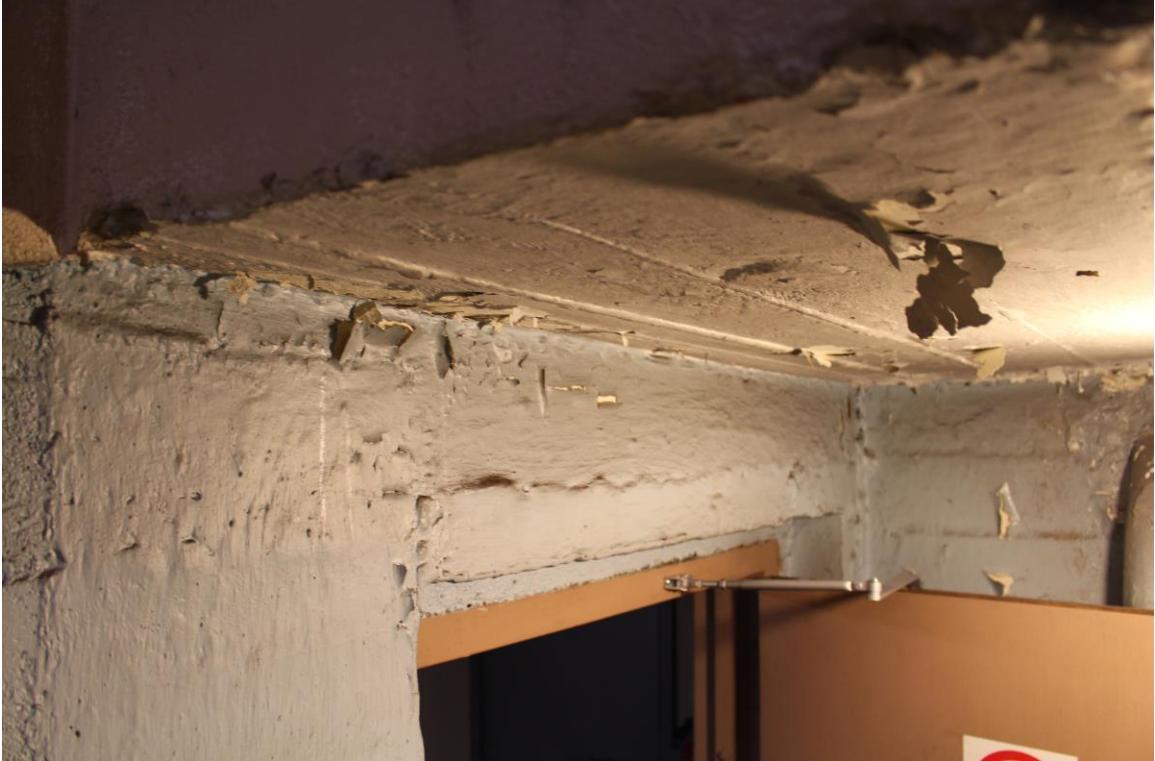
The water damage at the ceiling of the 2nd-floor auditorium and stair tower appears to be the result of improper flashing at the roof, at the juncture of the gable end and hipped roof. The deteriorated wall and ceiling finish in the interior basement stair could be the result of rising damp and a damp environment in the sub-grade spaces. The water damage at the acoustical ceiling tiles in the truck bays is likely caused by leaks in mechanical ductwork in the concealed spaces of the dropped ceiling.

Figure 3-76 Basement – Deteriorated finish at ceiling.

- 1. Repair or replace the deteriorated portions of the auditorium and stair tower ceilings. Remediate as required. Paint to match the existing finish.
- 2. Remove the wall and ceiling finish of the basement spaces. Remediate as required. Repair ceiling back-up as required. Apply new breathable wall and ceiling finish, color to match existing.

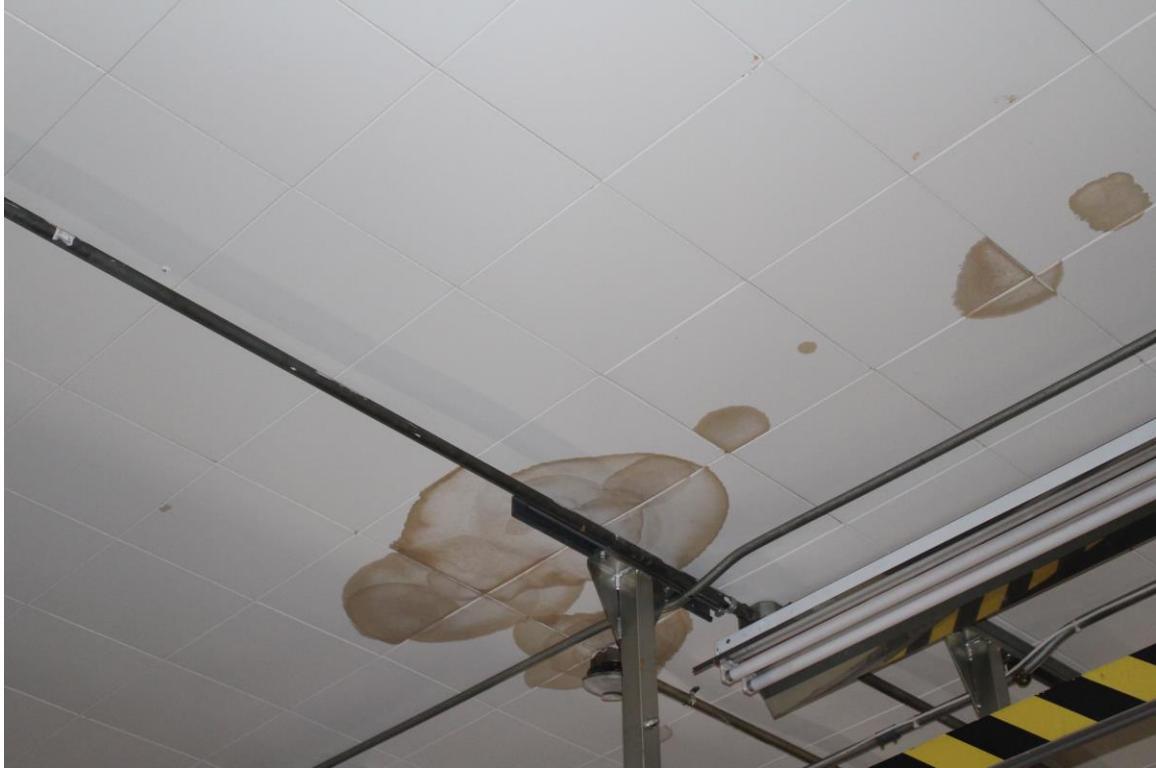
Figure 3-80 Stair tower – Water damage at ceiling (refer to Figure 3-13 for related exterior condition).
